Isivili Enjiniyering

April 2015 Vol 23 No 3

# CIVIL ENGINEERING

Profile on Geotechnical Gold Medallist  
Focus on Geotechnical Engineering

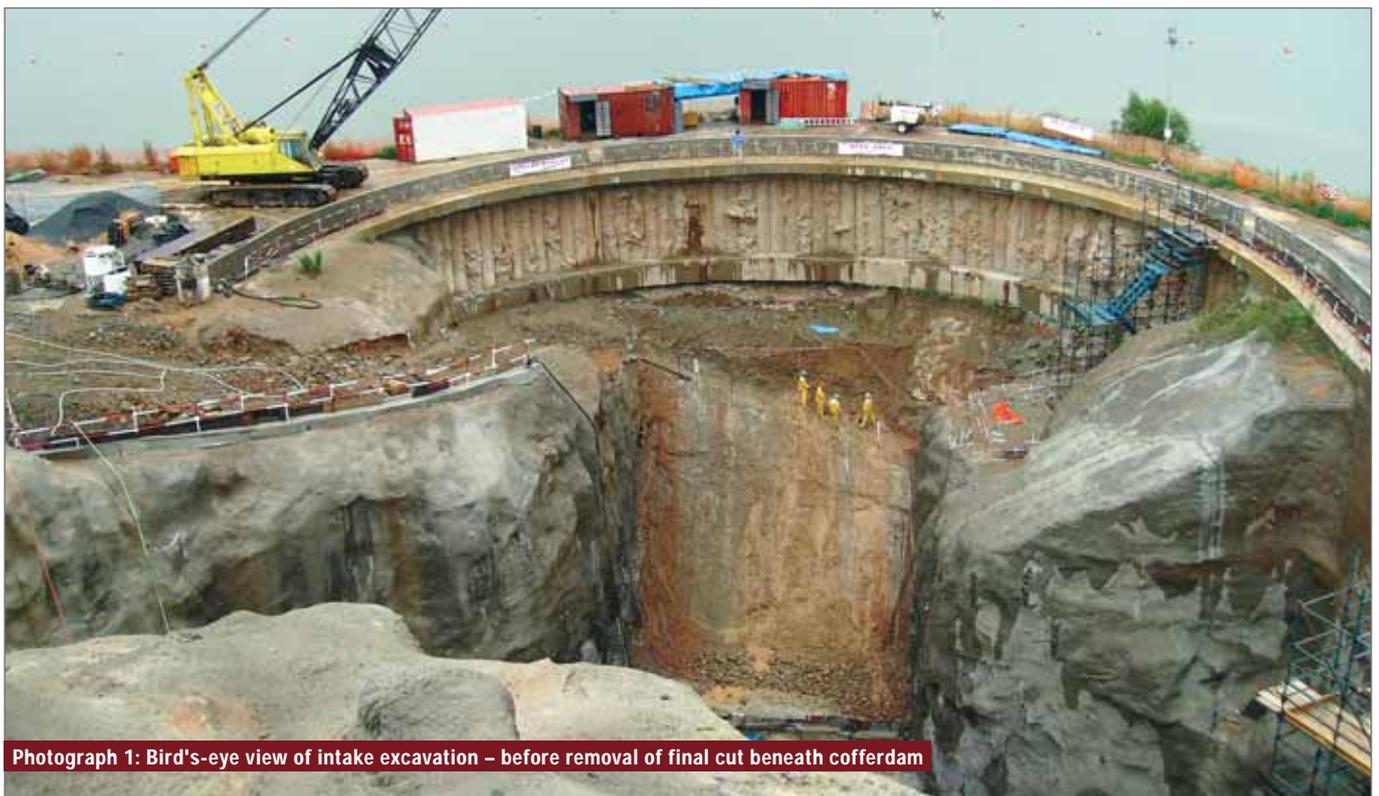
Photograph 1: Bird's-eye view of intake excavation – before removal of final cut beneath cofferdam

The cofferdam foundation, integrity and quality of pile–rock contacts, and the overall cofferdam stability condition could only be finally appreciated once the shaft excavation was substantially advanced, with the cut to the face of the cofferdam (Photographs 1, 2 and 3).

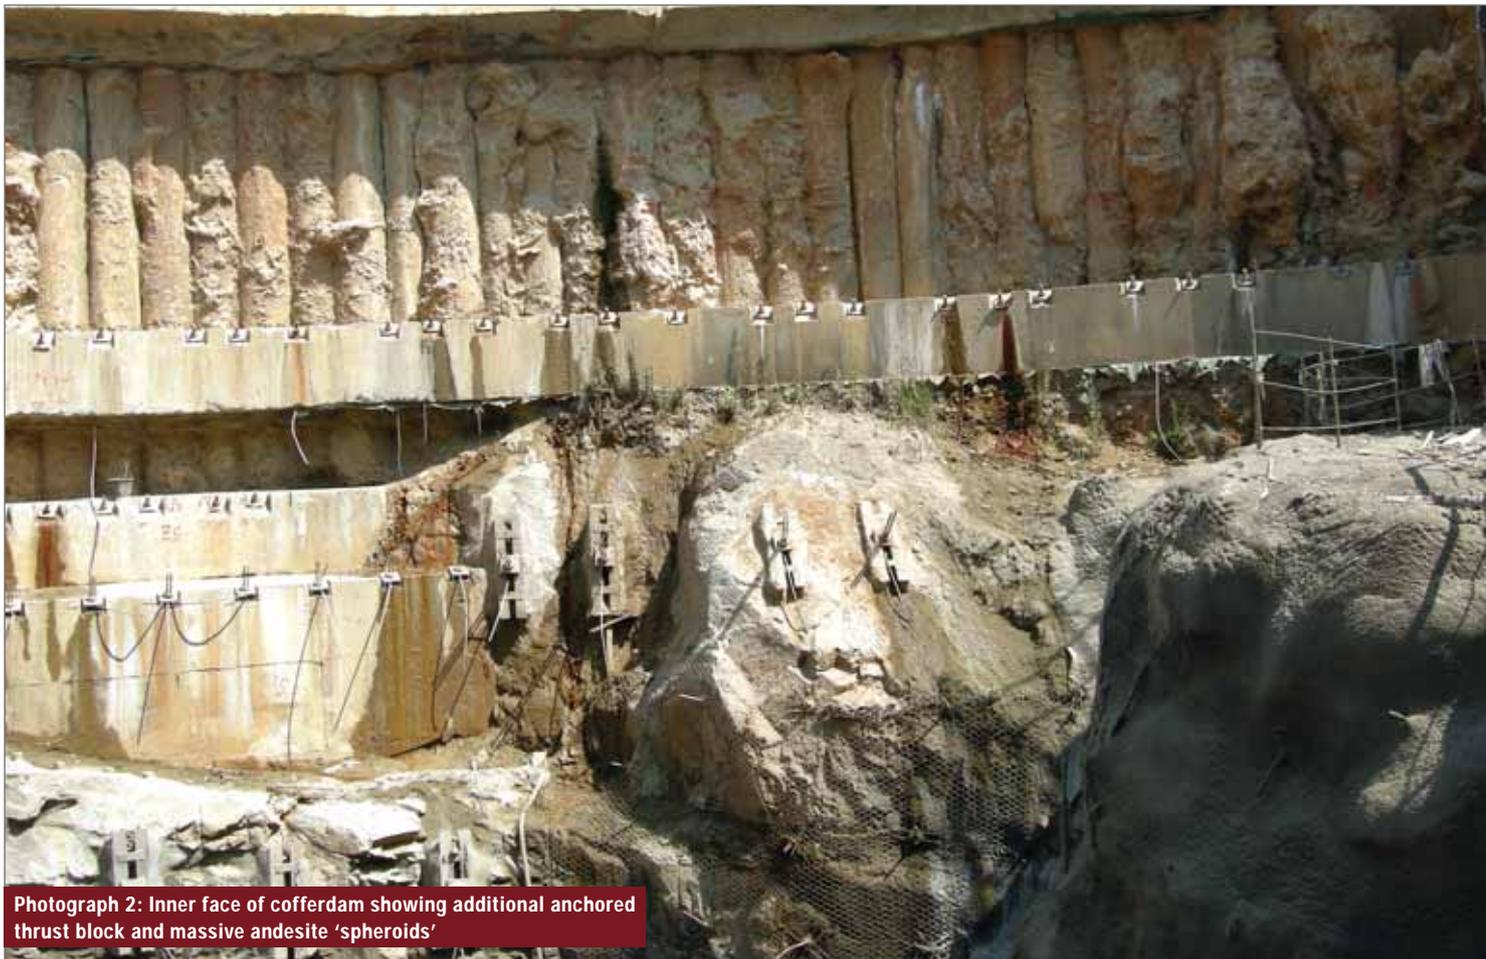
Photograph 2: Inner face of cofferdam showing additional anchored thrust block and massive andesite 'spheroids'

The pile founding/socketing materials could now be seen totally exposed, supported partially on ‘sound’ or weathered andesite rock (locally completely weathered to residual soil and accompanied by notable seepage), and elsewhere on massive tooth-like (large bouldery) spheroid features (Photograph 2).

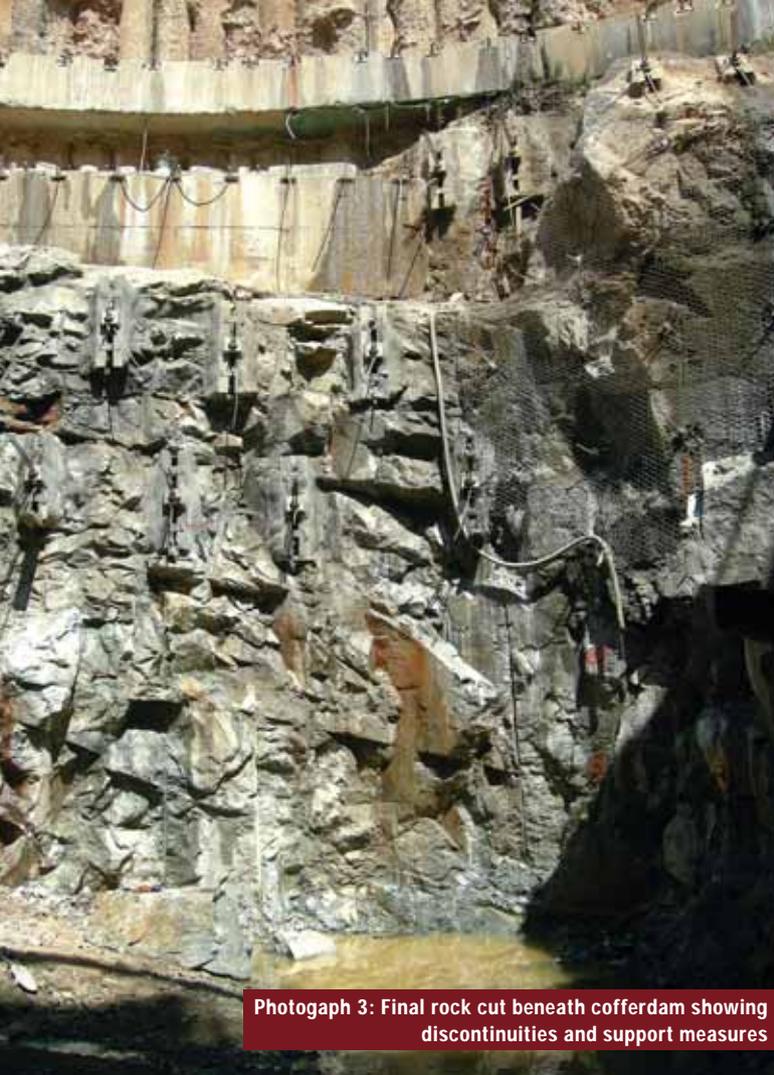
Photograph 3: Final rock cut beneath cofferdam showing discontinuities and support measures

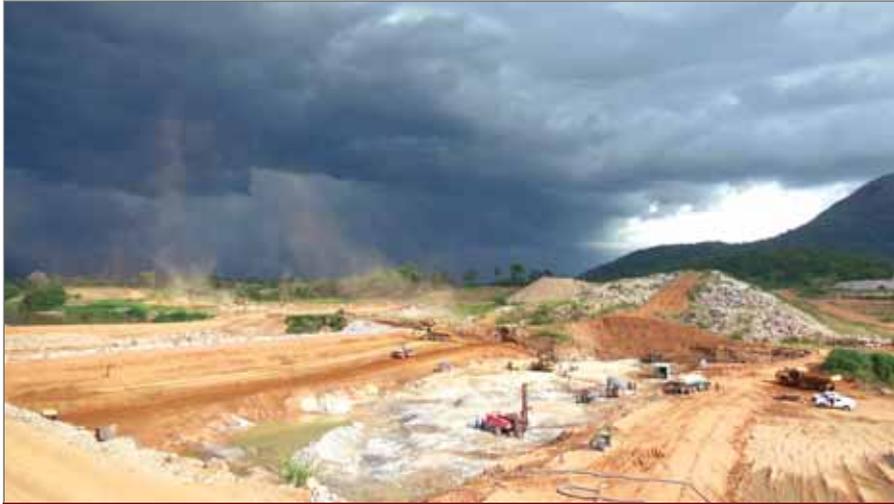
Figure 2: Kashimbila Dam – foundation preparation and grouting for the final section of the embankment

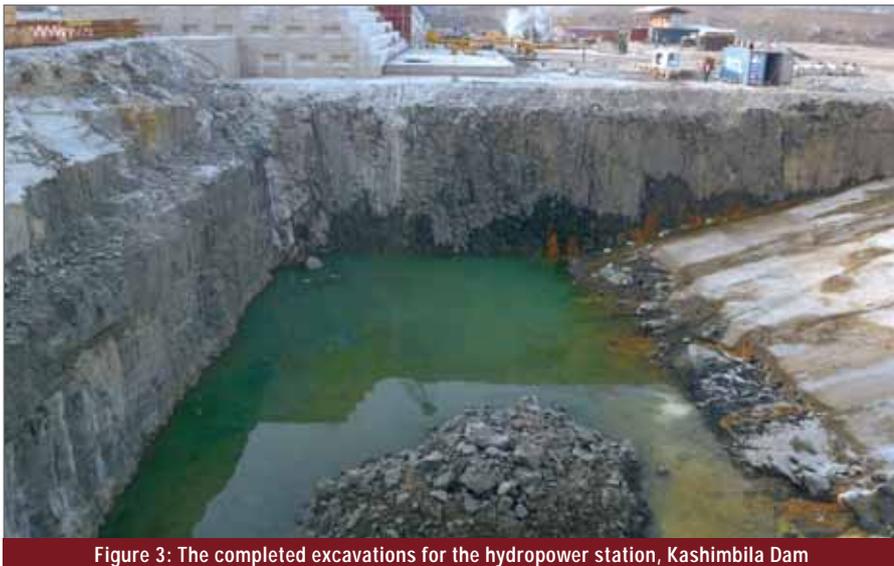
Figure 3: The completed excavations for the hydropower station, Kashimbila Dam

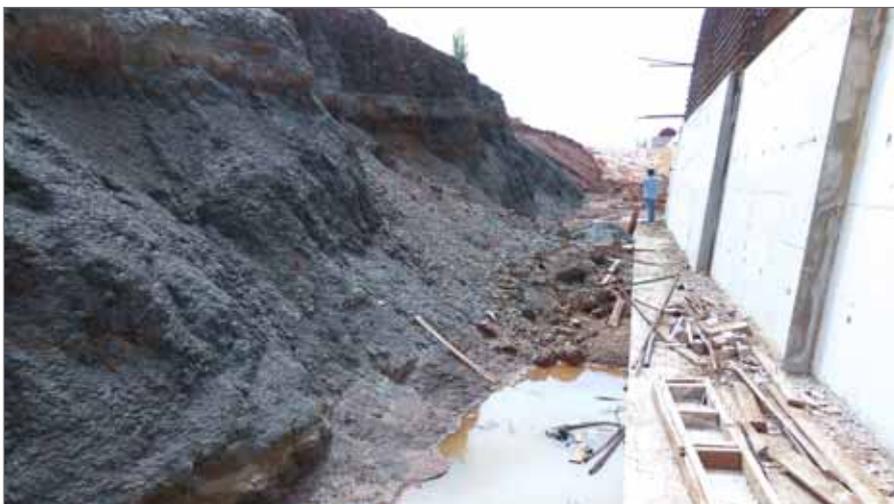
Figure 4: Otukpo Dam – foundations comprising slaking mud rock, exposed here adjacent to the outlet conduit

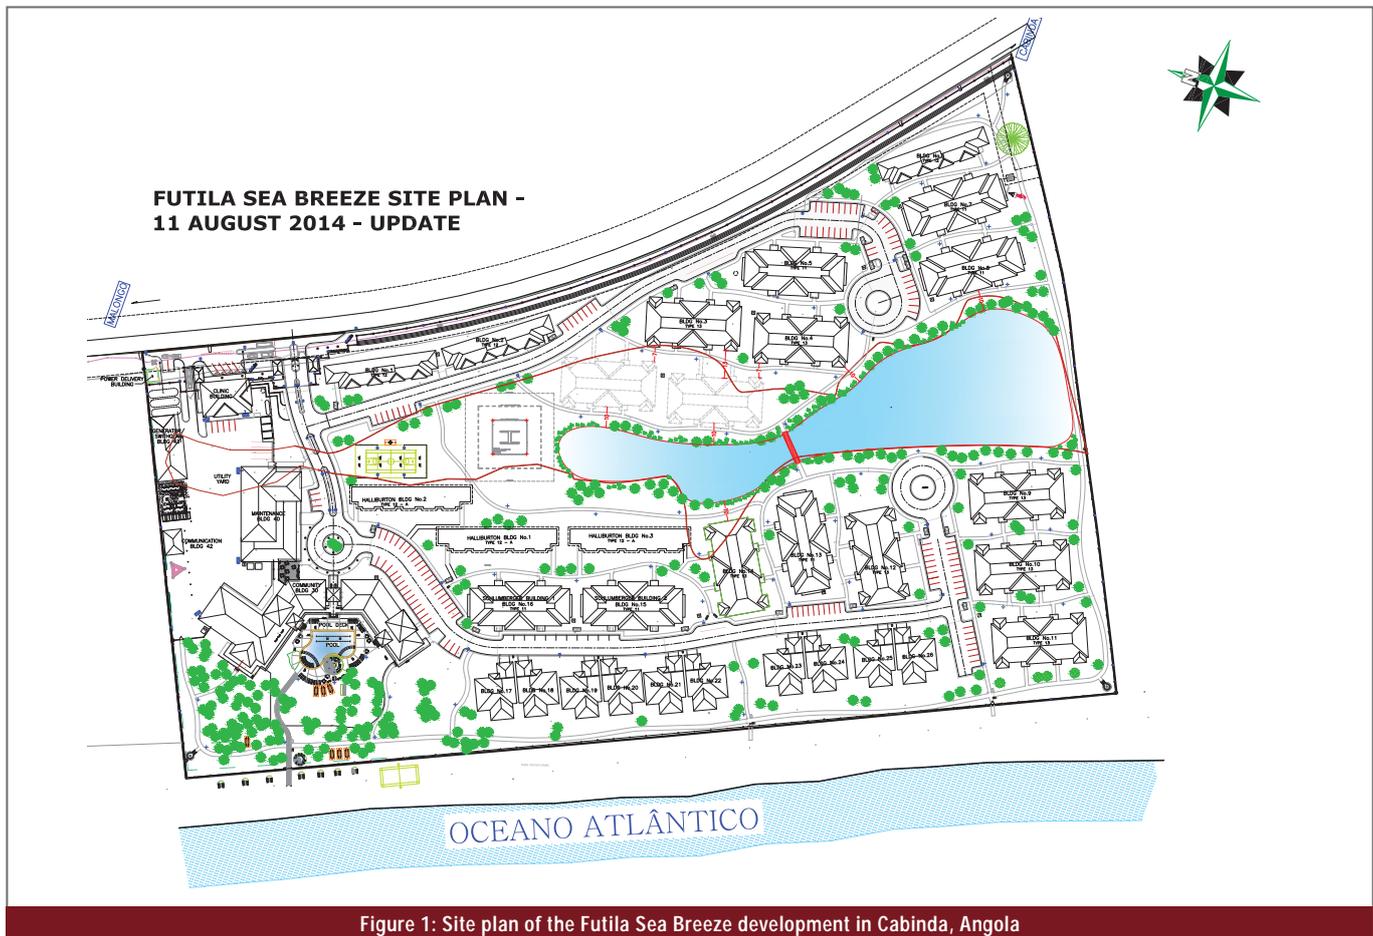
Figure 1: Site plan of the Futila Sea Breeze development in Cabinda, Angola

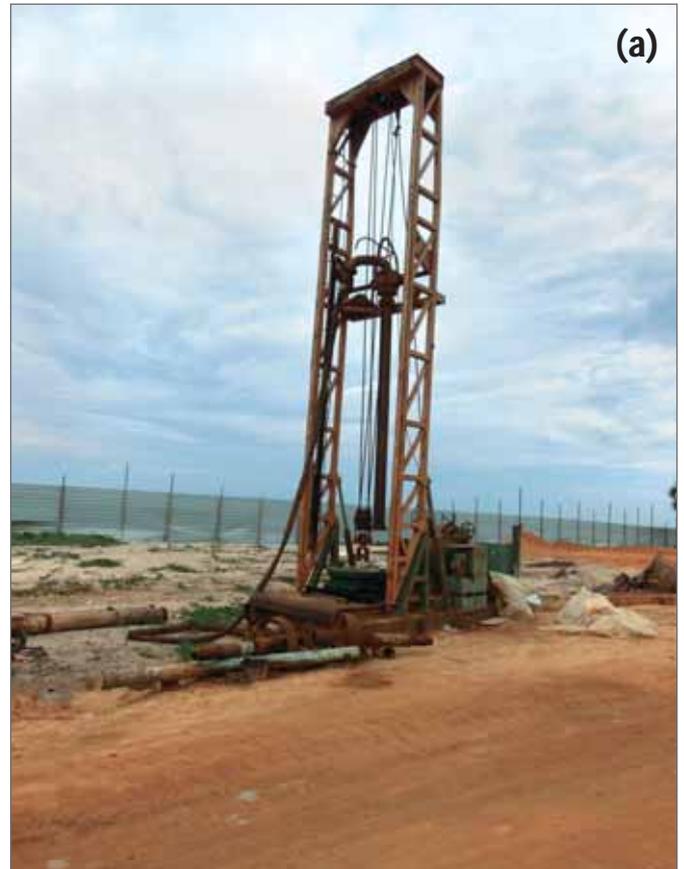
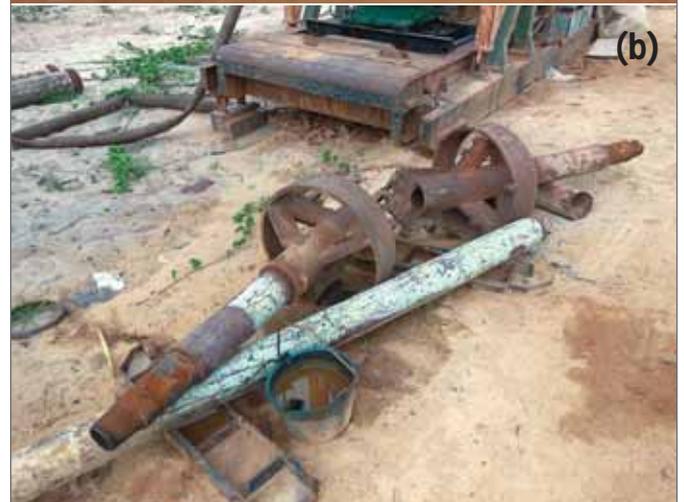
Figure 3: (a) Piling rig (Jintai GPS-15) and (b) drill bit used for test pile installation

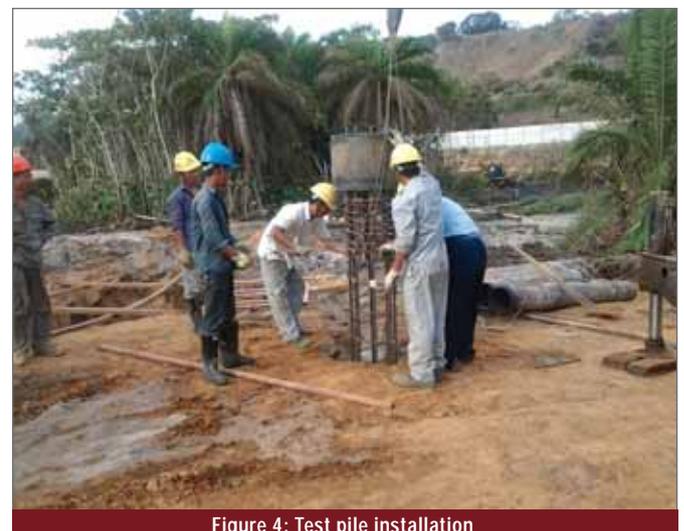
Figure 4: Test pile installation

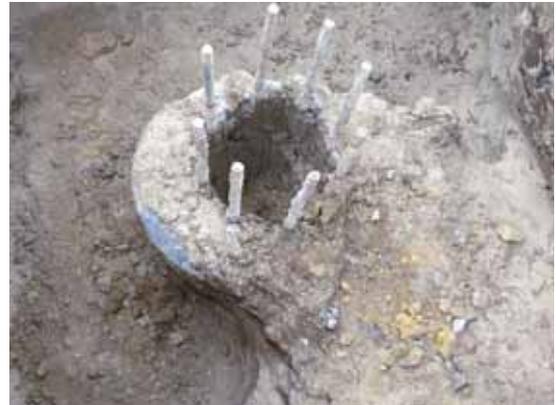
Figure 5: Material residue inclusions observed within centre of reinforcement cage

standard quality. At first, material residue inclusions were observed in the centre of the reinforcement cage in a number of piles, as shown in Figures 5 and 6. When the piles were cut back to reach what appeared to be sound concrete, this at times occurred at depths a lot greater than pile cut-off level (Figure 7). Based on these observations, the extent of the ma-

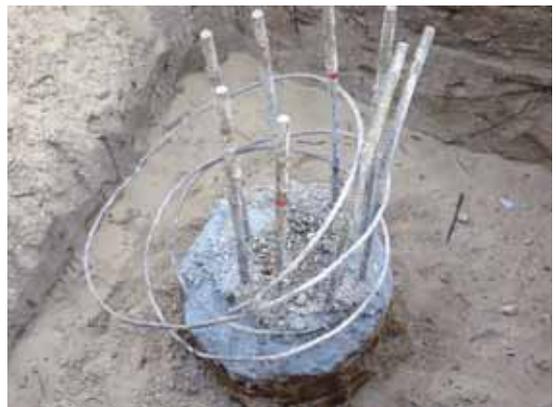
Figure 6: Another example of material residue inclusions observed within centre of reinforcement cage

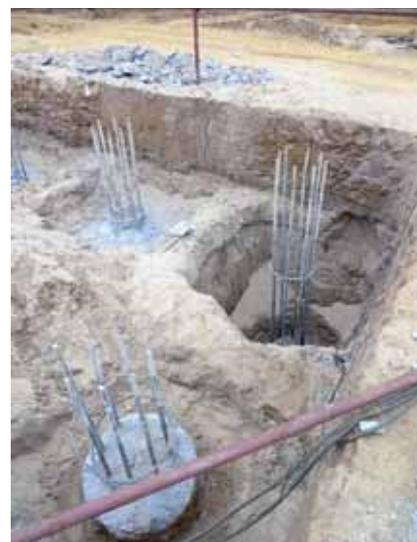
Figure 7: The length of pile that had to be cut back to reach sound concrete

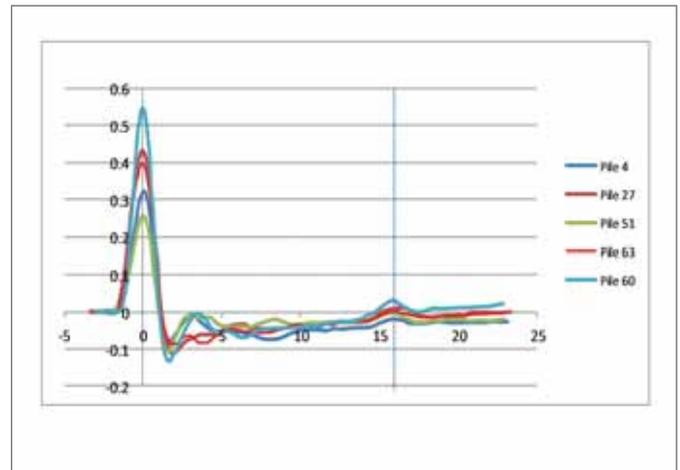
Figure 8: A typical 'good pile' response utilising PIT response curves from piles

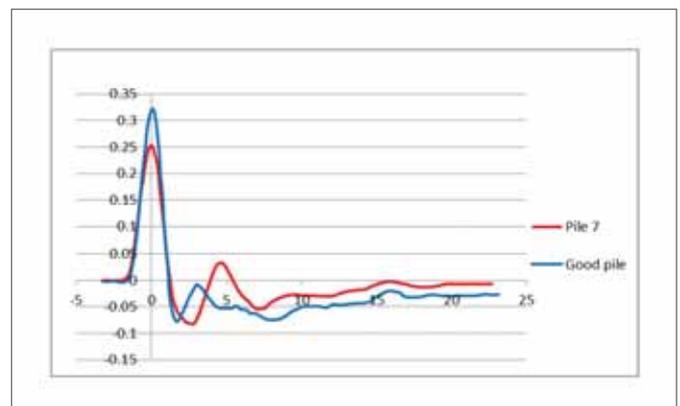
Figure 9: Defective pile showing possible necking in top 3 to 5 m of the pile

piles. Aurecon was uncertain about the level of detail in terms of the extent of necking that could be interpreted from the PIT results. However, notwithstanding the sub-contractor's clarifications, Aurecon assumed that the reduction in diameter still provided sufficient cover to the reinforcement. This was based on the anomalies occurring below the water table, hence there would be low oxygen levels present and the potential for corrosion of the reinforcement was considered low. The small moments exerted on the respective piles also supported the interpretation that some of the piles associated with 'necking' anomalies were satisfactory.

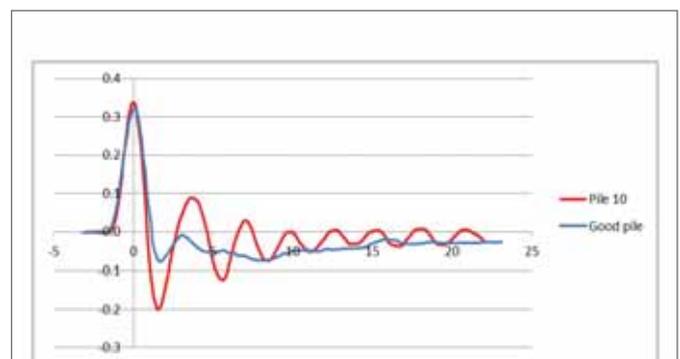
Figure 10: Isotropic reflected signal and multiple reflection in top 4 m length of pile could be associated with necking, segregation, material residue inclusions or a broken pile

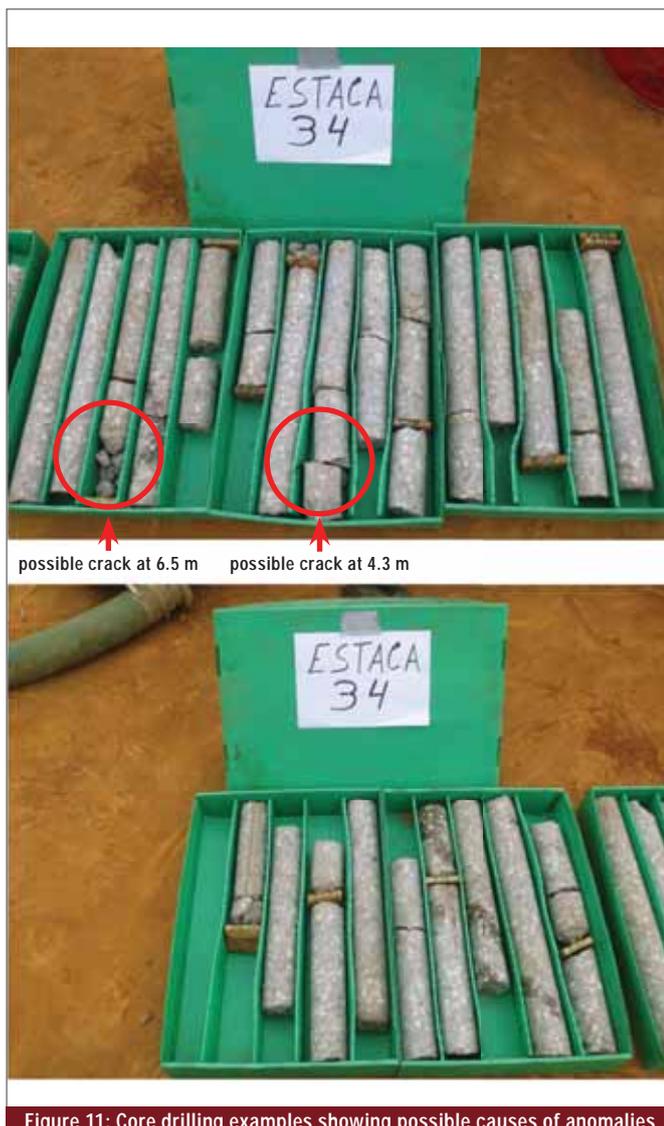
Figure 11: Core drilling examples showing possible causes of anomalies

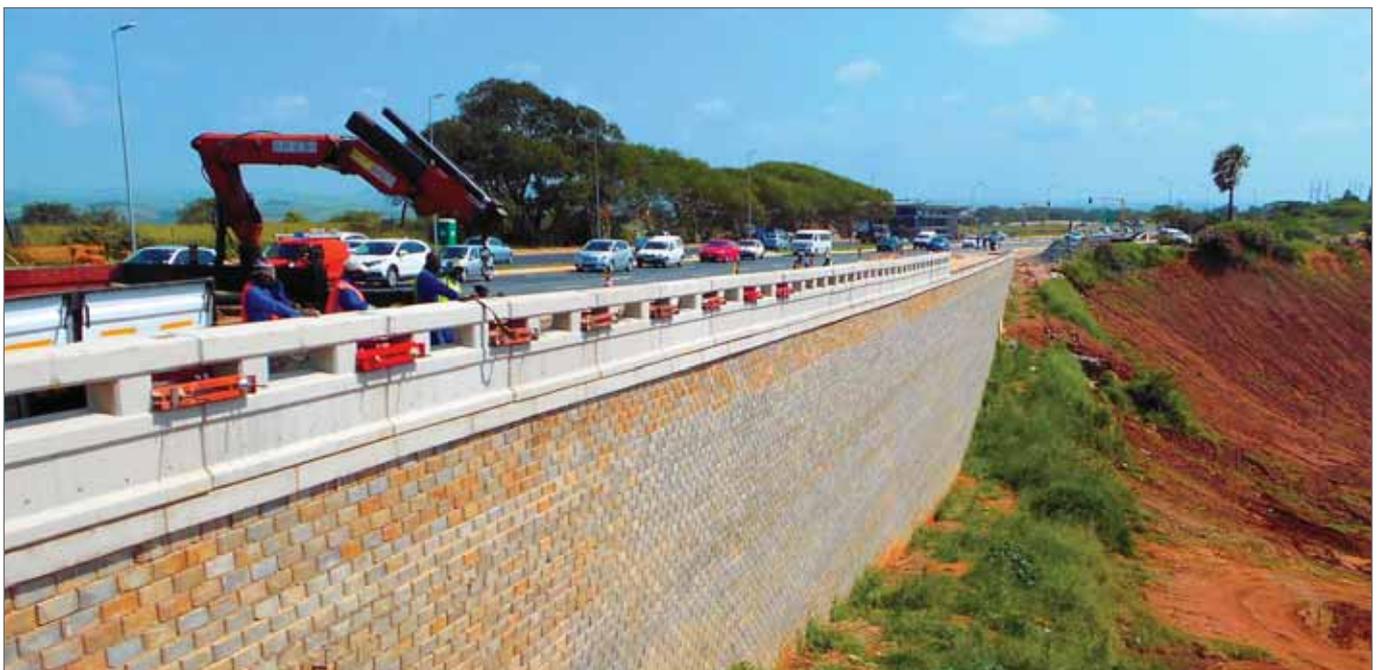
Figure 1: Installation of crash barrier on 11 m high Tensor TW1 wall at Ballito Drive

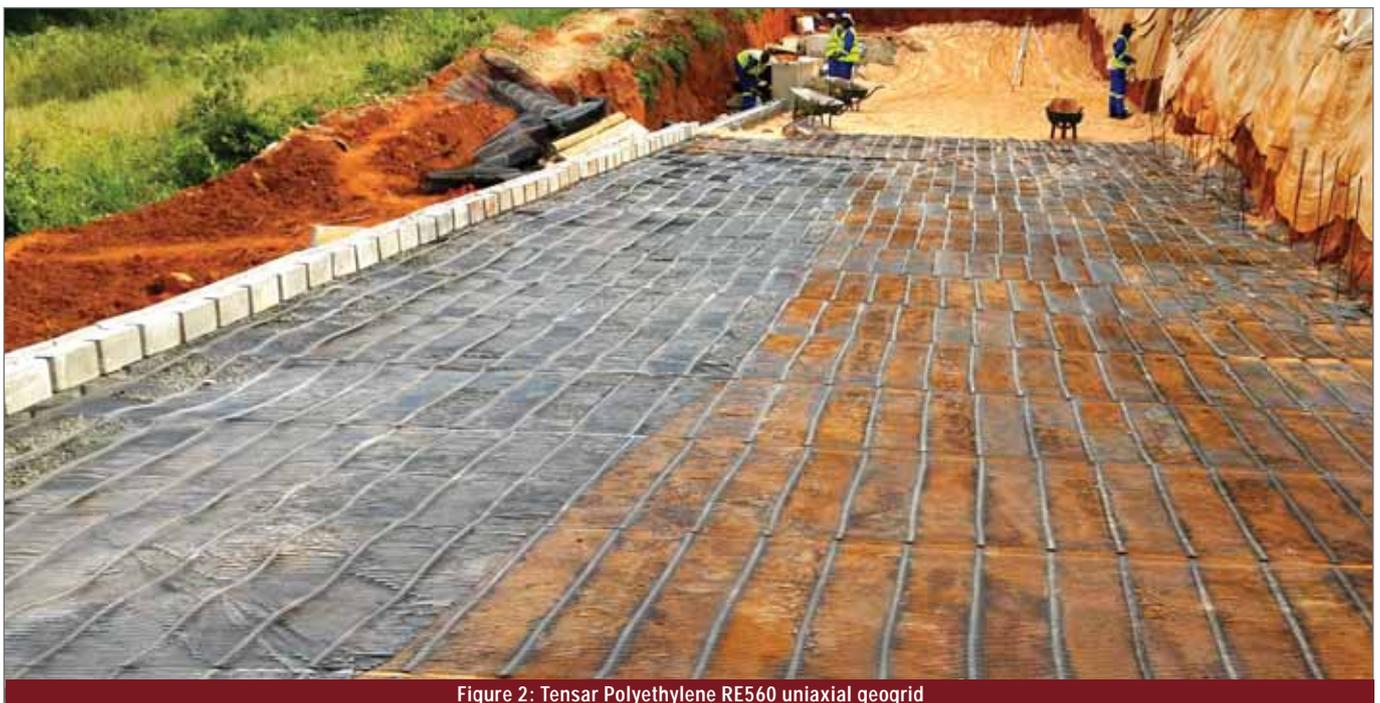
Figure 2: Tensar Polyethylene RE560 uniaxial geogrid

Modelling material properties for the membrane and interface elements in a finite element model can be problematic, especially considering that the geogrid's pull-out resistance is derived from friction generated on the soil-reinforcement boundary,

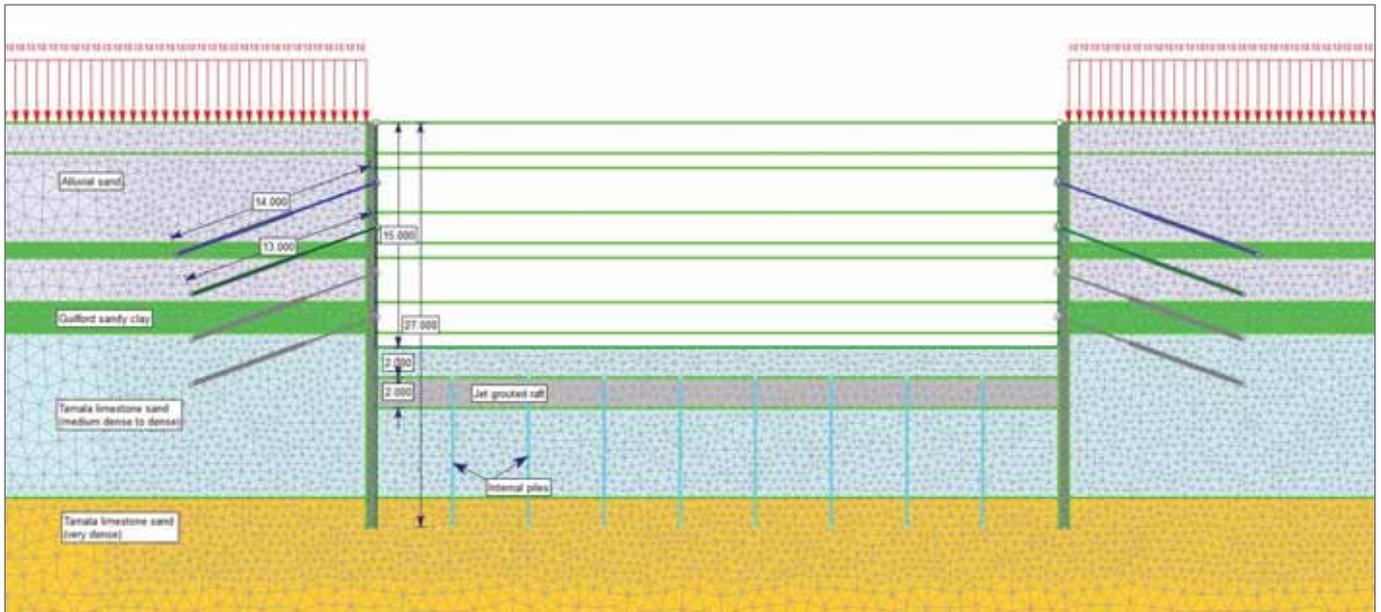
Figure 2: Dimensioned model of Design Option 2

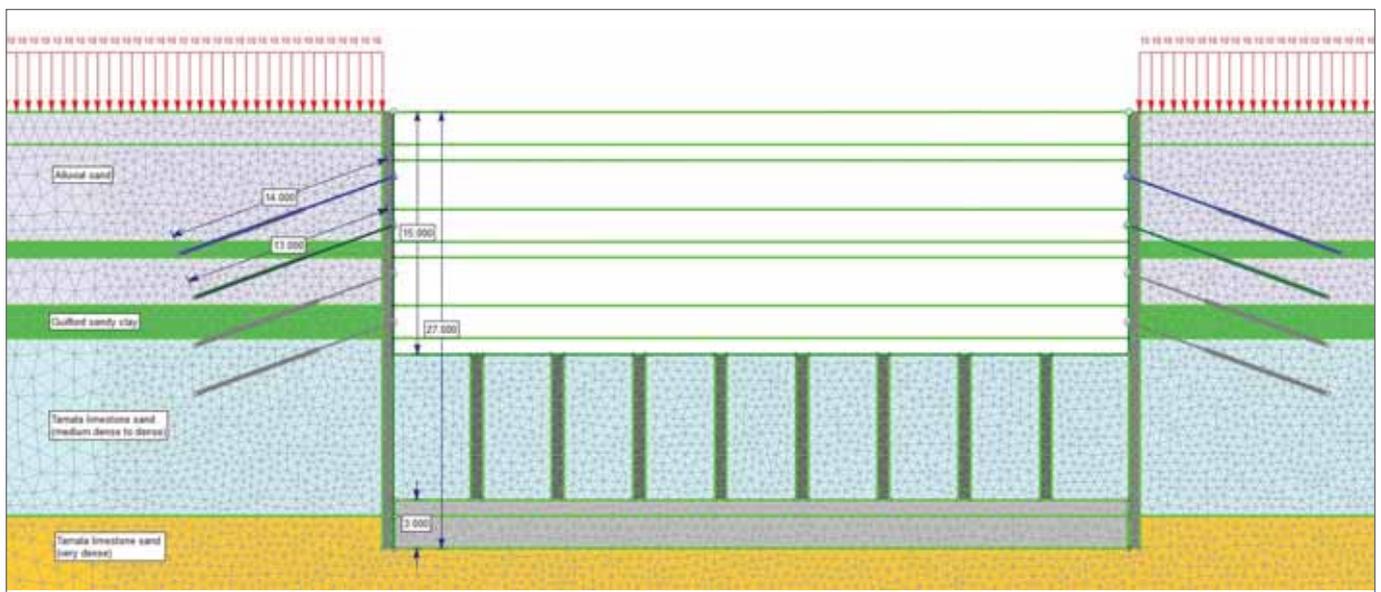
Figure 3: Dimensioned model of Design Option 3

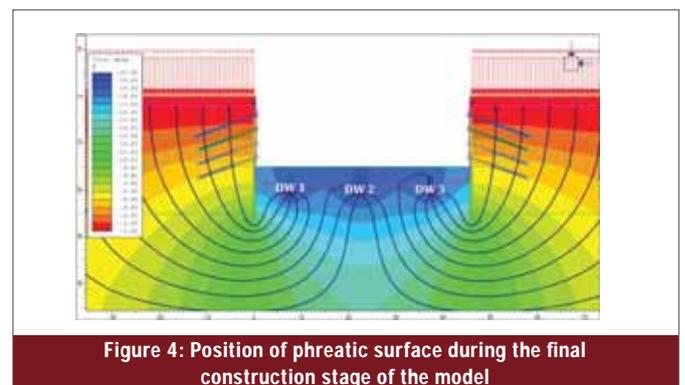
Figure 4: Position of phreatic surface during the final construction stage of the model

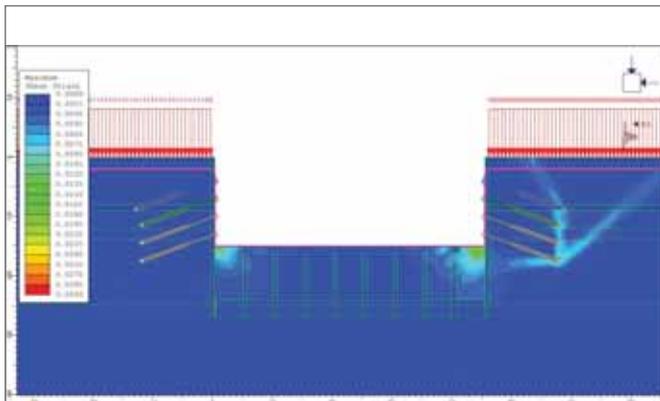
**Figure 6:** Contour plot of maximum shear strains during the final stage of construction for the model under ultimate load conditions

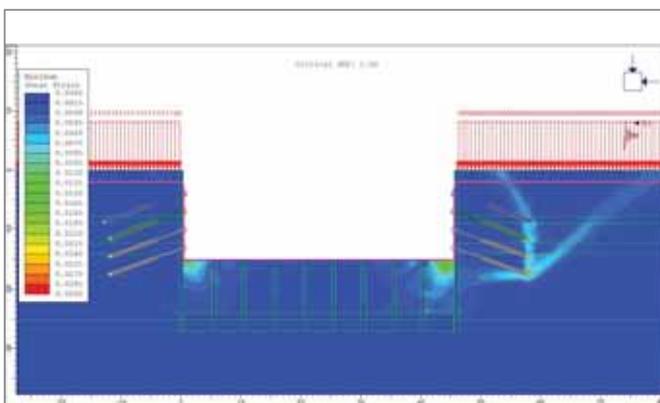
**Figure 7:** SRF output for the model under ultimate load conditions

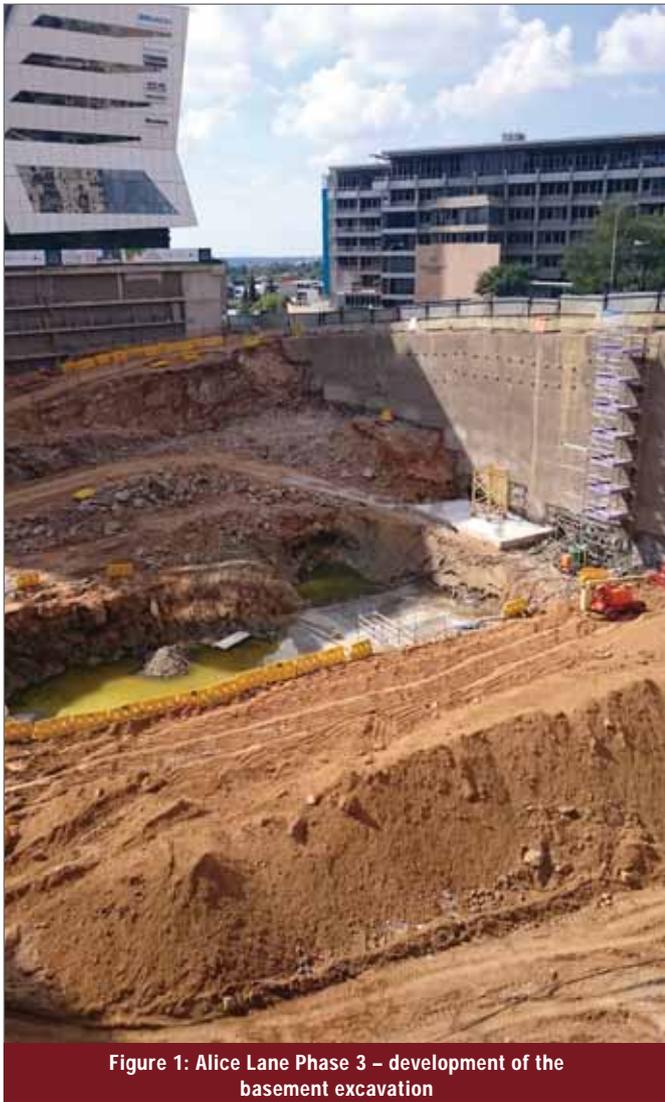
Figure 1: Alice Lane Phase 3 – development of the basement excavation

*In order to realise this vision, the original Standard Bank building had to be demolished, and an excavation with a total volume of 110 000 m<sup>3</sup> and a maximum depth of 20.1 m was excavated for the basement parking structure.*

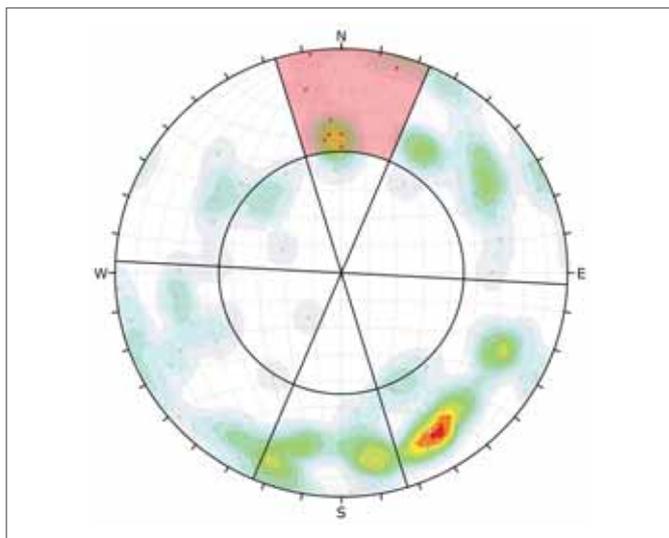
Figure 7(a): Planar failure

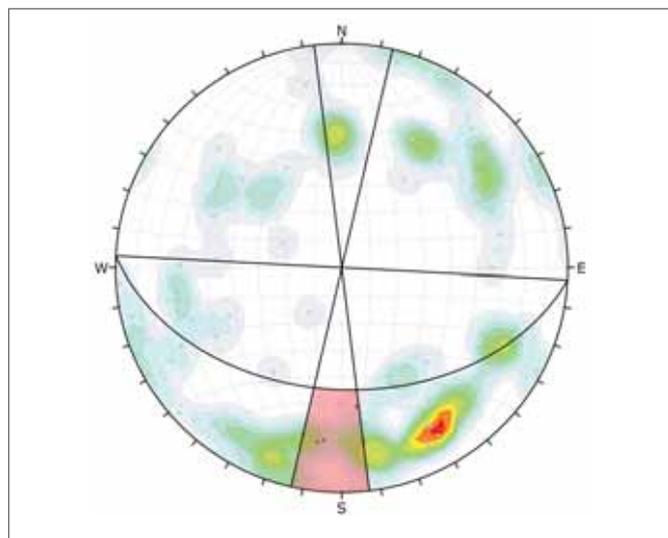
Figure 7(b): Toppling failure

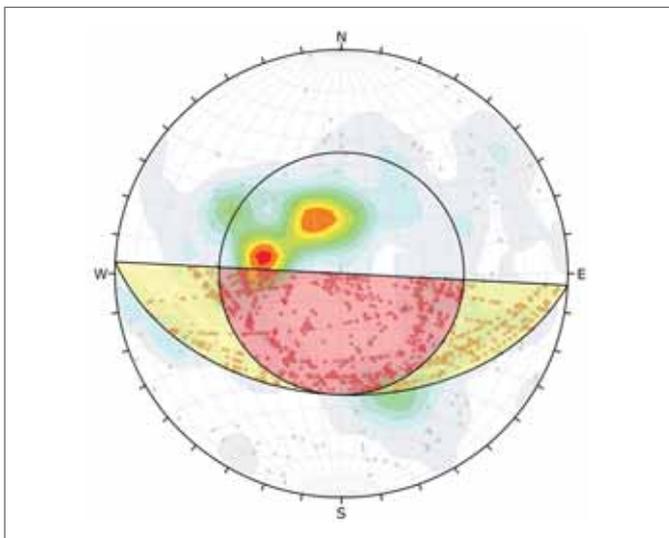
Figure 7(c): Wedge failure (intersections)

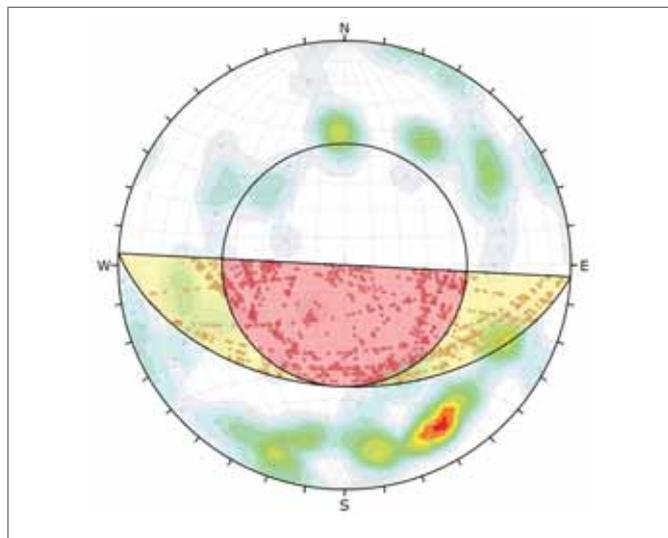
Figure 7(d): Wedge failure

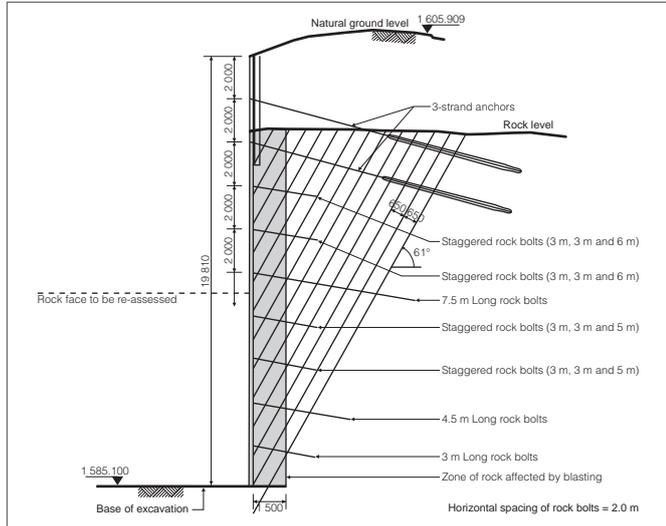
Figure 8: Typical modified section

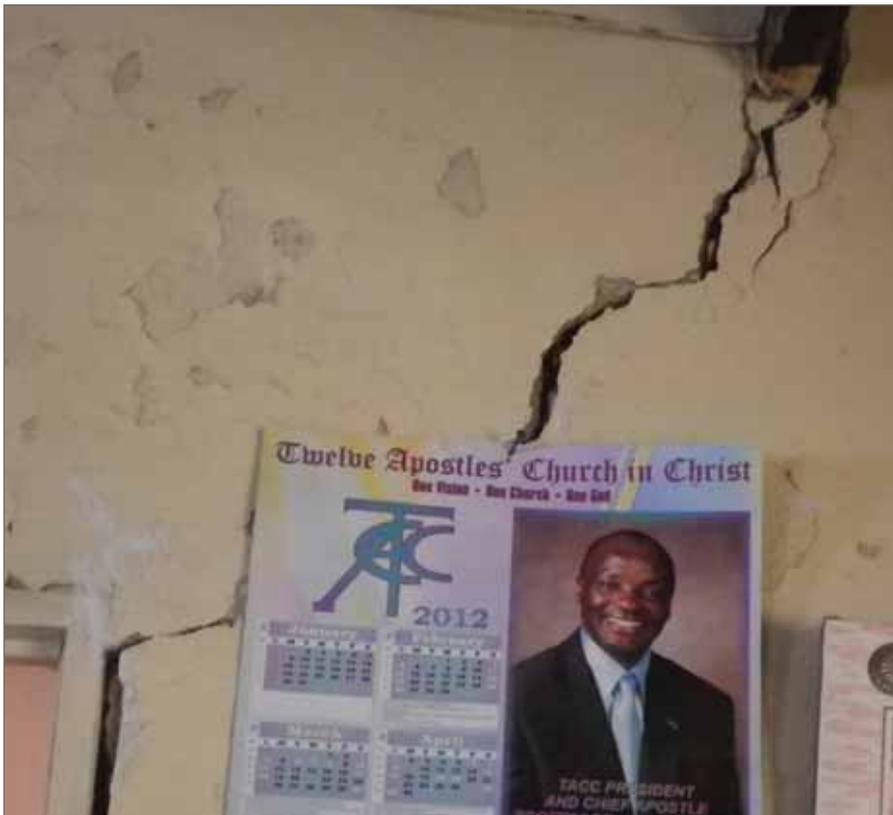
**Deterioration of structural integrity typical of subsidy housing projects. In the development where this photograph was taken, approximately 25% of the houses were in a condition similar to this within five years after completion. The CUT research group has examined one development where almost 30% of the houses became unfit for habitation and had to be demolished.**

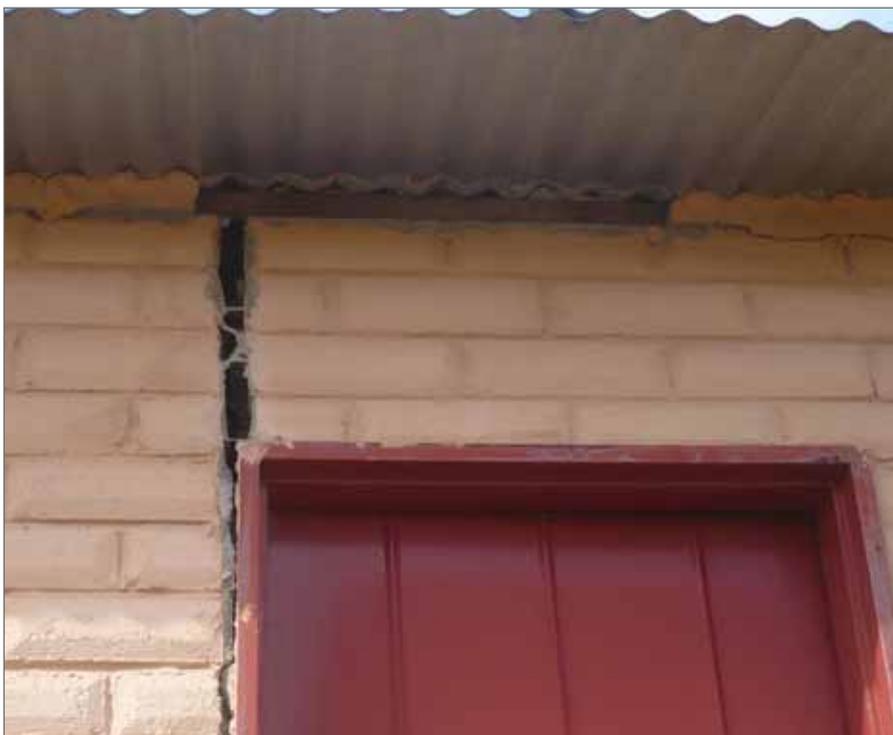
**Heave damage to a house shortly after completion. The CUT research group examined a development where one of the houses became structurally unsound (and had to be demolished) even before it was completed. The tests performed in the geotechnical investigation had given a very misleading indication of heave potential.**

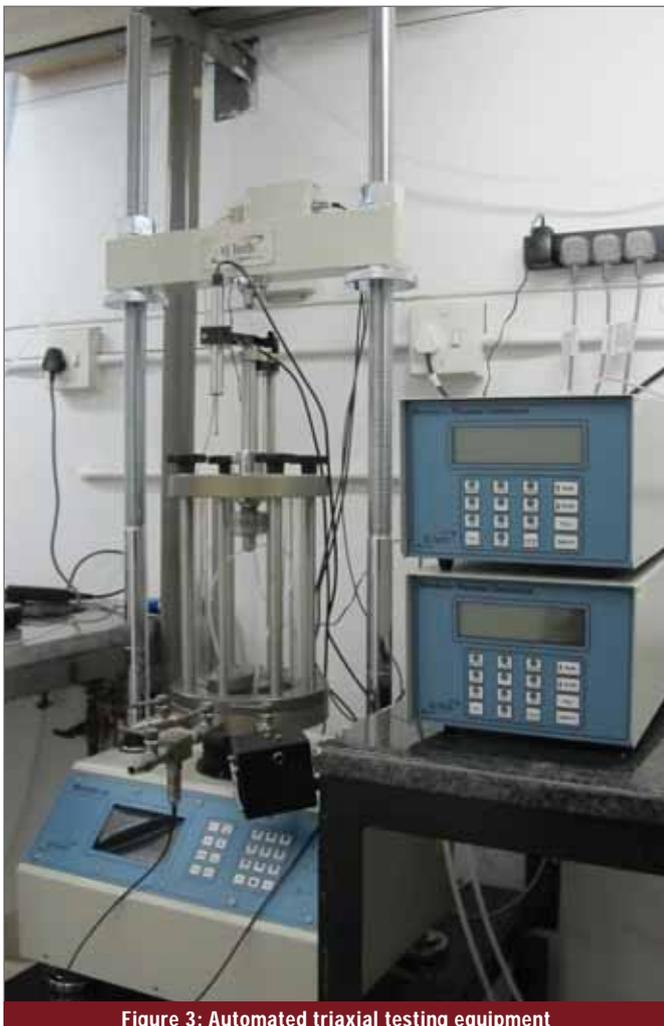
Figure 3: Automated triaxial testing equipment
