CIVIL ENGINEERING

April 2016 Vol 24 No 3

Focus on:
Geotechnical Engineering

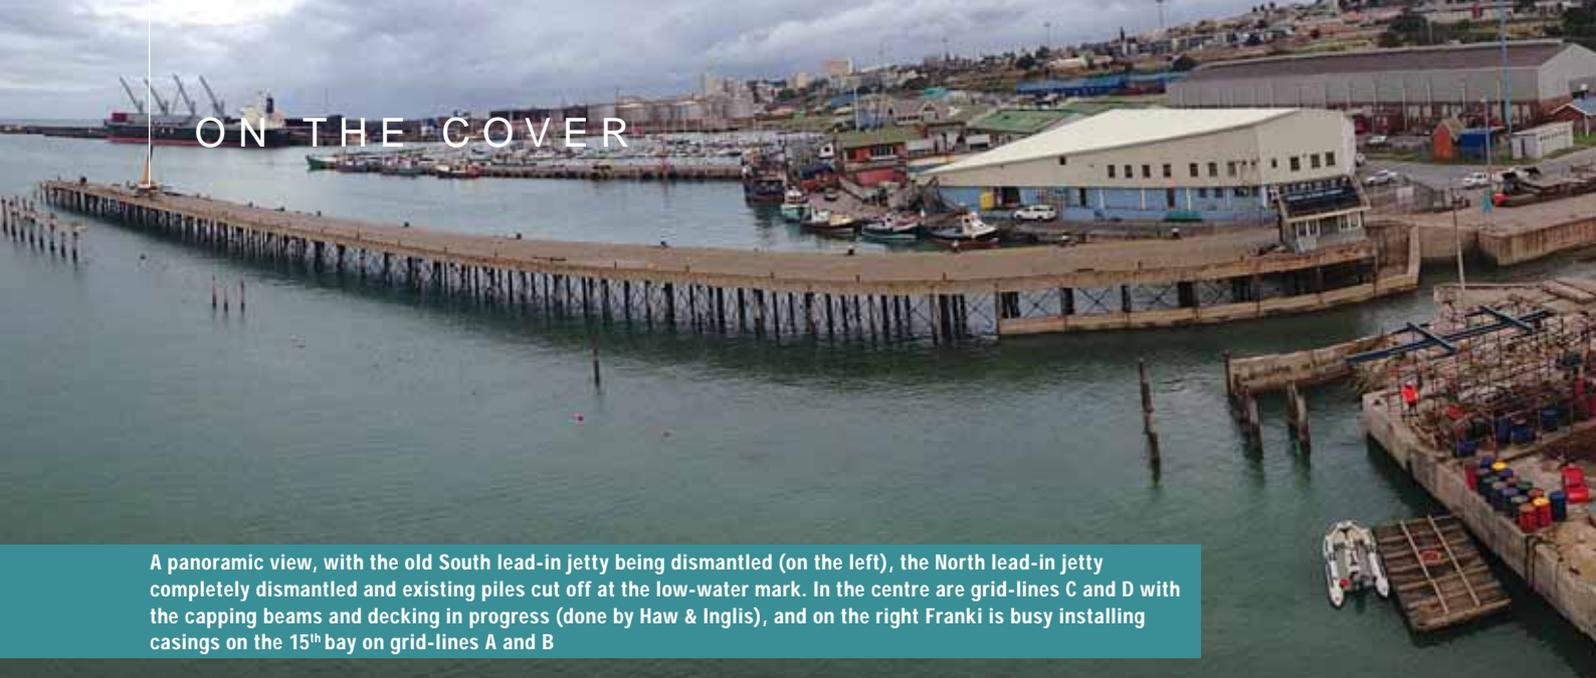
A panoramic view, with the old South lead-in jetty being dismantled (on the left), the North lead-in jetty completely dismantled and existing piles cut off at the low-water mark. In the centre are grid-lines C and D with the capping beams and decking in progress (done by Haw & Inglis), and on the right Franki is busy installing casings on the 15th bay on grid-lines A and B

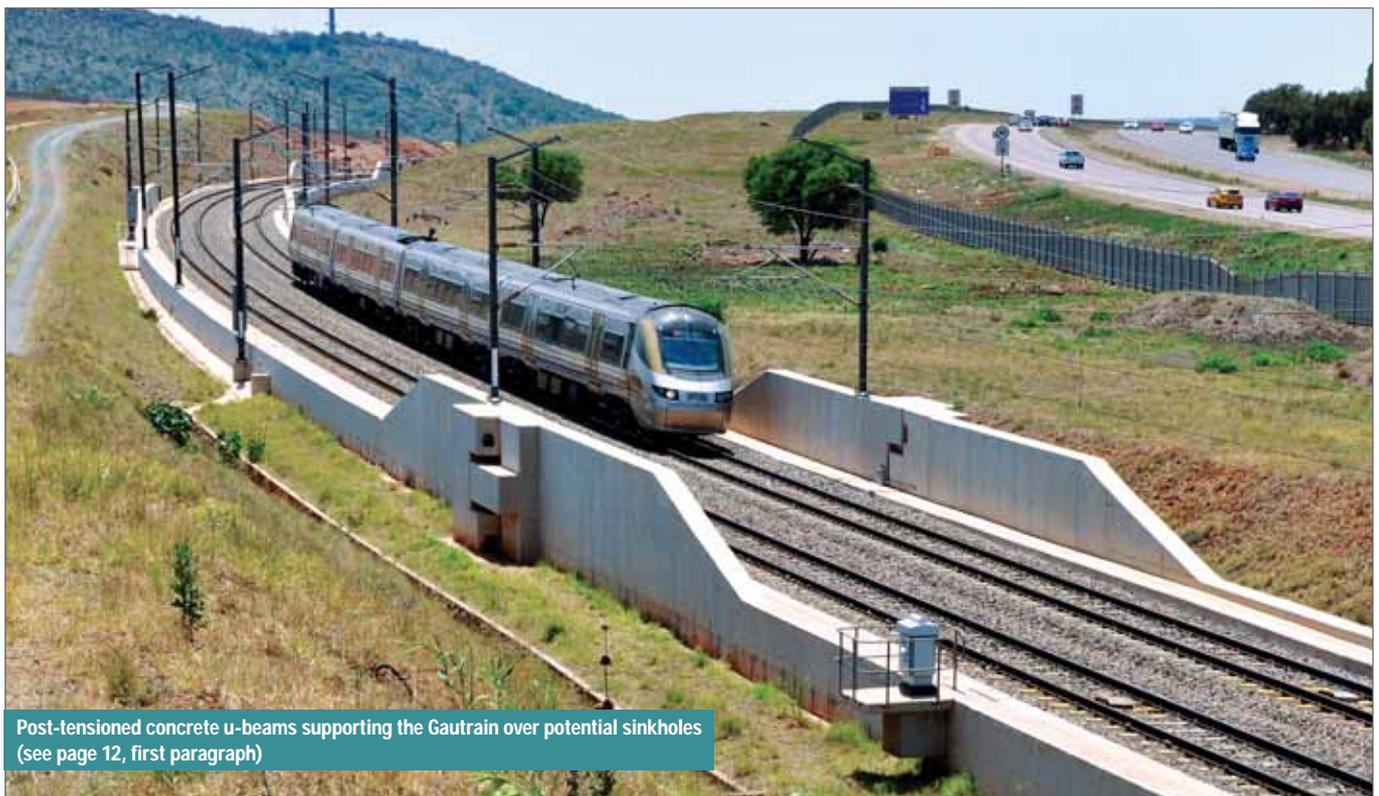
Post-tensioned concrete u-beams supporting the Gautrain over potential sinkholes (see page 12, first paragraph)

For example, from early research work on thin shells, the design solution of the Gautrain Rapid Rail Link over sinkholes was inspired (one of Hendrik’s current projects includes assuring statutory compliance of dolomite land use); steel-fibre-reinforced shotcrete led to plant root reinforcement of soils; key stones in masonry vaults were found to explain the stability of jointed rock around mining stopes at great depth; the principles of mechanically stabilised earth were employed to arrest squeezing of soft ground into tunnels; and mechanical ripping of rock progressed to hydraulic erosion of soil and jet-cutting of stainless steel and ceramics.

This enabled Hendrik to design (on a probability basis) road bridge foundations under hydraulic action in the UK, tunnel support in mines in the USA, the post-tensioned concrete U-beams for the Gautrain Rapid Rail Link over potential sinkholes, the population density in single-, double- and treble-storey residential developments, and multi-storey office and residential buildings on dolomite land, which included the safety of the largest private hospital in the southern hemisphere on dolomite land.

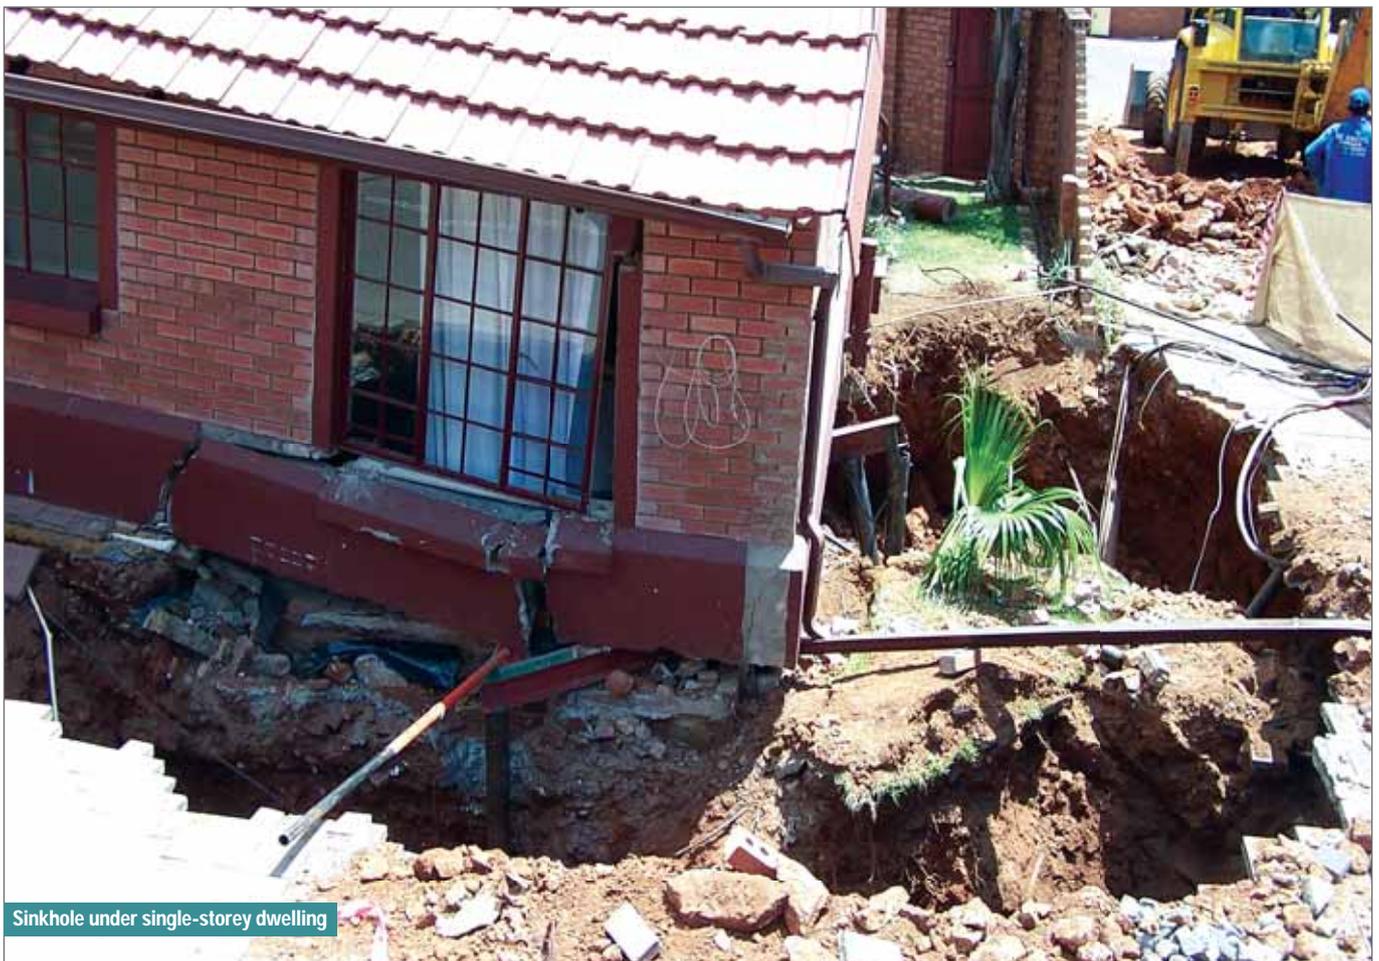
Sinkhole under single-storey dwelling

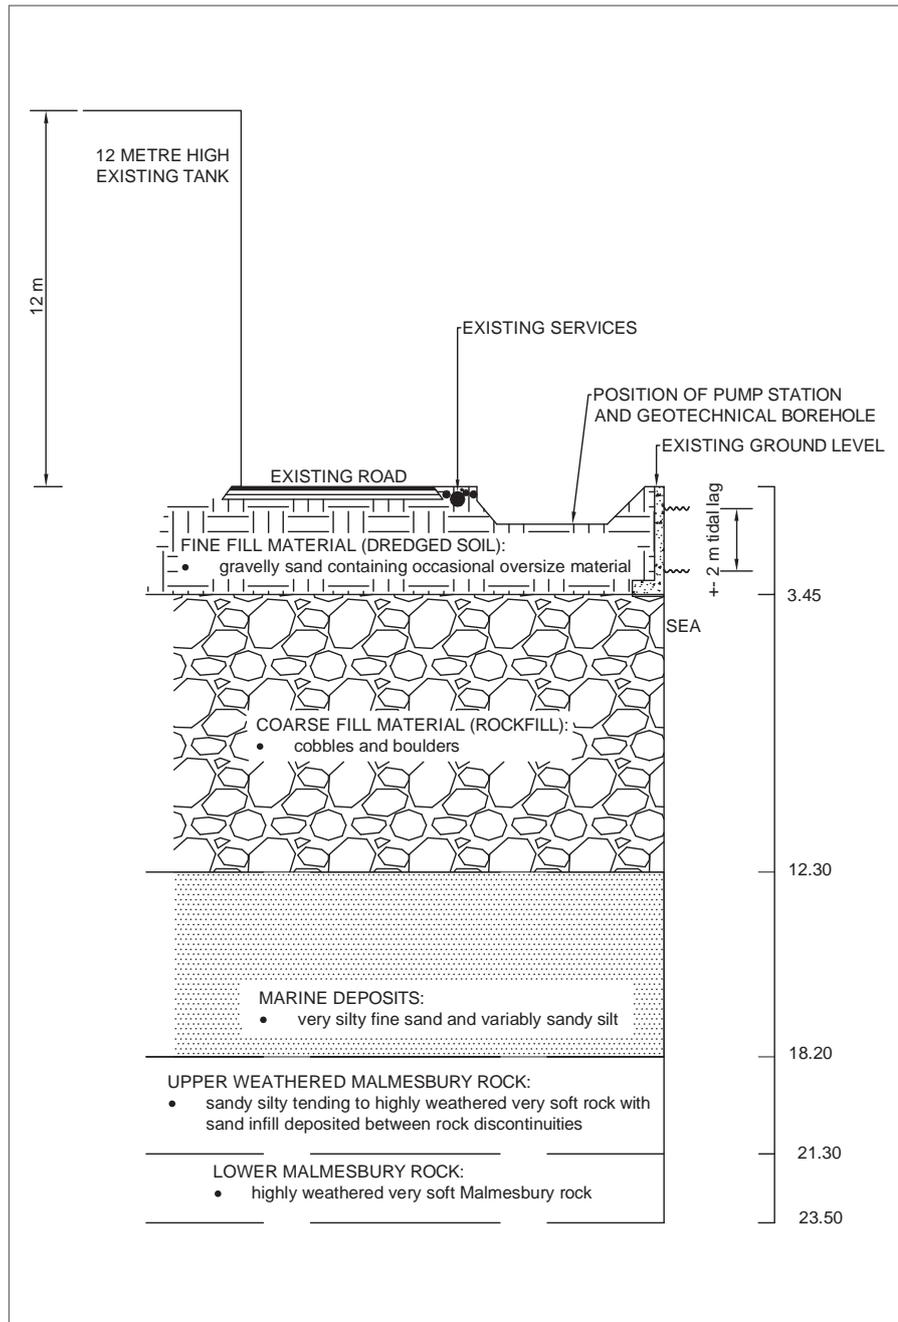
Figure 2: Schematic diagram of the subsoil conditions

A geotechnical site investigation was conducted using a small-diameter rotary core barrel with standard penetration tests (SPT). The exploratory borehole was drilled to a depth of 23.5 m below the existing ground level. The schematic diagram in Figure 2 shows the subsoil conditions that were encountered during the investigation. These subsoil conditions can be summarised as follows:

- Variable fill materials in terms of composition, low consistency and thickness creating compressible soil conditions (problem soil)
- Presence of large obstacles, such as tetrahedron dollies and very hard boulders up to 1.5 m in diameter, as well as a rockfill layer at depth (quay construction), which could hamper piling installation
- Soft, variable marine deposits in the order of 6.0 m thick
- Weathered meta-sedimentary strata associated with Malmesbury rock,

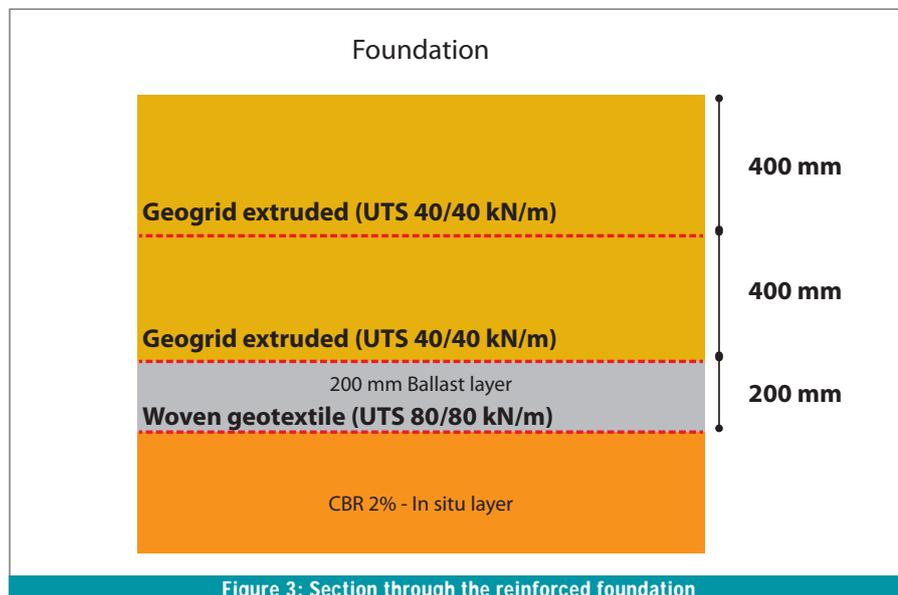
Figure 3: Section through the reinforced foundation

The design pressure of 150 kPa and the California Bearing Ratio (CBR) of 2% (in-situ bearing capacity of 15 kPa) were used for the design calculations. In unreinforced conditions the foundation thickness required was in the order of 2 m. However, through the use of geosynthetic reinforcements the thickness was reduced to 1.2 m, as shown in Figure 3, with one layer of woven geotextile (in polypropylene with an ultimate tensile strength of 80 kN/m in both directions) functioning

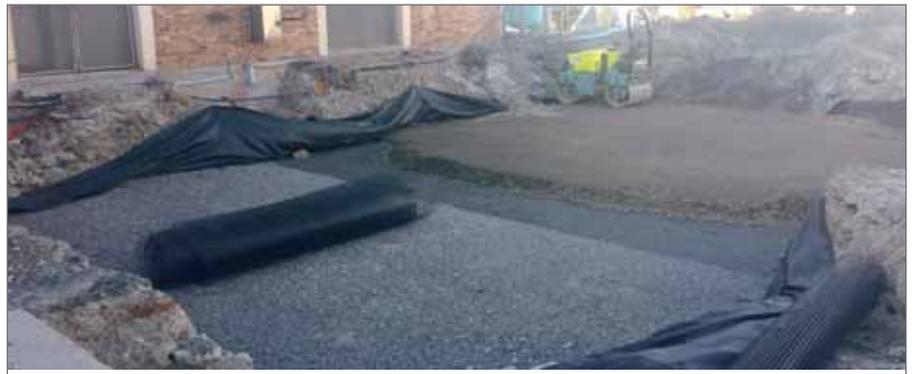
Figure 4: Construction of the geosynthetic reinforced soil raft foundation

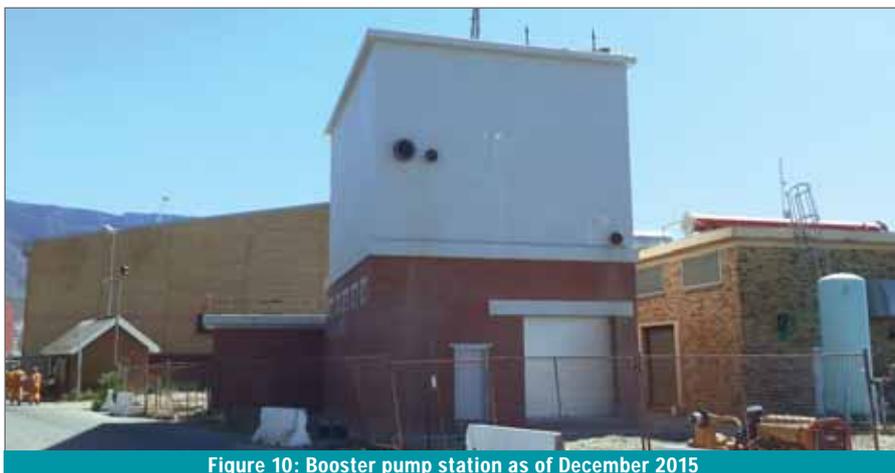
Figure 10: Booster pump station as of December 2015

During the construction phase the settlement of the pump station was measured on a weekly basis to record its average structure settlement. These readings confirmed that minimal settlement had occurred during the construction phases (with 95% construction completed). Following completion and leak detection testing, the structure settled uniformly and attained equilibrium with the ground.

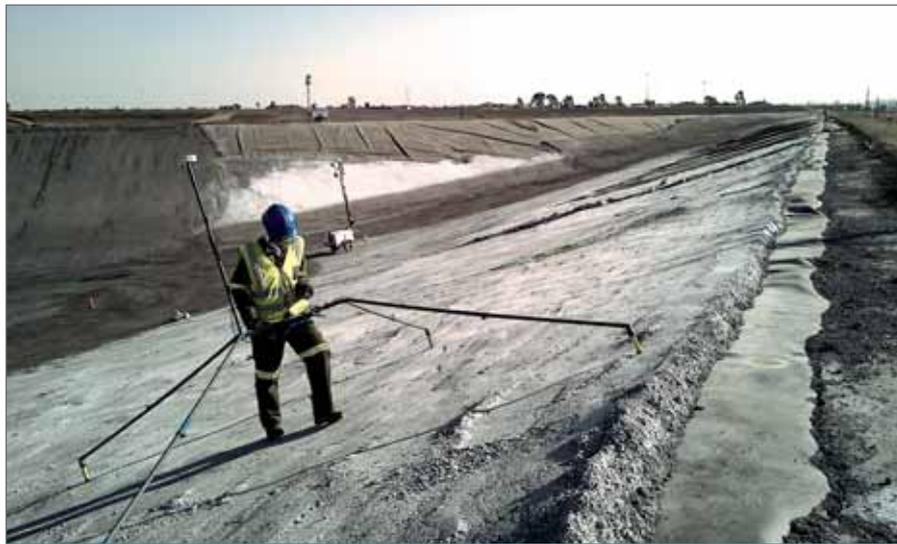
Figure 6: Electric leak detection (ELD) in progress

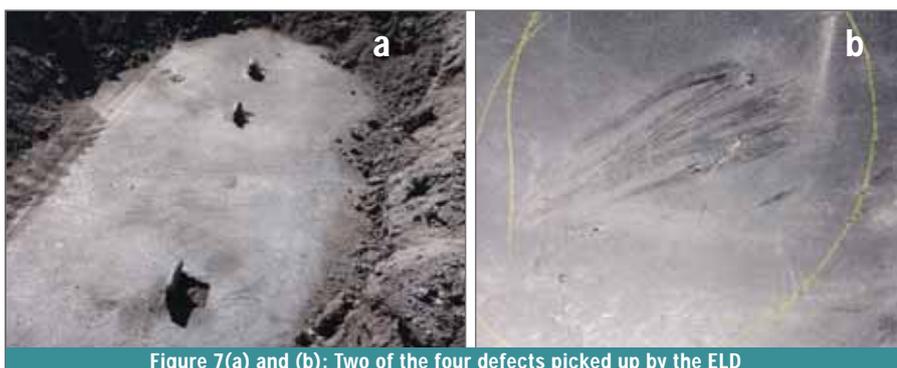
Figure 7(a) and (b): Two of the four defects picked up by the ELD

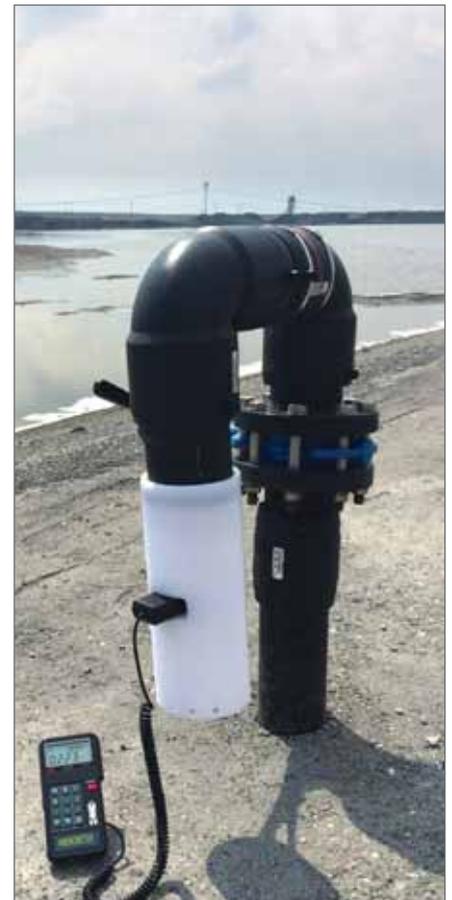
Figure 8: Airflow measurement and calibration at one of the air intakes

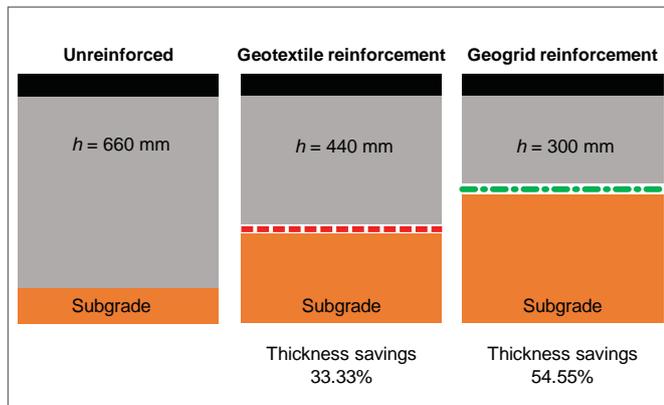
Figure 4: Reduction in layer thickness using geotextiles and geogrids

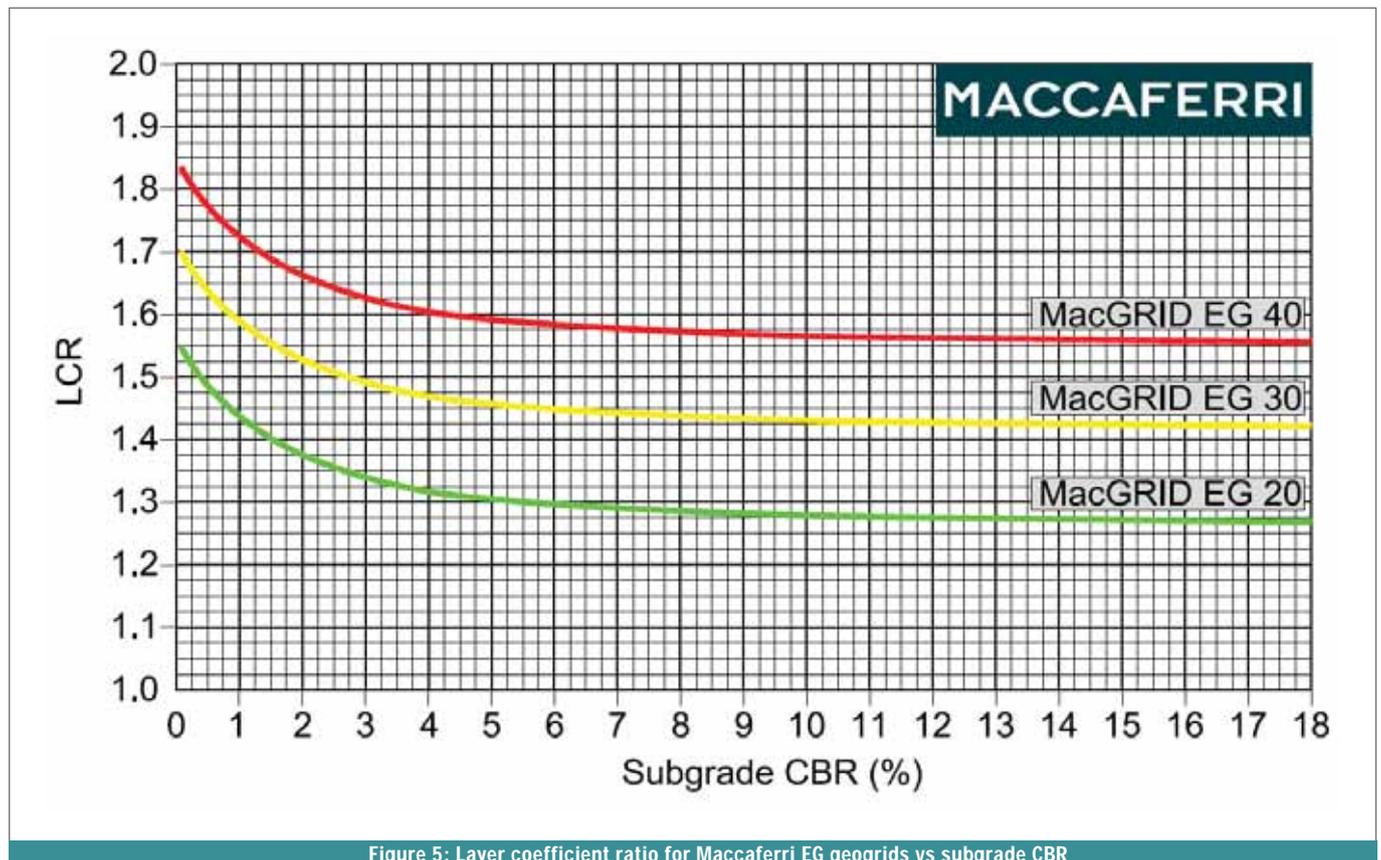
Figure 5: Layer coefficient ratio for Maccaferri EG geogrids vs subgrade CBR

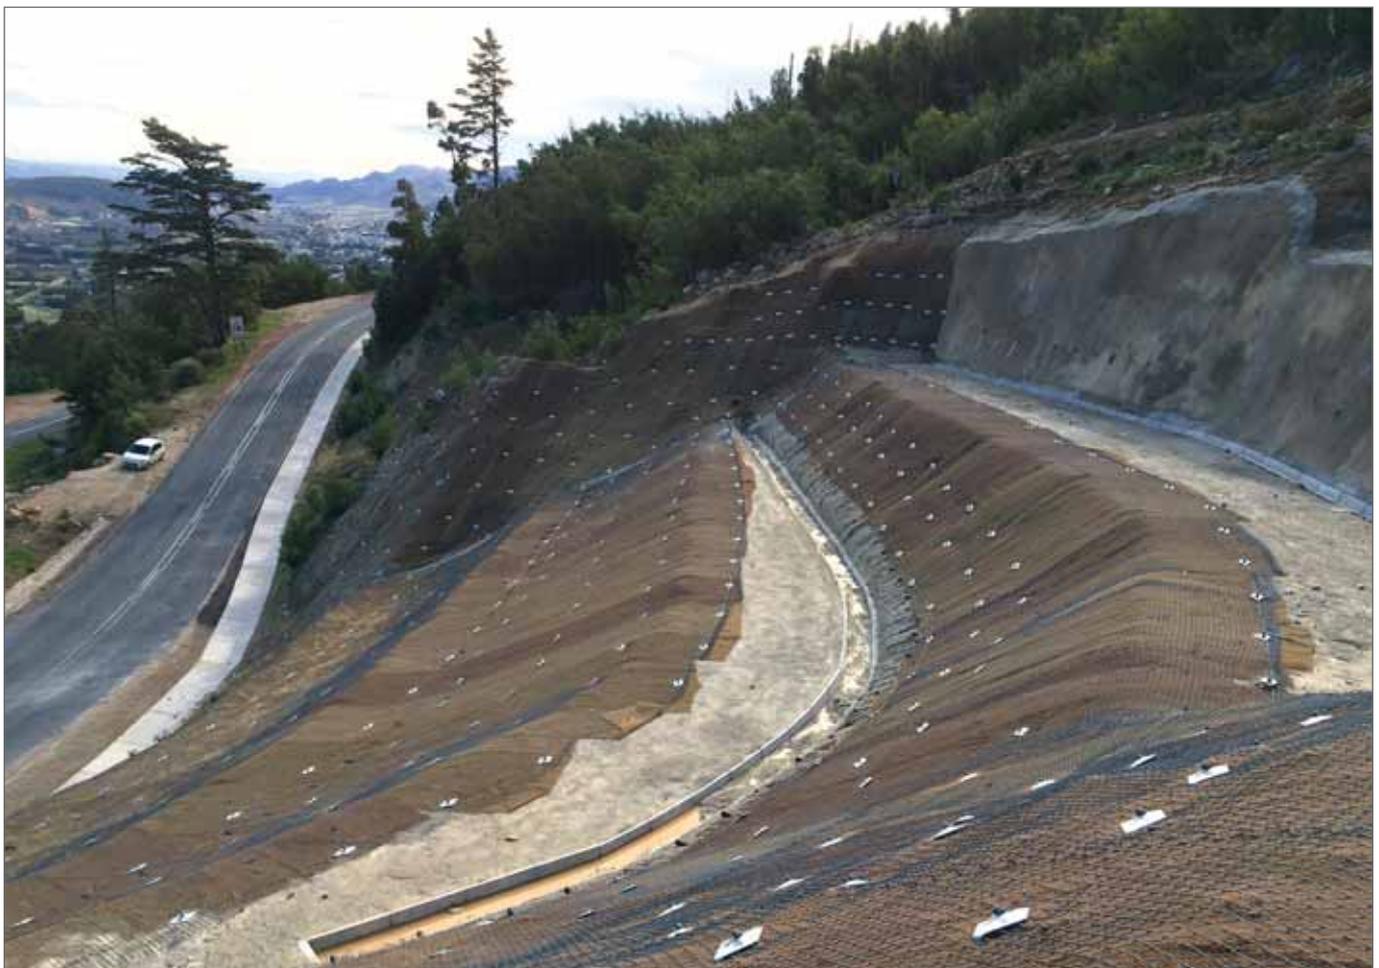
Figure 1: Overview of the primary slope stabilisation works set against a backdrop of the Franschhoek Valley

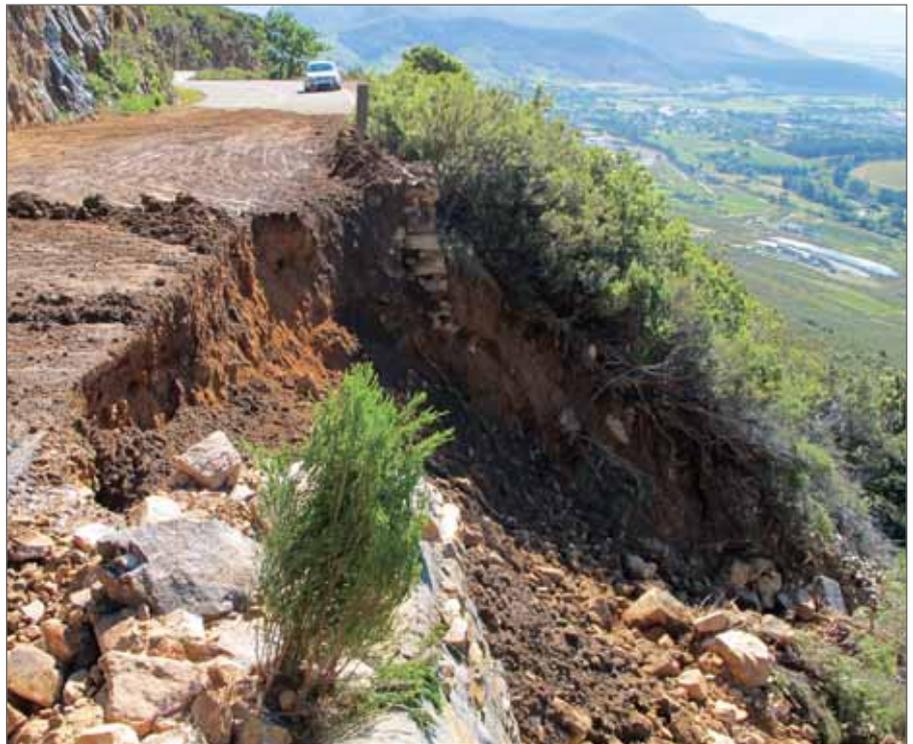
Figure 2: Unseasonably high rainfall resulted in rock falls, erosion and scouring along the Franschhoek Pass in November 2013

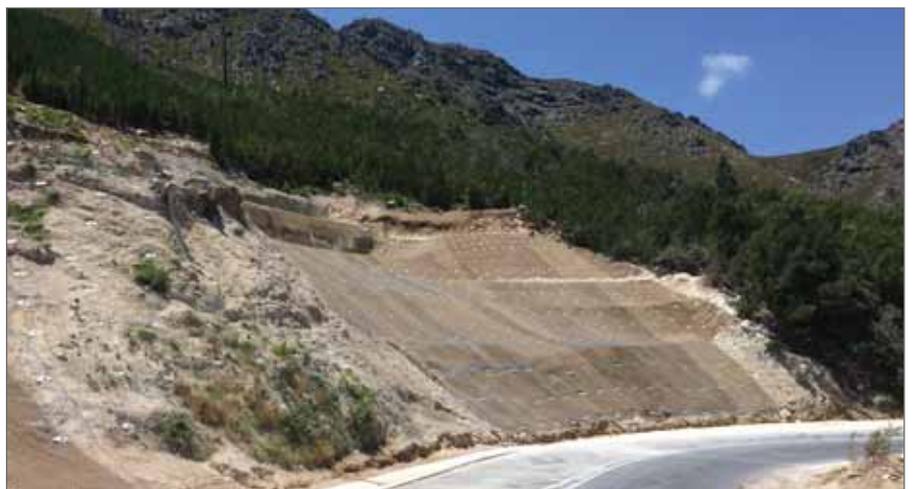
Figure 3: A soil nail and high-tensile strength steel mesh configuration was used to stabilise the lower reaches of the slope undergoing a progressive, deep-seated failure. Dyed sprayed concrete and soil nails were used on the upper reaches. Erosion control mats and 12 m inclined purpose-made subsoil drains were used to control seepage

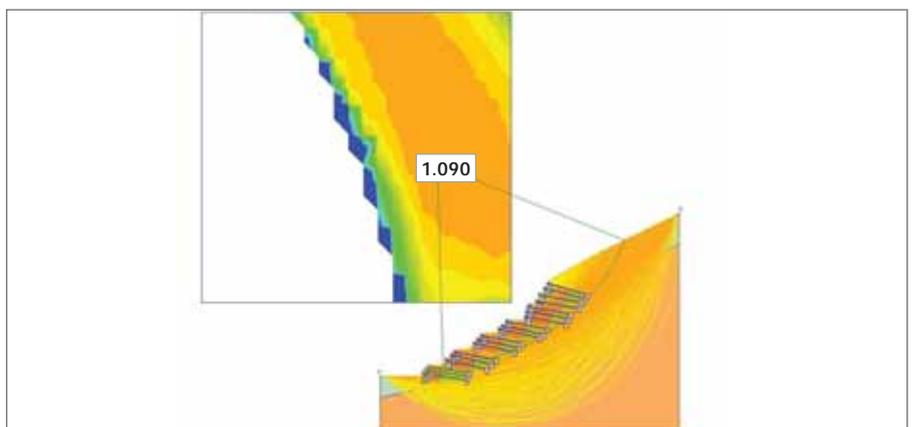
Figure 4: A combination of limit equilibrium and finite element method modelling techniques were used to evaluate overall slope stability, as well as the structural capacity of the soil nails and high-strength steel mesh based on different soil nail spacing, diameter and lengths, groundwater conditions and external loads; this was carried out in accordance with SANS 10160

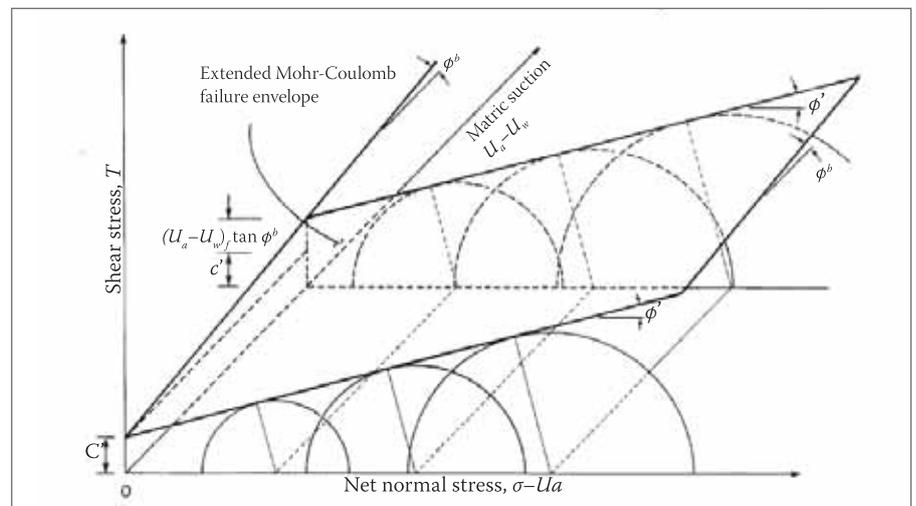
Figure 5: Extended Mohr-Coulomb failure envelope for unsaturated soils (Fredlund 2012)

The effect of matric suction is depicted graphically in Figure 5 in the extended Mohr-Coulomb plot whereby

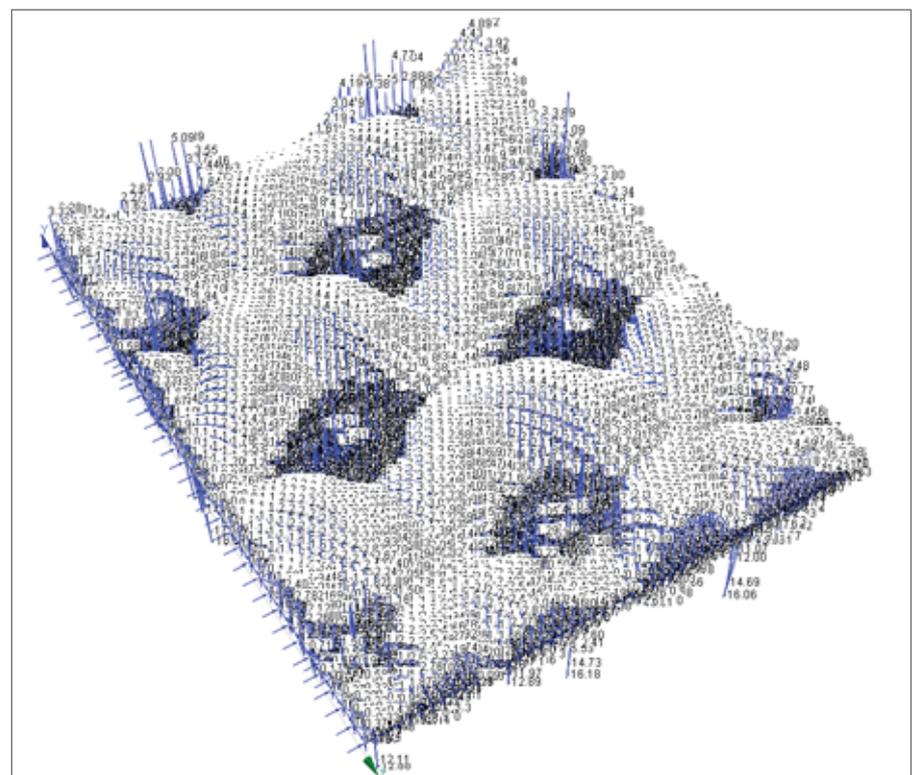
Figure 6: Structural FEM analysis incorporating pressures from the geotechnical FEM analysis

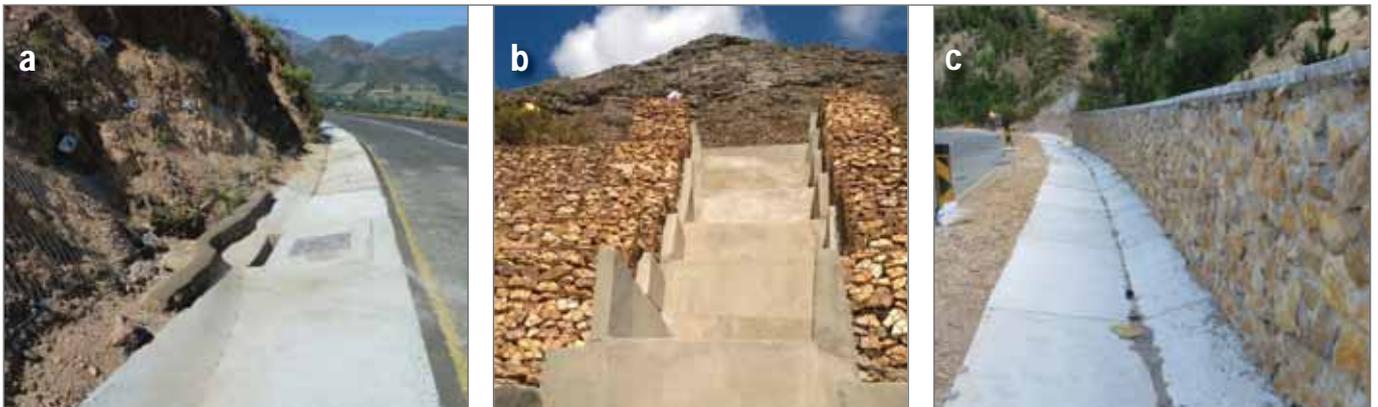
Figure 7(a), (b) and (c): Improved culvert inlets, energy dissipaters, and stone-clad retaining walls were a few of the measures put in place to improve the drainage of stormwater along the route

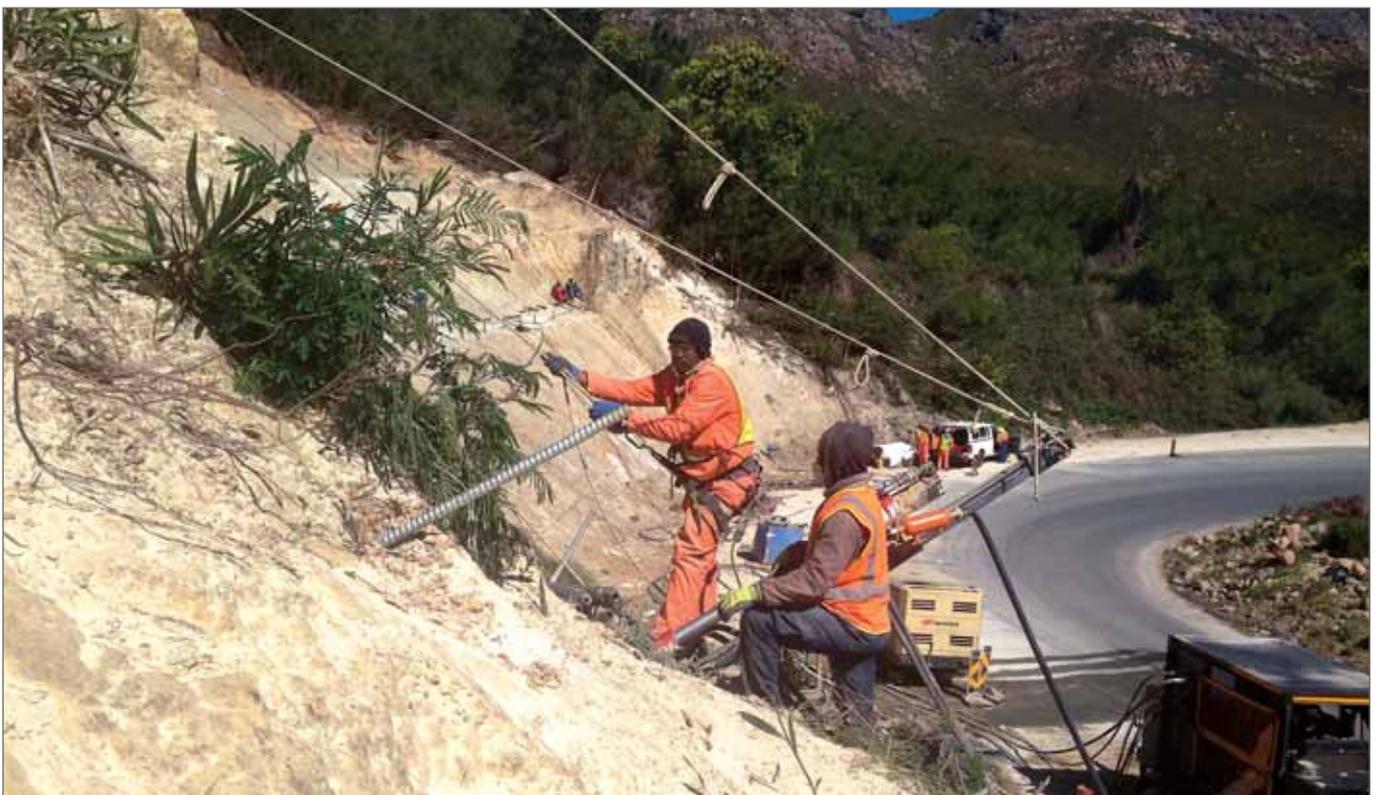
Figure 8: Tailored drilling plant and installation methods were used to ensure a safe and efficient construction sequence for the soil nails

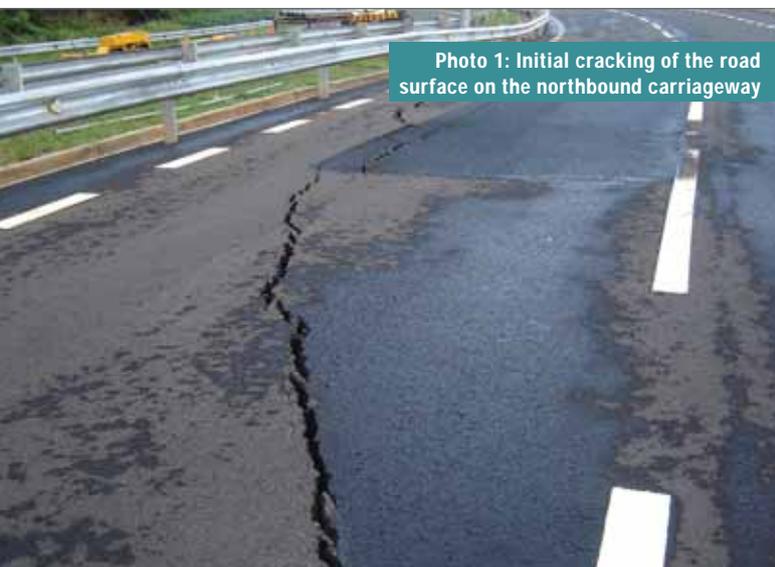
Photo 1: Initial cracking of the road surface on the northbound carriageway

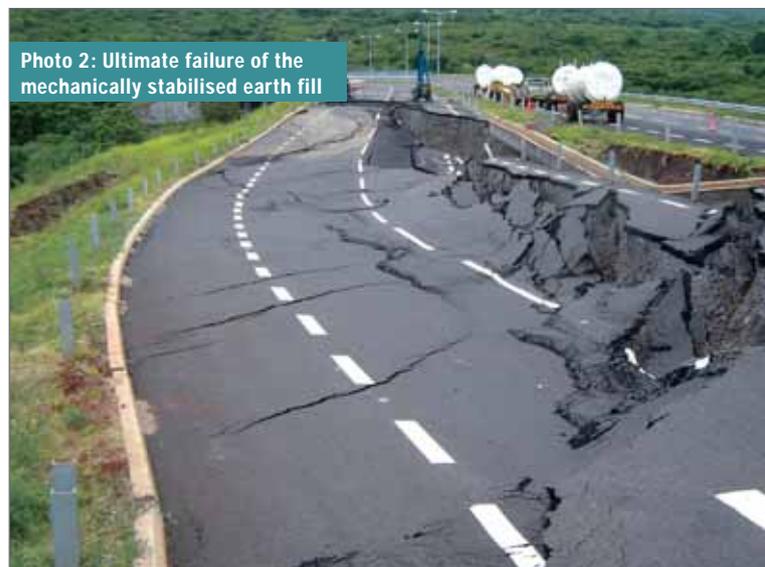
Photo 2: Ultimate failure of the mechanically stabilised earth fill

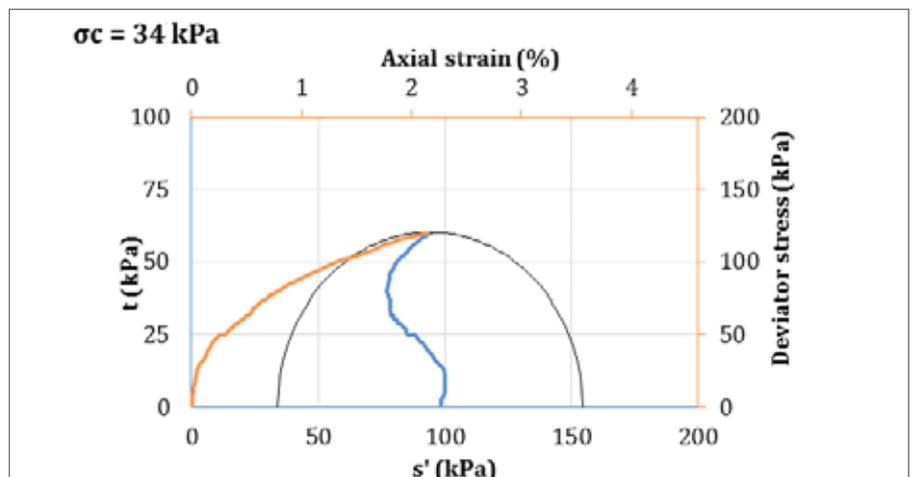
Figure 2: Graphical depiction of a typical triaxial test with (a) deviator stress/strain, (b) stress path and (c) Mohr circle

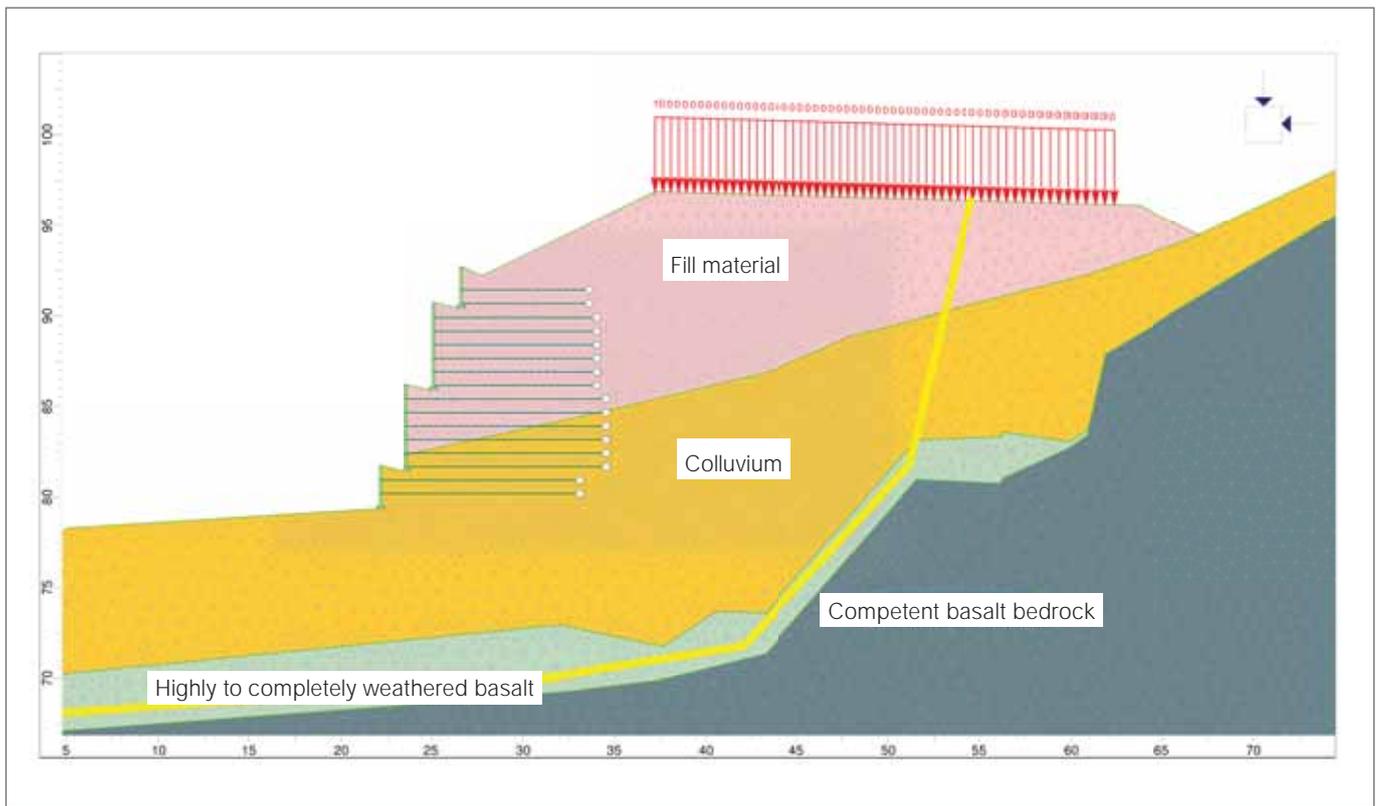
Figure 3: Cross section through mechanically stabilised earth fill prior to failure

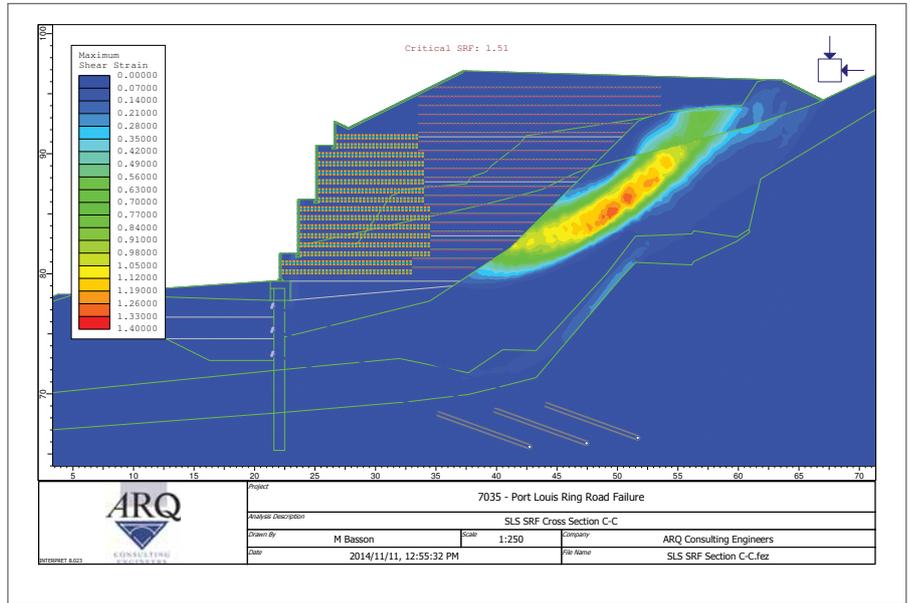
Figure 4-1: Critical SRF in the serviceability limit state (SLS)
(Here it is desired that the SRF should be 1.5. This condition is thus satisfied, if only just.)

- aim was to reach an SRF = 1.5 for serviceability limit state (SLS) condition.
 2. Pore pressure coefficient ru -value, which was assumed as 0.15 in the initial serviceability limit state analysis, but was then upped to 0.25 and combined with a seismic acceleration of 0.2 g in an ultimate limit state (ULS) case. The aim was to reach an SRF > 1.01 for ULS.
 3. Axial force in the upper anchor position.
 4. Tensile force in the high-strength geosynthetic.
 5. Maximum moment in the pile.
- The above are depicted in graphical format in Figures 4-1 to 4-4, for one of the cross sections.

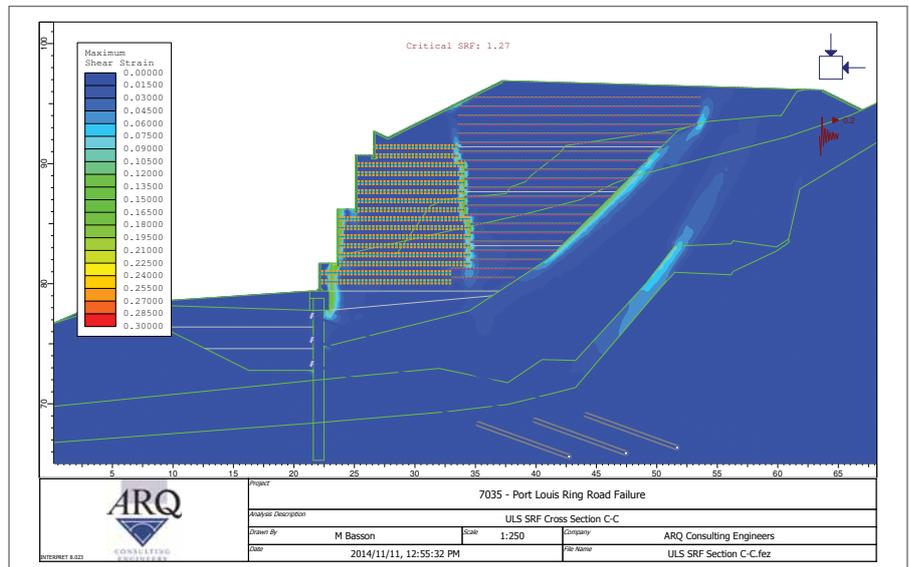
Figure 4-2: Critical SRF in the ultimate limit state (ULS)
(Here it is desired that the SRF should be > 1.01. This condition is thus also satisfied.)

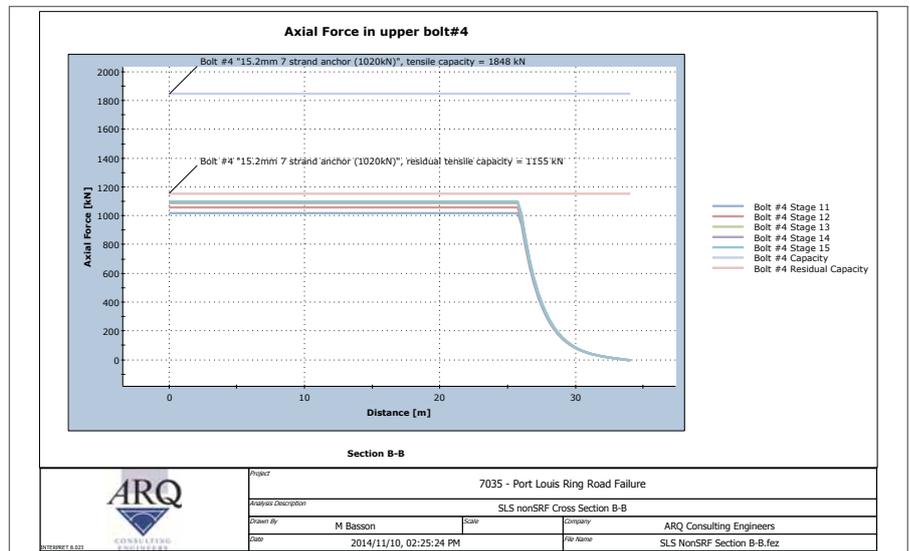
Figure 4-3: Forces in the anchors
(The anchor/bolt force should be < 65% of the ultimate value = 1 200 kN. This condition is thus satisfied, as all predicted forces are < 1 200 kN.)

nitude check was made on (a) force in anchors and (b) moments in pile. These sanity checks indicated fairly good compliance, leading to a verification of the correctness of the finite element model.

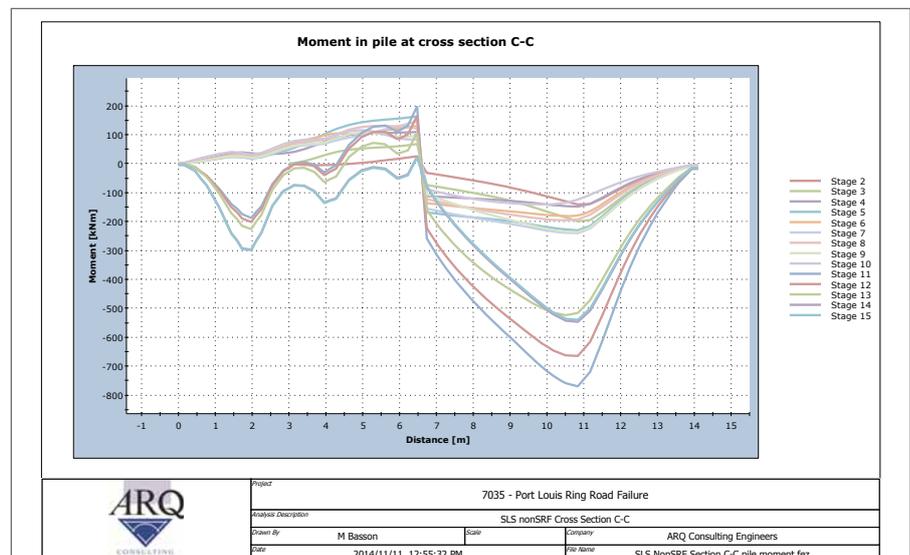
Figure 4-4: Moments in the pile
(The maximum moment in the pile should be < 1 200 kNm for the steel which is detailed as 18 Y32. This condition is thus satisfied.)

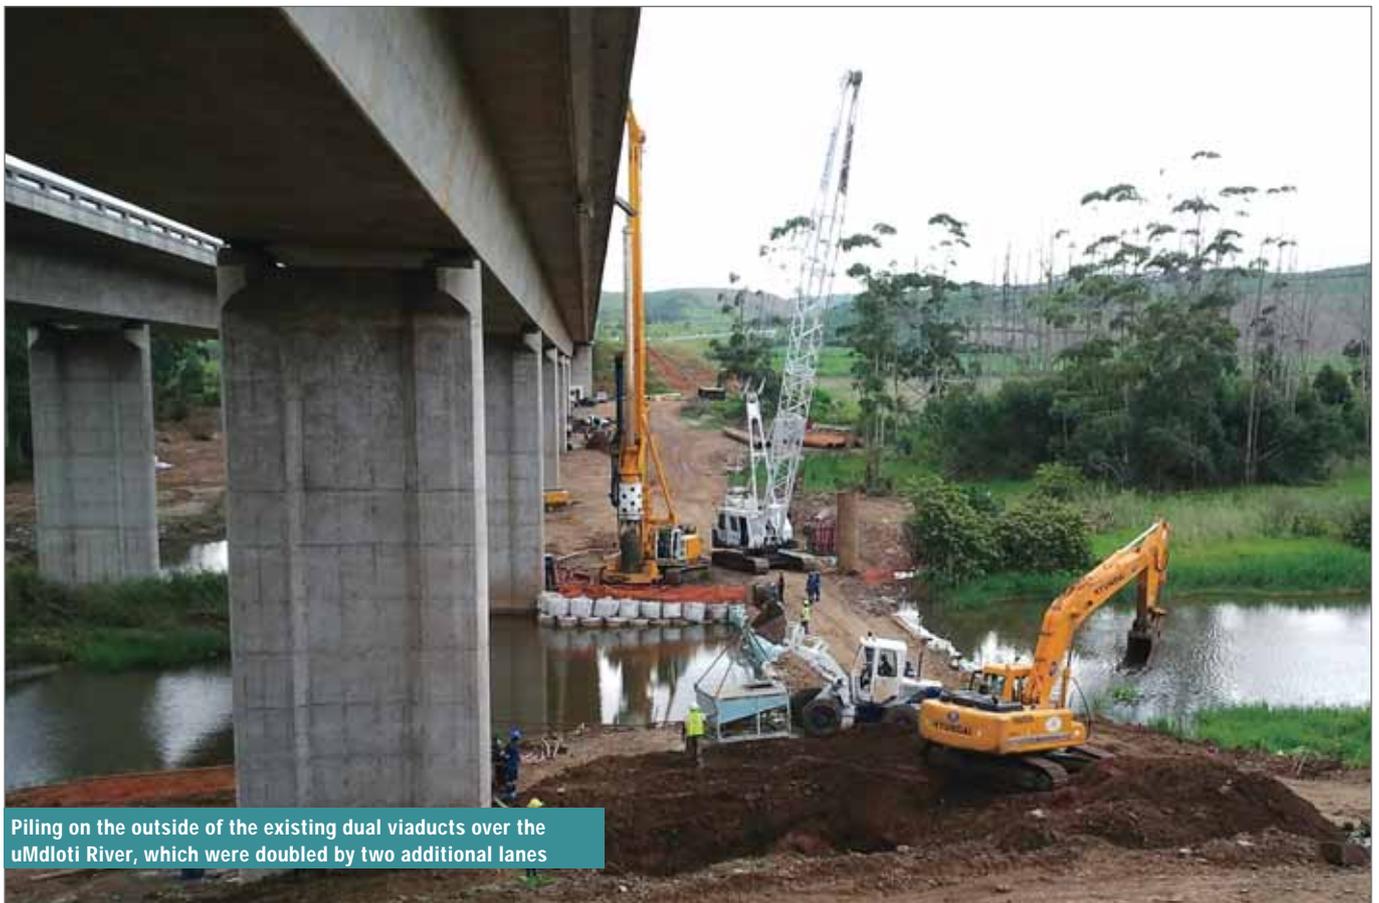
Piling on the outside of the existing dual viaducts over the uMdloti River, which were doubled by two additional lanes

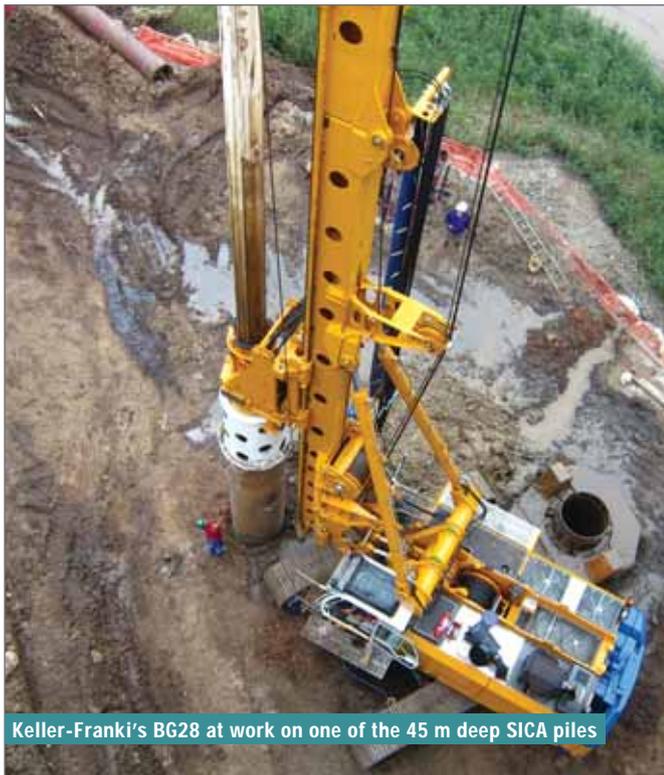
Keller-Franki's BG28 at work on one of the 45 m deep SICA piles
