CIVIL ENGINEERING

April 2016 Vol 24 No 3

Focus on:
Geotechnical Engineering

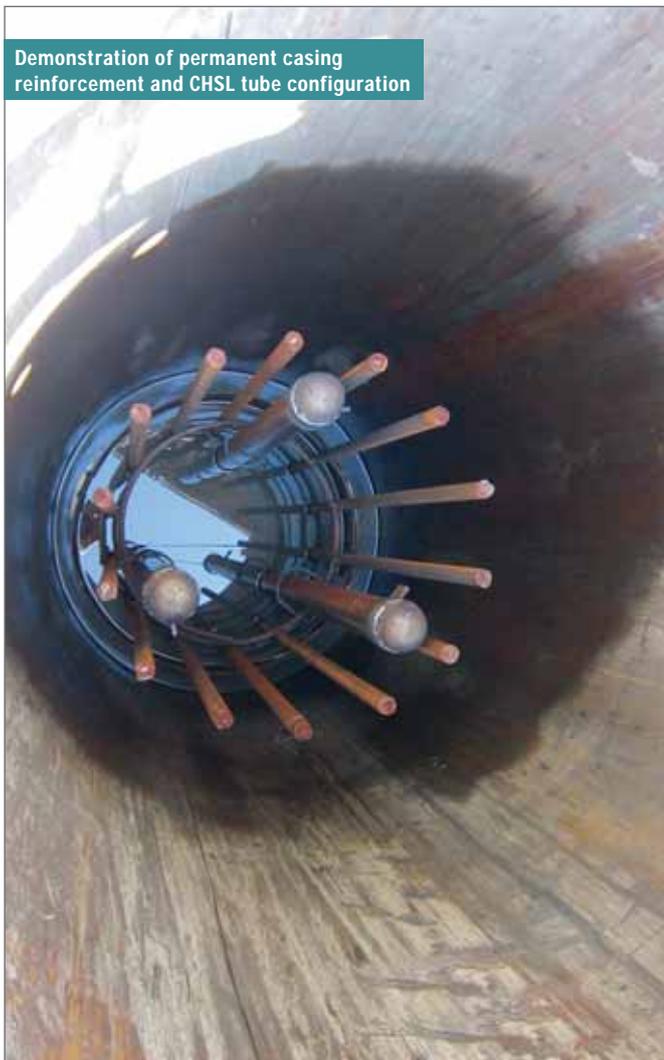
Demonstration of permanent casing reinforcement and CHSL tube configuration

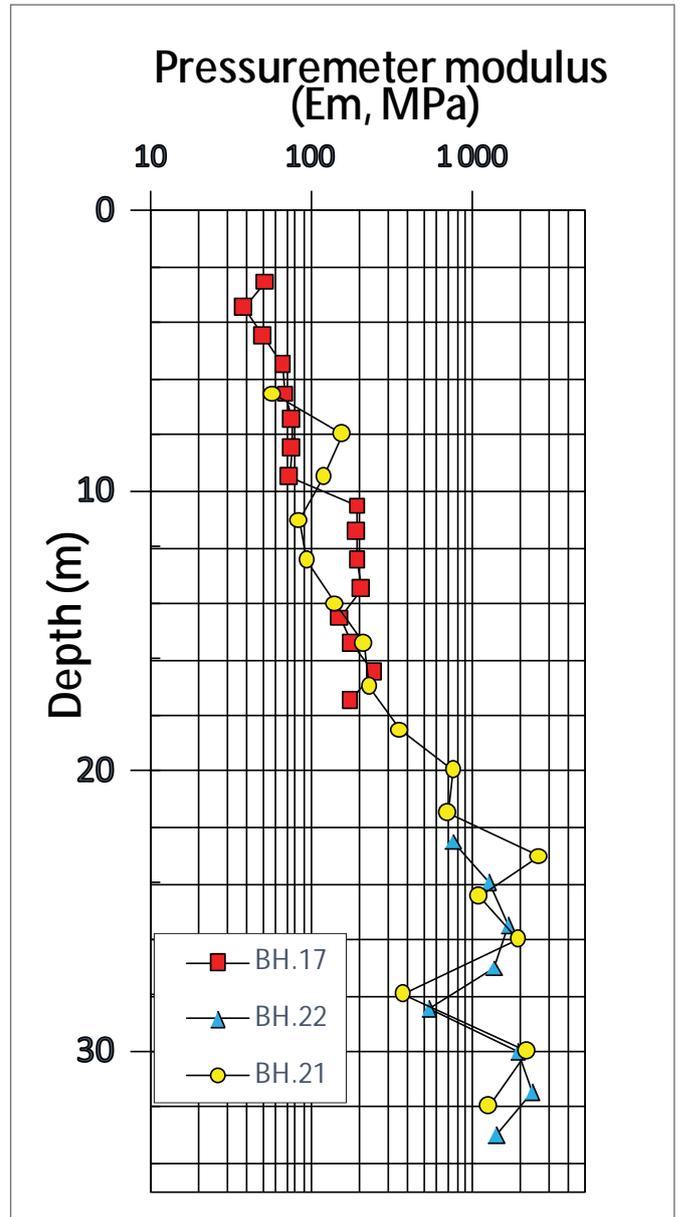
Figure 3: Some pressuremeter test results showing variation of pressuremeter modulus with depth

■ A series of Menard pressuremeter tests (PMT), carried out mostly at 1 m depth intervals within the pylon and back span section of the bridge for a more accurate appreciation of the engineering behaviour of the various formations encountered. The tests were carried out using the latest pressuremeter equipment.

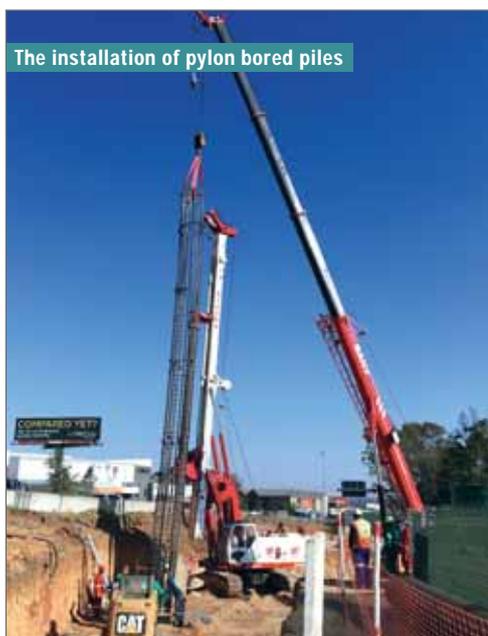
The installation of pylon bored piles

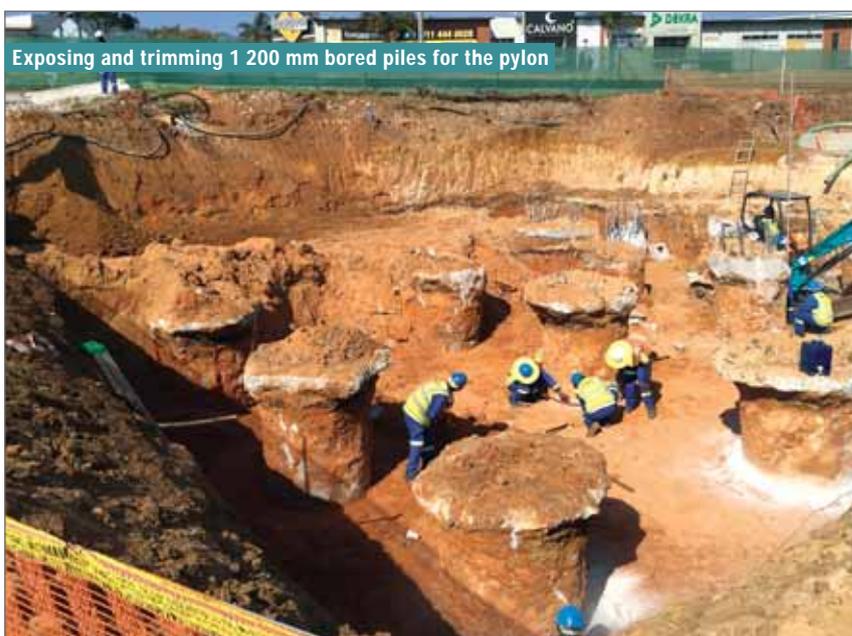
Exposing and trimming 1 200 mm bored piles for the pylon

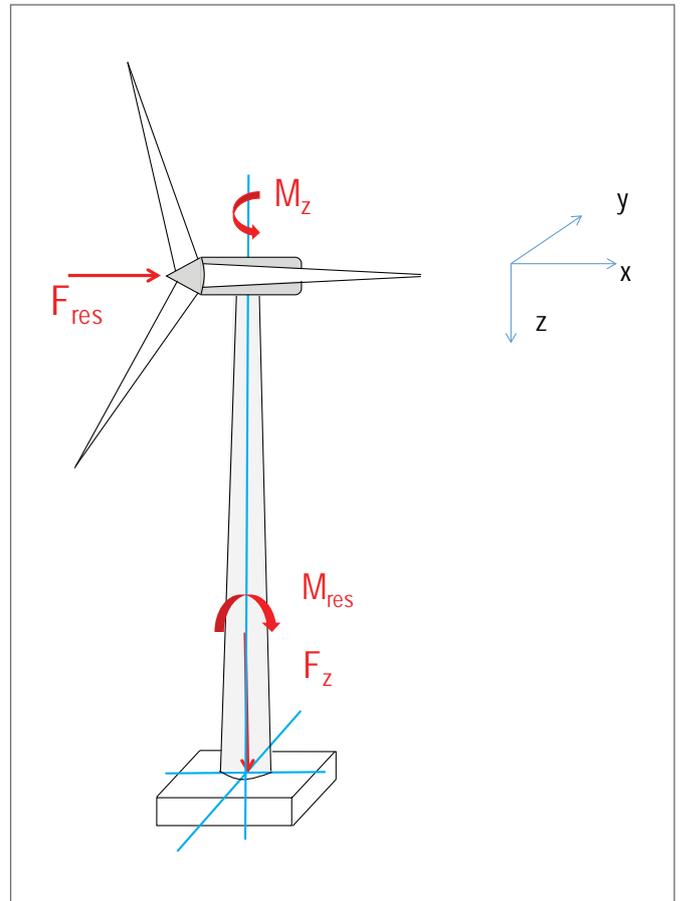
Figure 1: Simplified annotation of loading as applied to wind turbine structure (Source: Mawer 2015)

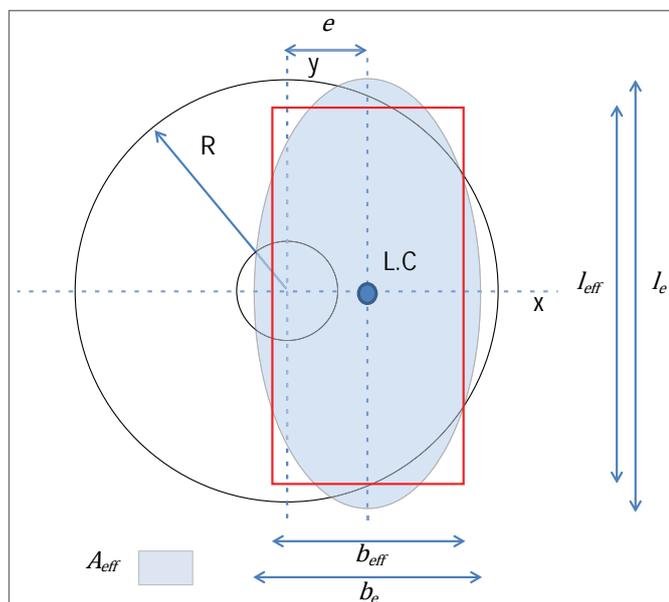
Figure 2: Calculation of effective area of circular-shaped gravity footing (Source: Adapted from DNV/Risϕ 2002)
