CIVIL ENGINEERING

**Focus on:
Geotechnical Engineering**

- Southern Cape Landslip
- Upgrading the Kranspoort Pass

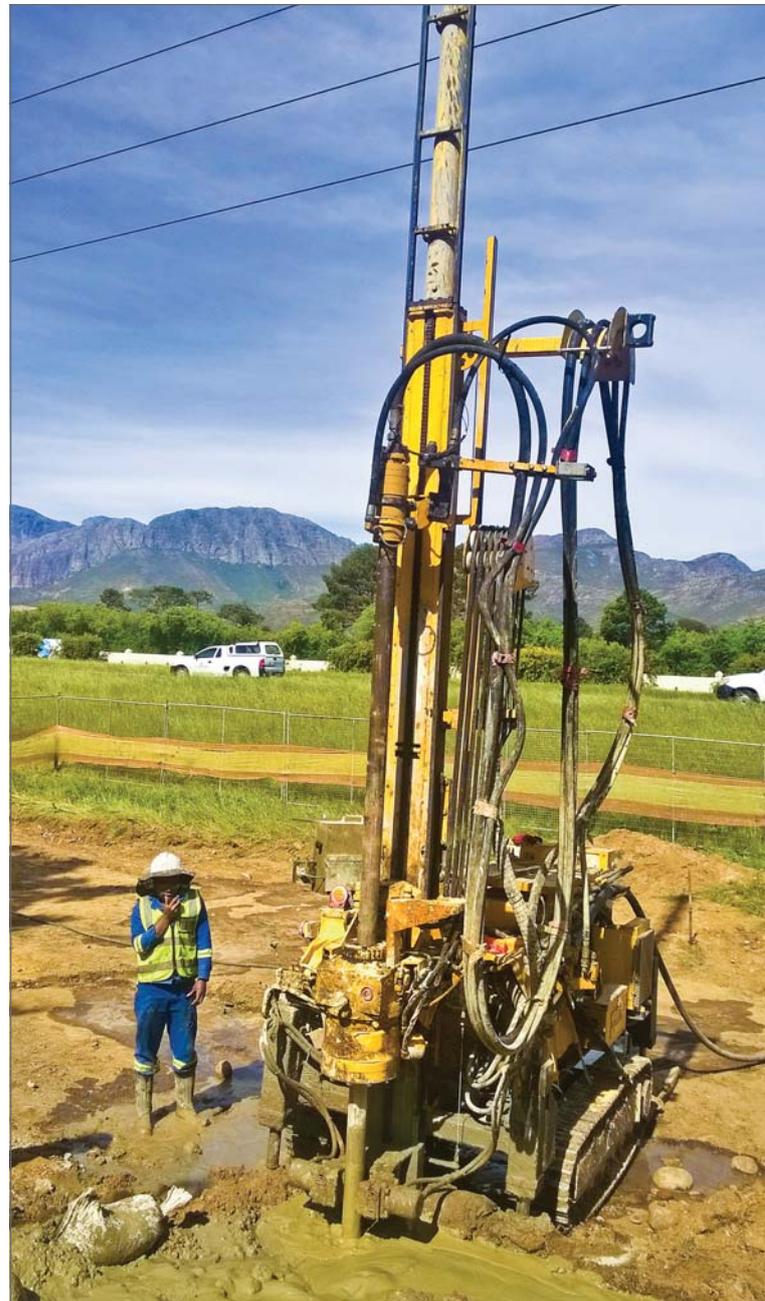
Jet grouting rig working on the Paarl bulk sewer line alongside the N1

The proposal entailed jet grouting – which involves the mixing and partial replacement of the in-situ soil with cement slurry – to consolidate the in-situ ground condition along the sewer centreline and between the depths of –4 to –9 m, and to then install a pipe jack through the treated ground. “The treatment of the ground would prevent collapse of the sand and cobbles during pipe jack excavation and would reduce the ingress of water to manageable levels,” Field says.

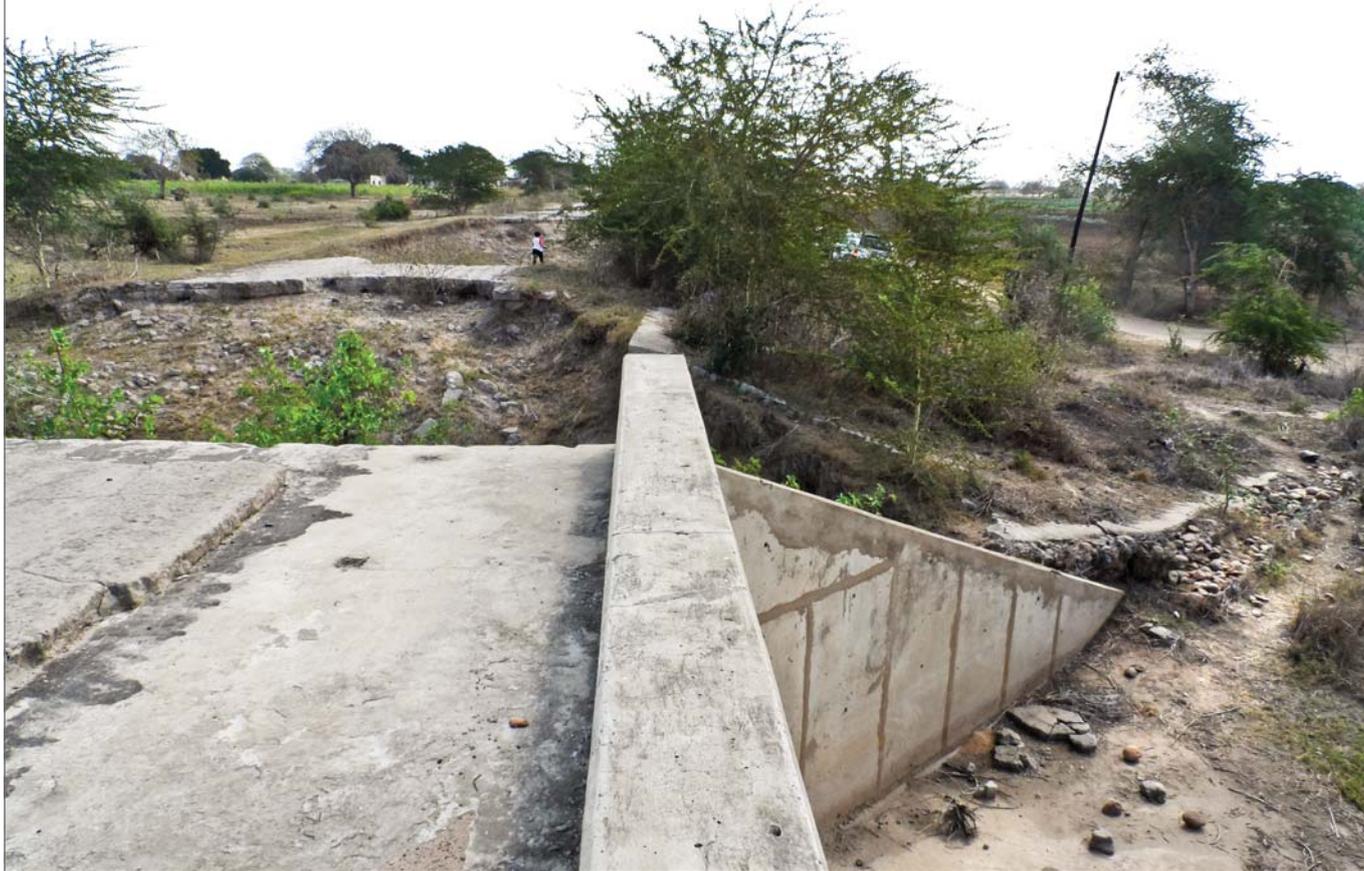
The damage to the approach fill of this bridge in Mozambique during the 2013 floods illustrates the overlap between engineering geology and geotechnical engineering

“The overlap between engineering geology and geotechnical engineering was nowhere more apparent to me than when I recently looked at bridges which had lost their approach fills during the 2013 floods in the Gaza Province in Mozambique. The embankment strength is a function of the geological/geotechnical properties, as well as of the construction and design. The erosion is a function of the geomorphology, rainfall and design. The failure is thus a combination of geology, geotechnical, geomorphological and engineering inputs, together with the one thing we can’t control – the climate. My career has re-treaded my geological background into a much wider horizon overlapping geotechnical and road engineering. I like to think I know enough about all of these issues now to pull them into one composite solution.”

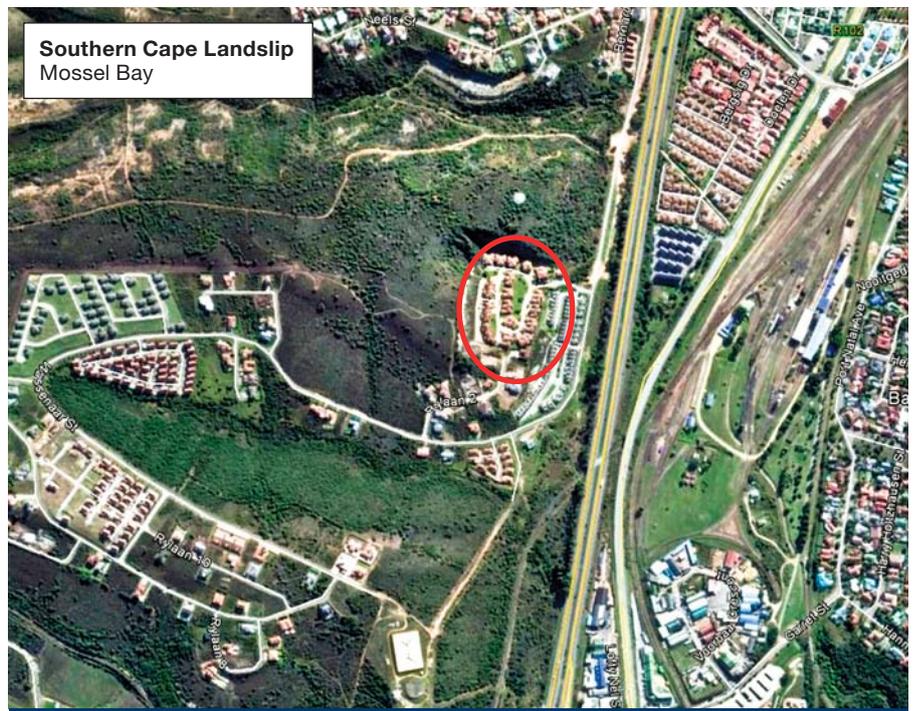
Figure 1: Aerial photo of the area affected by the landslide

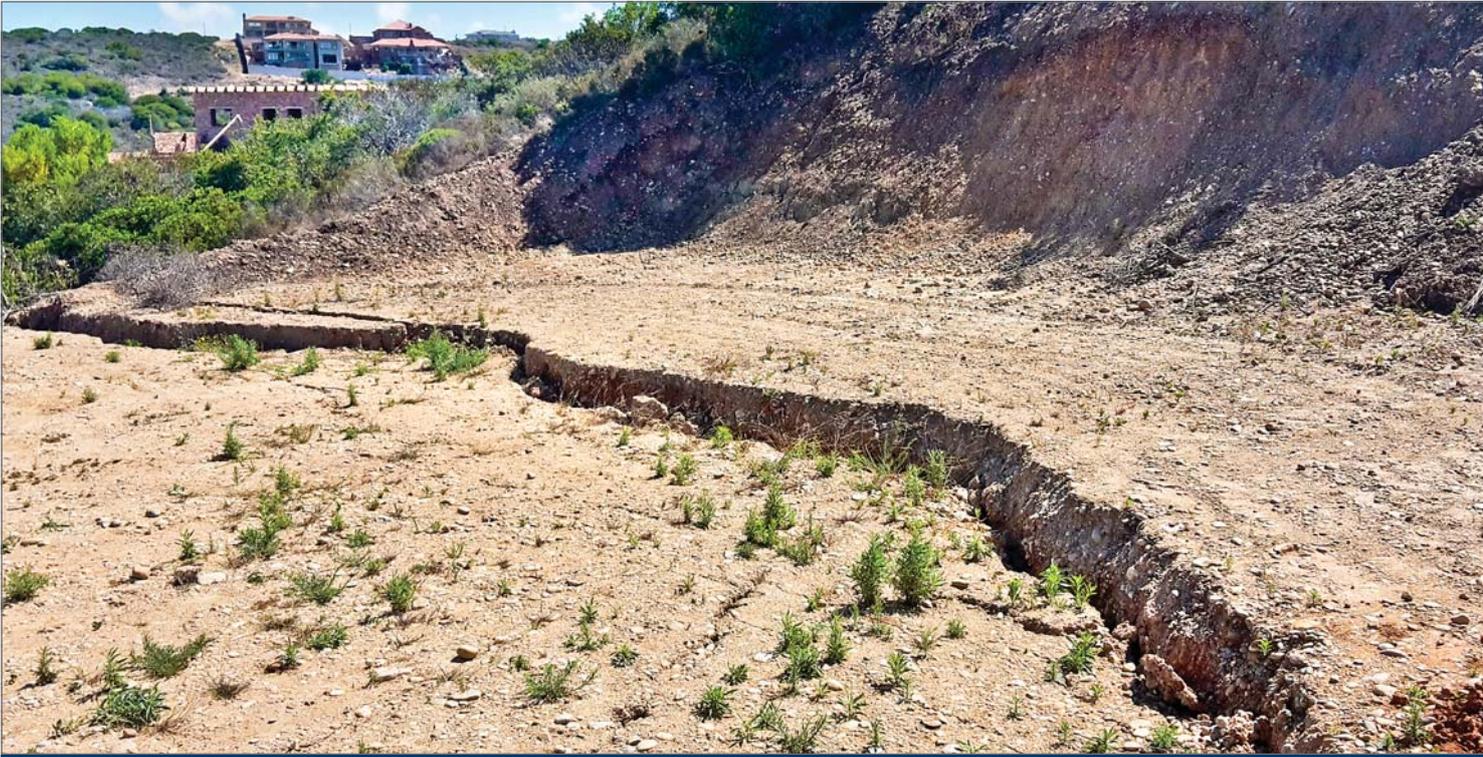
Figure 3: Tension crack observed in the ground next to the upper estate

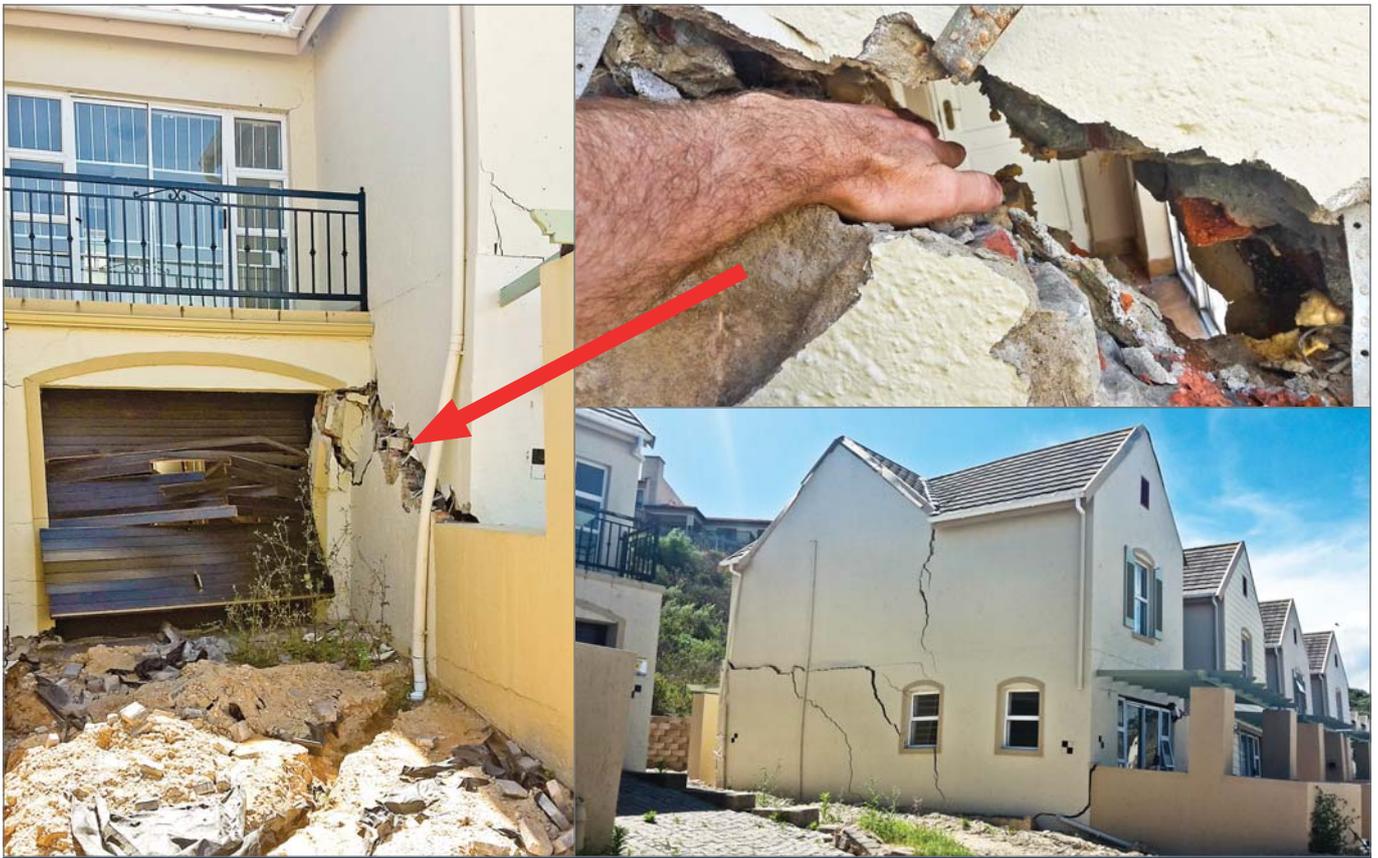
Figure 4: Typical distress observed in many of the residential structures

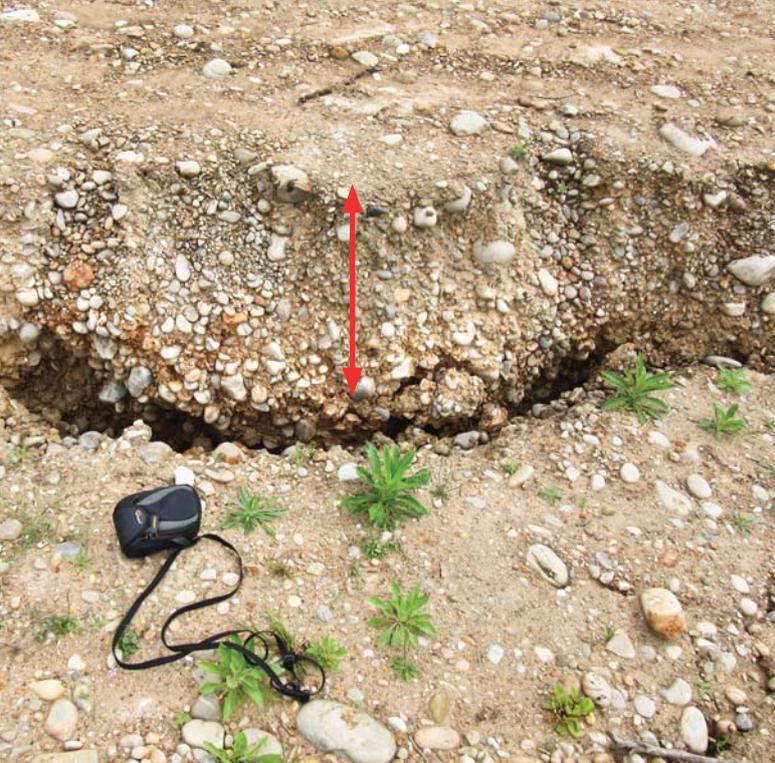
Figure 6: Tension crack with 500 mm vertical displacement

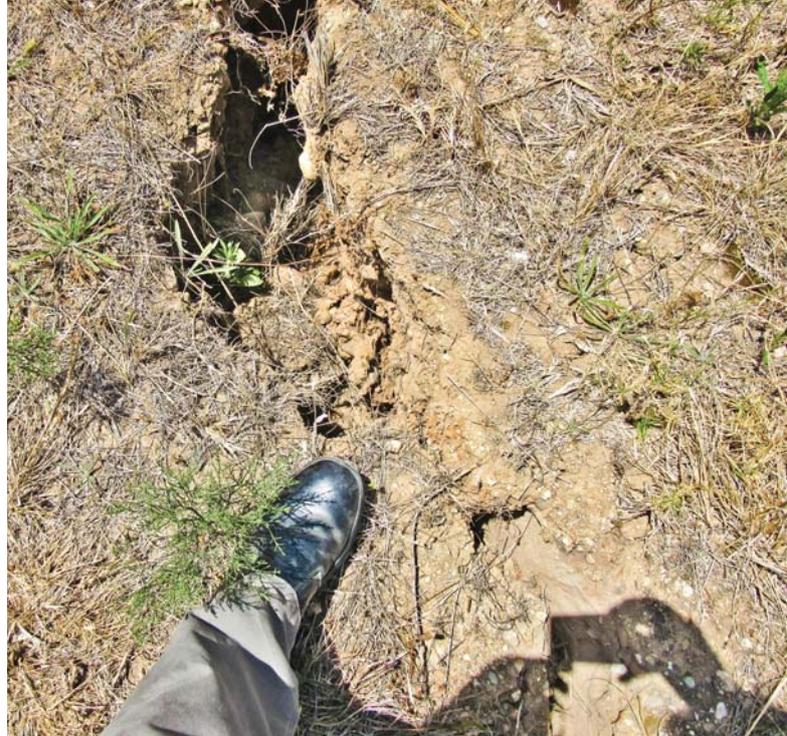
Figure 7: Tension crack extending several metres into the ground with 200–300 mm horizontal displacement

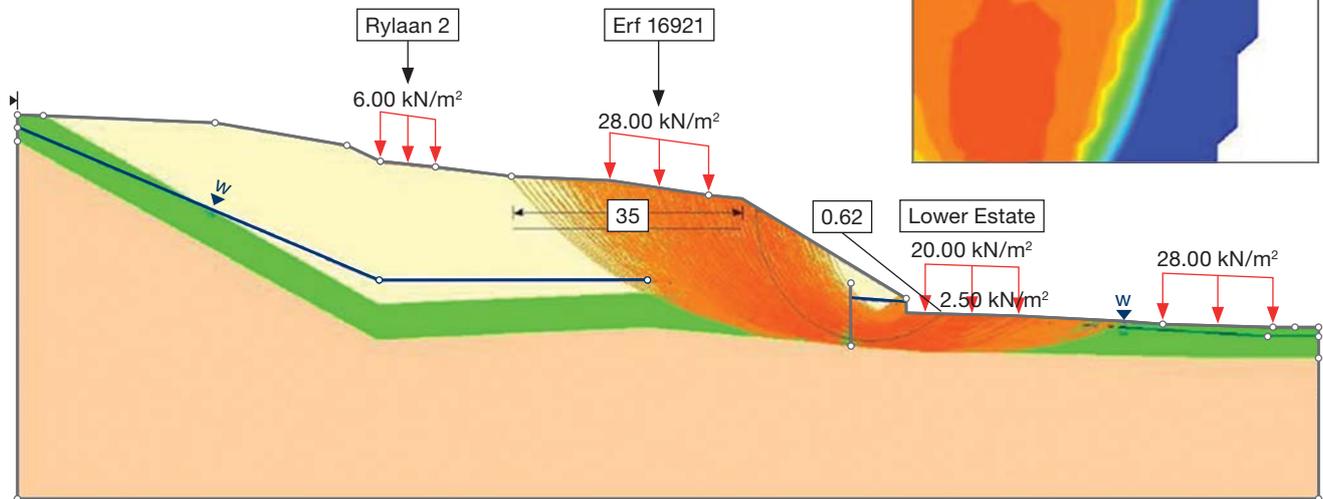
Figure 10: Conceptual 2D slope model showing failure plane analysis

Analysis of potential failure planes, using 2D slope modelling, indicates very low factors of safety along semi-circular planes in the upper 10 m of the Kirkwood clay. Potential failure planes extend from the upper complex/estate, where tension cracks are visible, to the lower complex/estate, where a classical bulging toe of the embankment is observed. The conceptual slope model is shown in Figure 10.

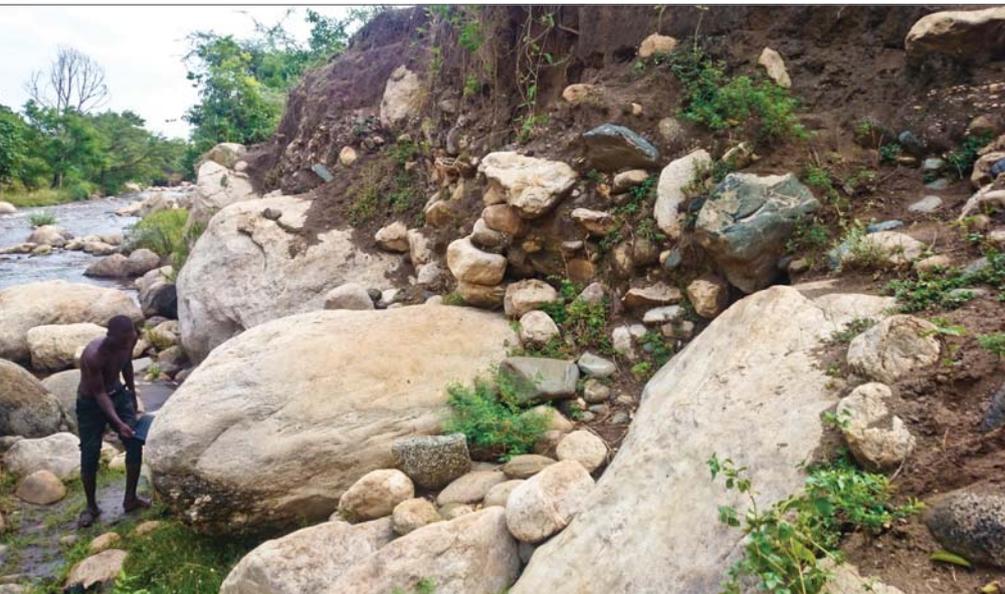
Photo 2: Thick boulder accumulations are likely to have been deposited during floods associated with ice sheet retreat at higher elevations, and are not a feature of current climatic conditions

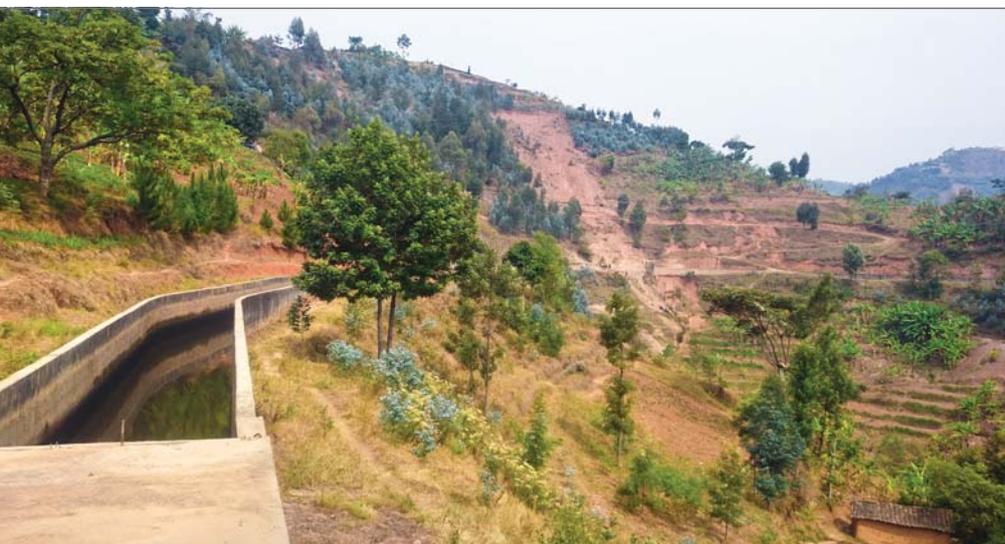
Photo 3: The major slope failure in the background also destroyed the headrace canal – and shut down the power plant

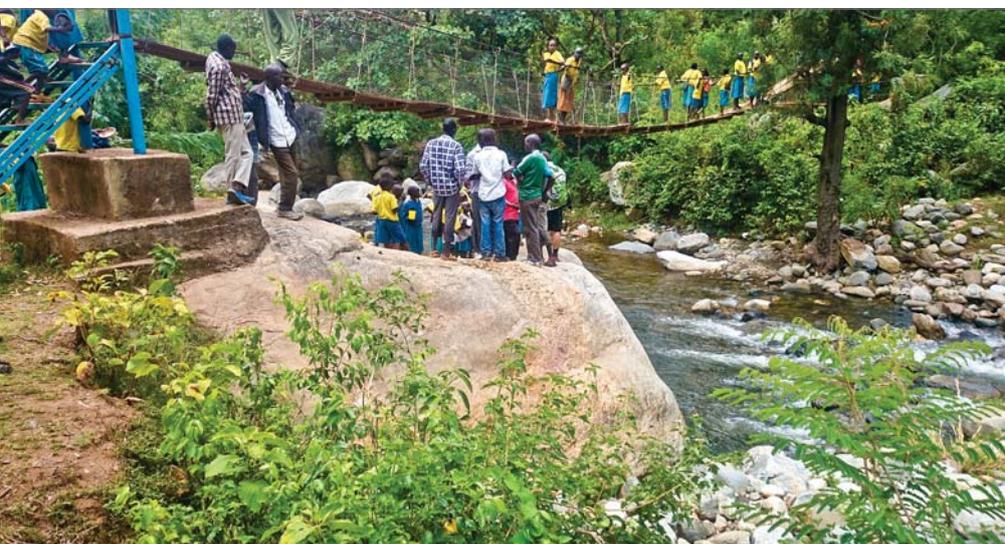
Photo 4: A further example of very large boulders that predate the current flood regime, whereas the smaller boulders comprise the mobile bedload

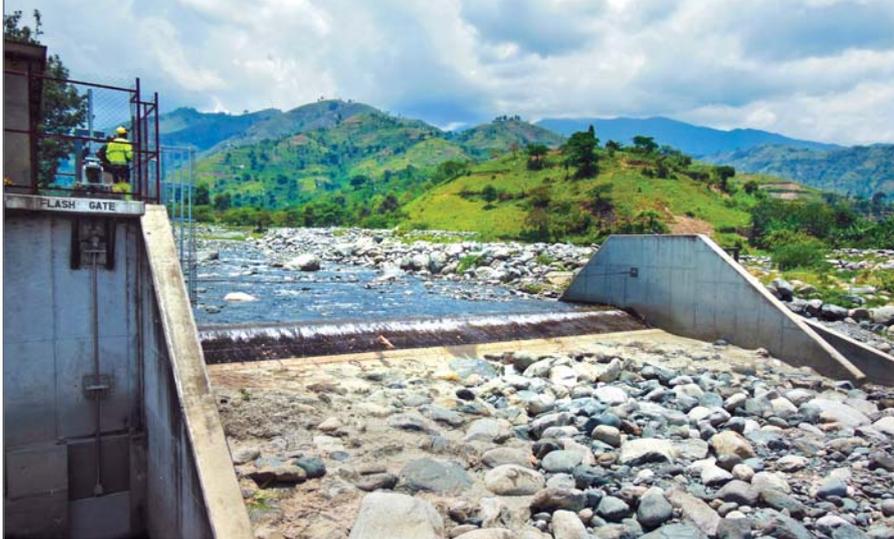
Photo 5: An example of a Tyrolian weir which allows the mobile bedload to pass through while the water is diverted

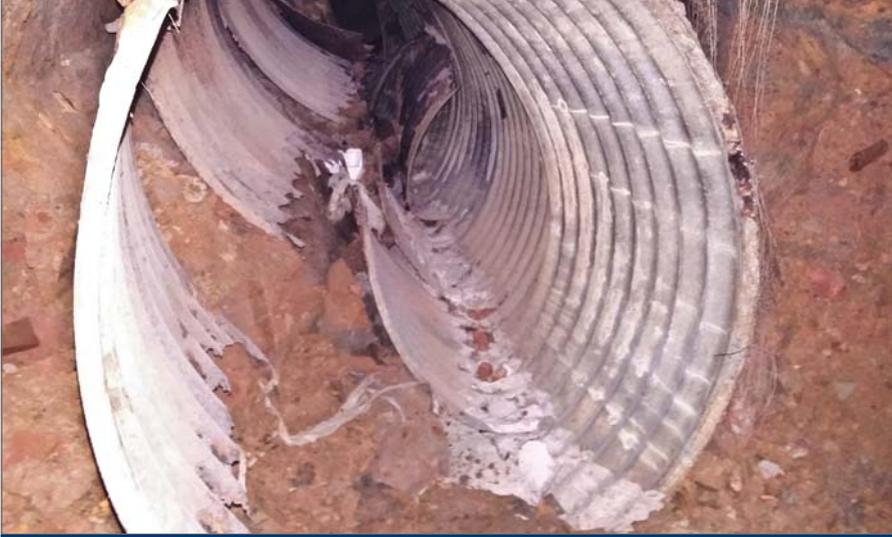
Figure 3: Existing Armco pipe collapsed and damaged

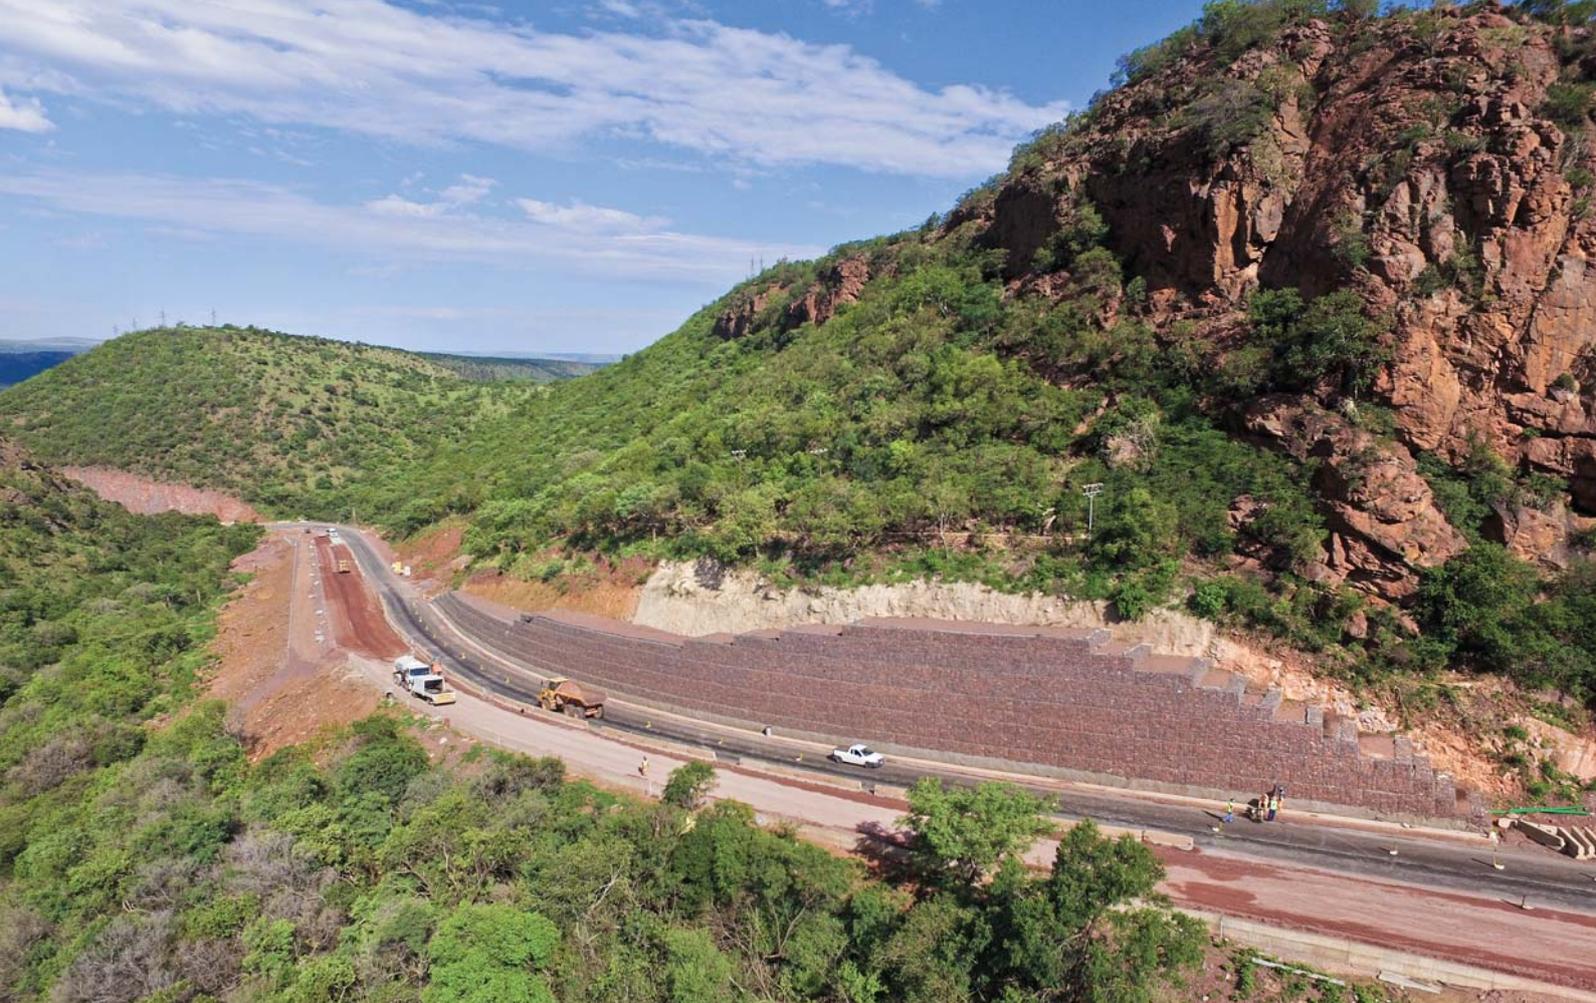
**The completed gabion tie-back wall
(December 2016)**

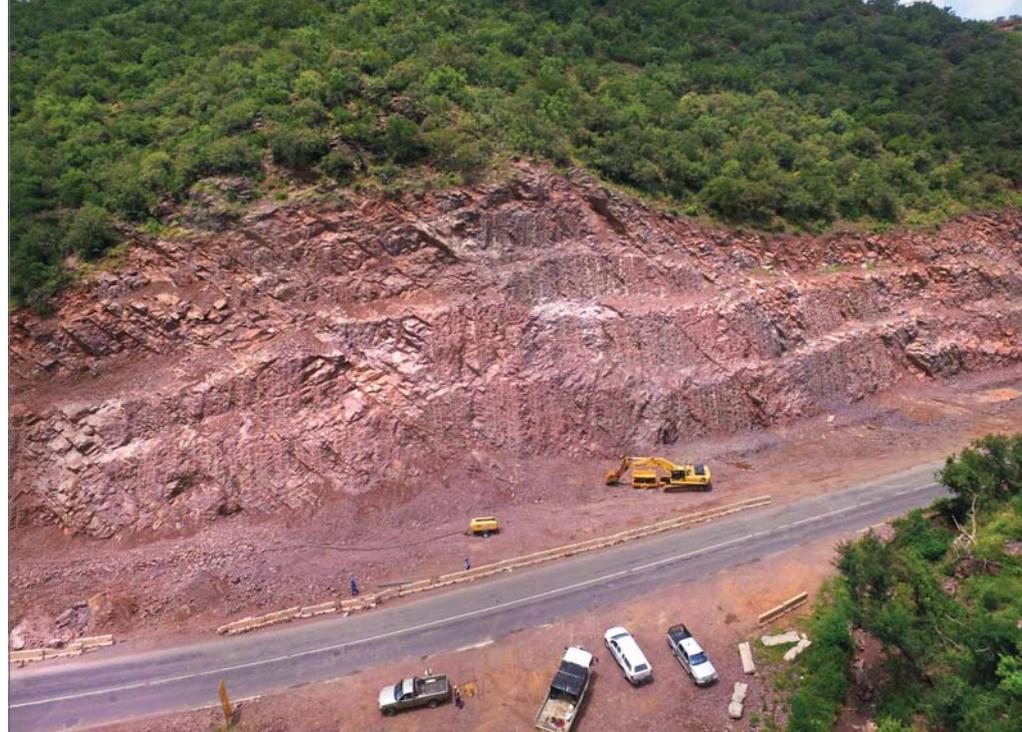
Main rock cut with wire mesh installation nearing completion (February 2017)

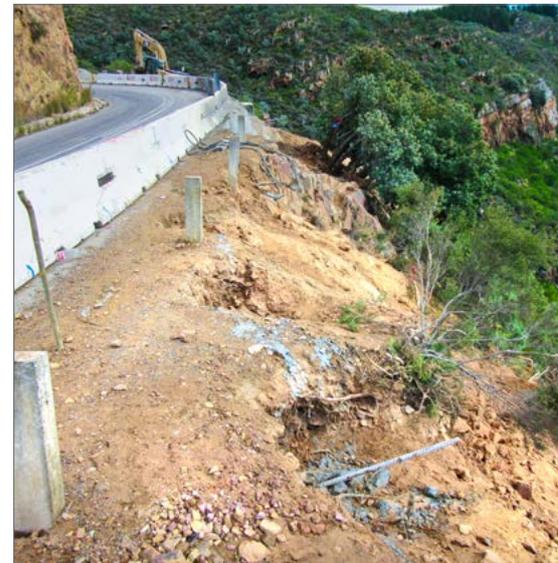
Figure 2: Existing site conditions on the Versfeld Pass

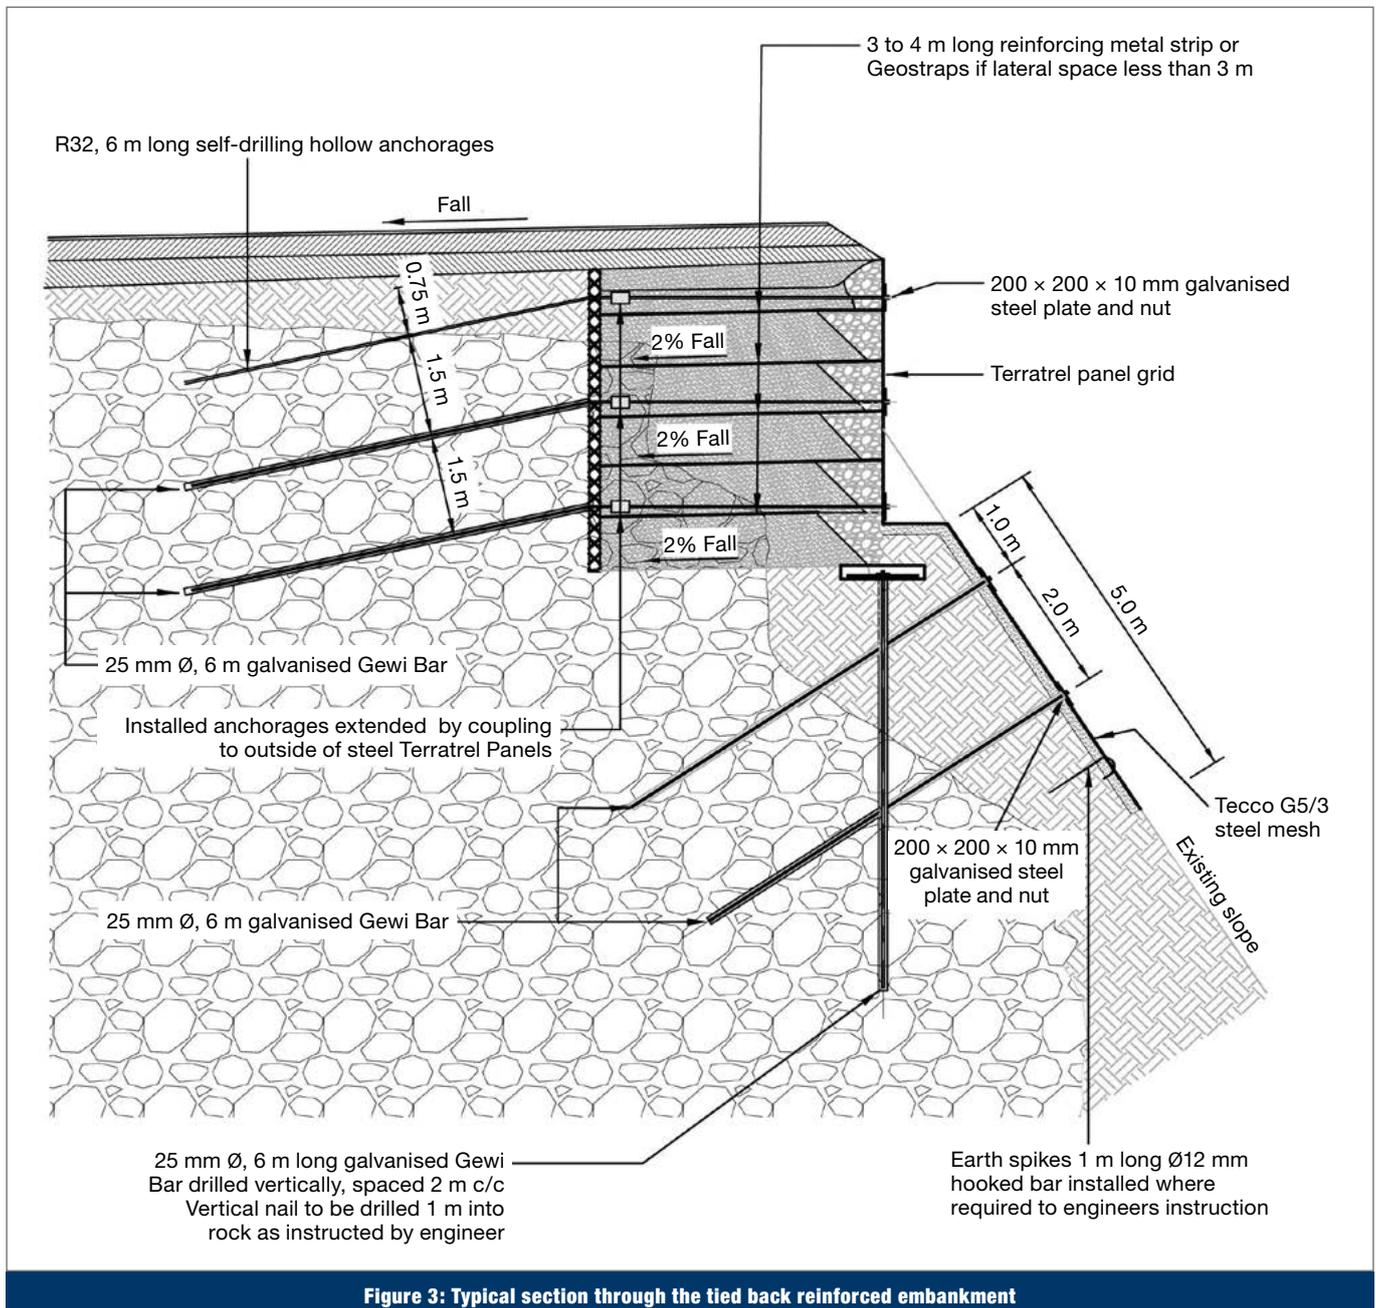
Figure 3: Typical section through the tied back reinforced embankment

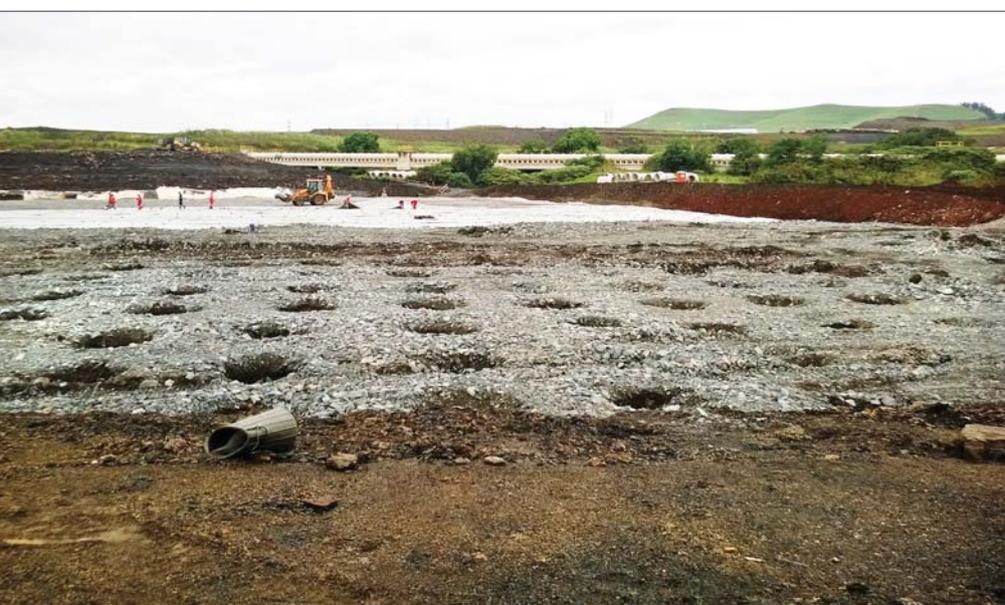
Ground improvement comprising dynamic replacement craters

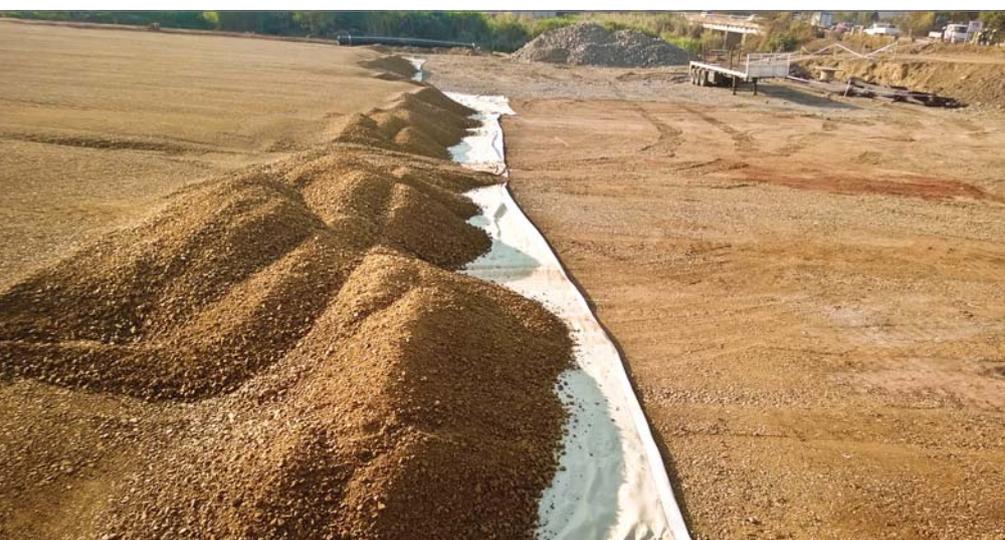
Load transfer platform designed in accordance to EBGE0

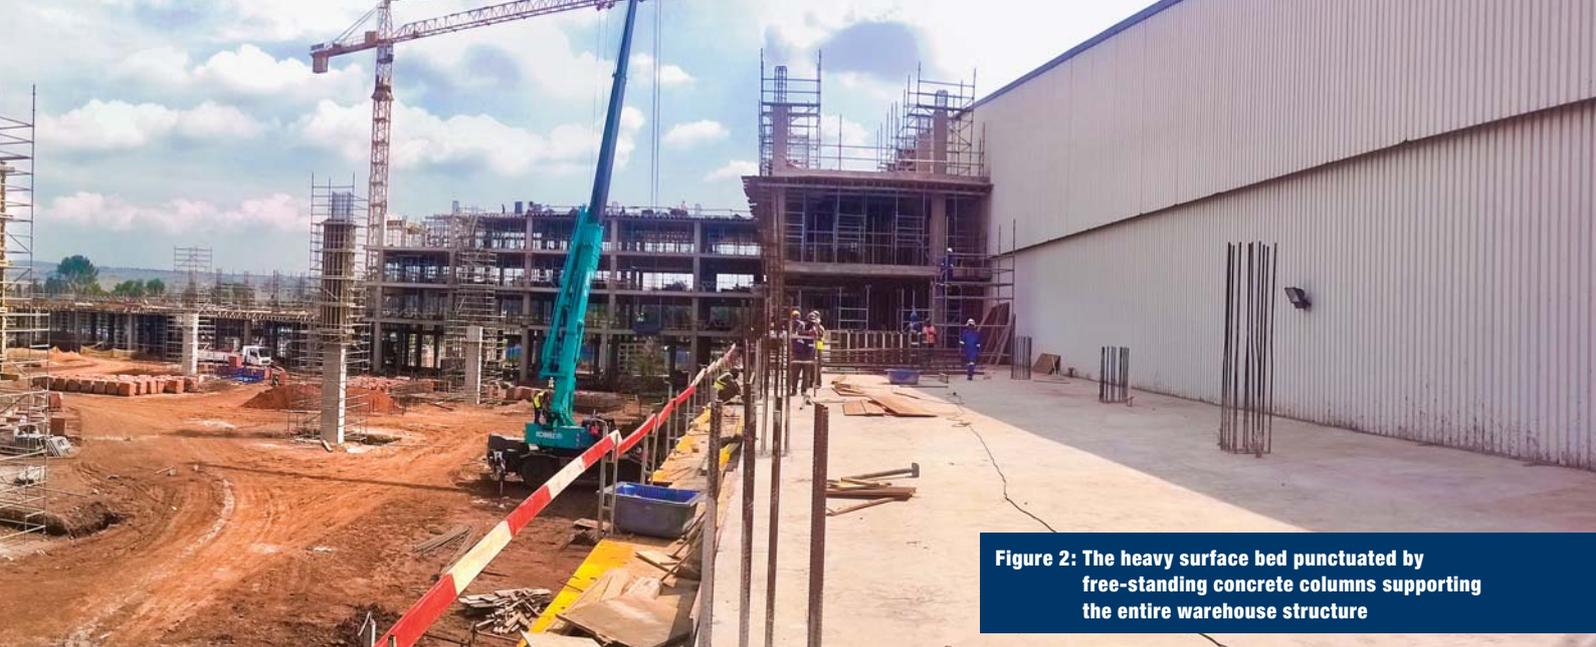
Figure 2: The heavy surface bed punctuated by free-standing concrete columns supporting the entire warehouse structure

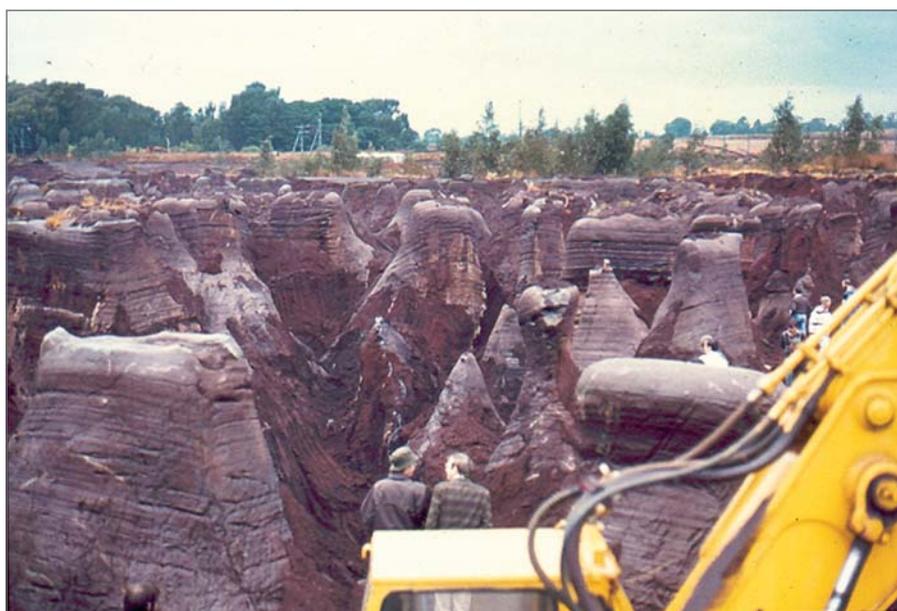
Figure 4: The local dolomite bedrock morphology is inferred to follow a similar mosaic to that exposed in the Lyttleton dolomite quarry (pinnacles) (Photo: Dr Peter Day, Jones & Wagener)

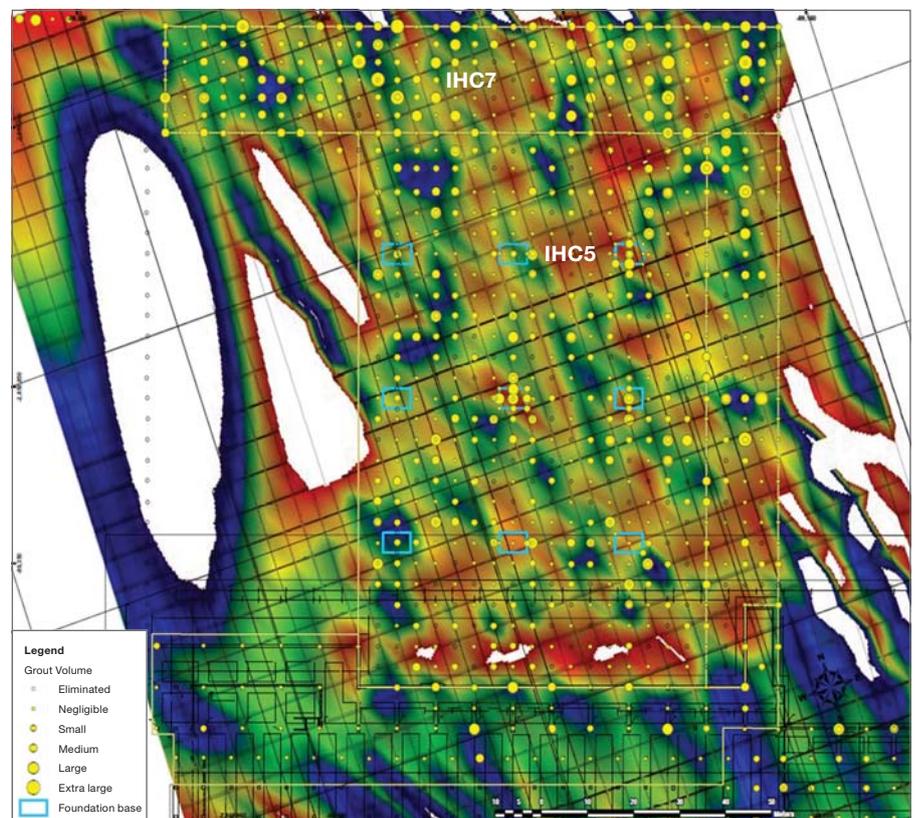
Figure 6: Portions of the site underlain by shallow bedrock are not a guarantee of problem-free bedrock, a case in point being where the two most severely impacted support columns for the warehouse (light blue base outlines) are underlain by shallow dolomite rock

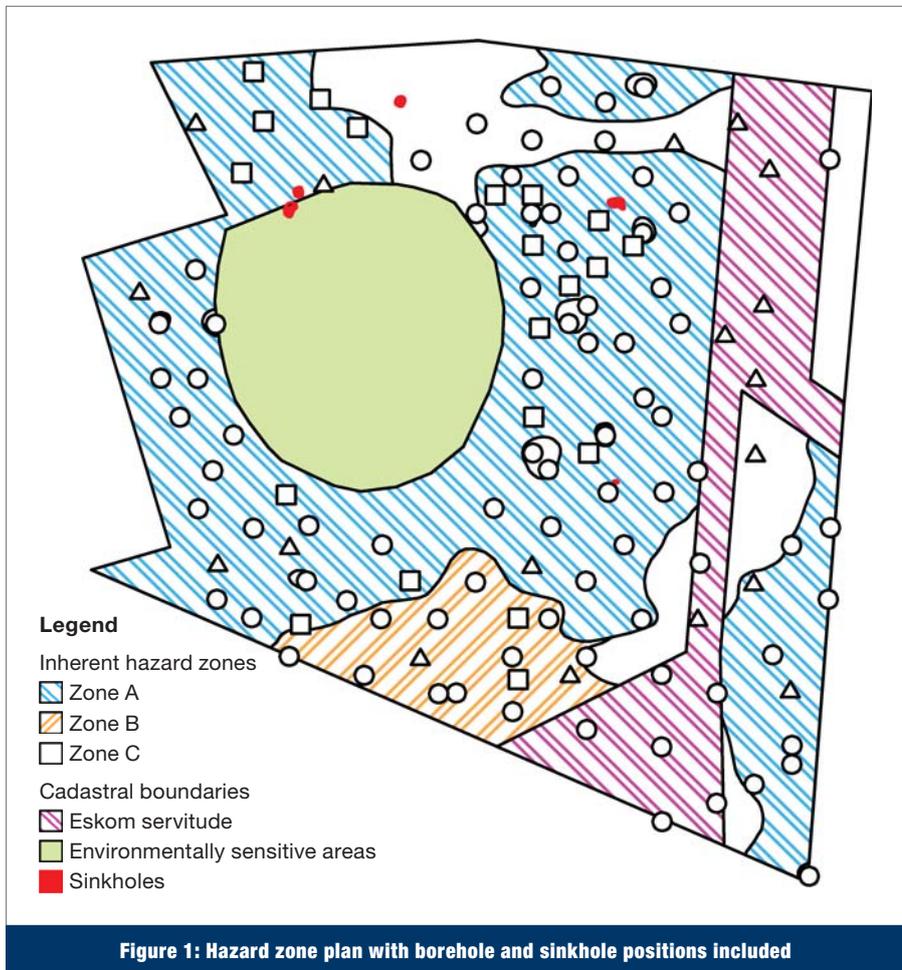
Figure 1: Hazard zone plan with borehole and sinkhole positions included

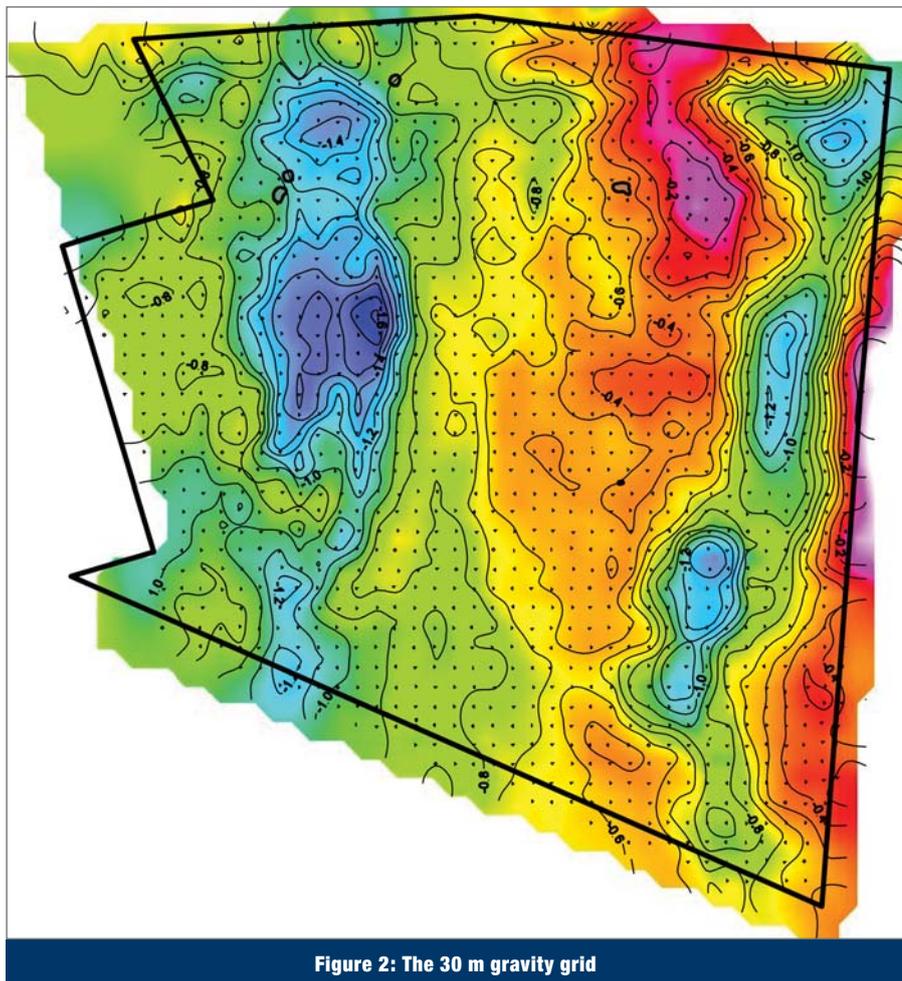
Figure 2: The 30 m gravity grid

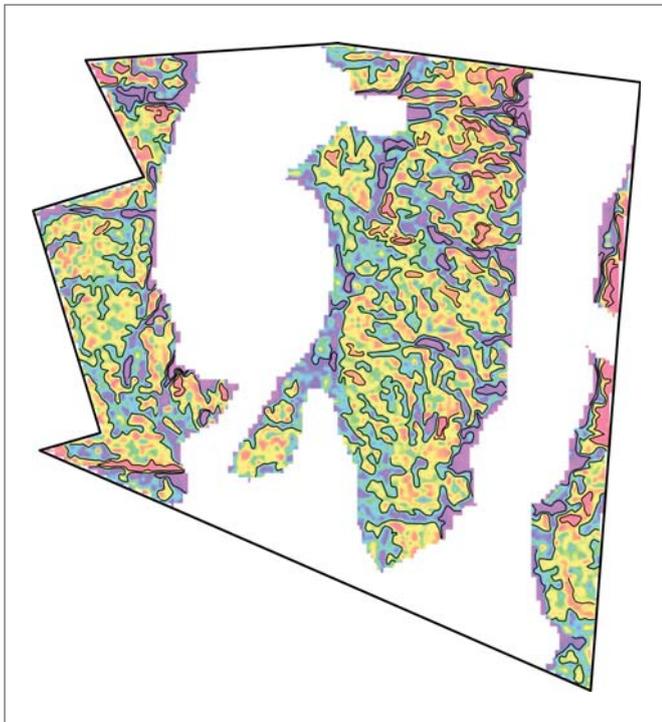
Figure 3: The 10 m gravity grid

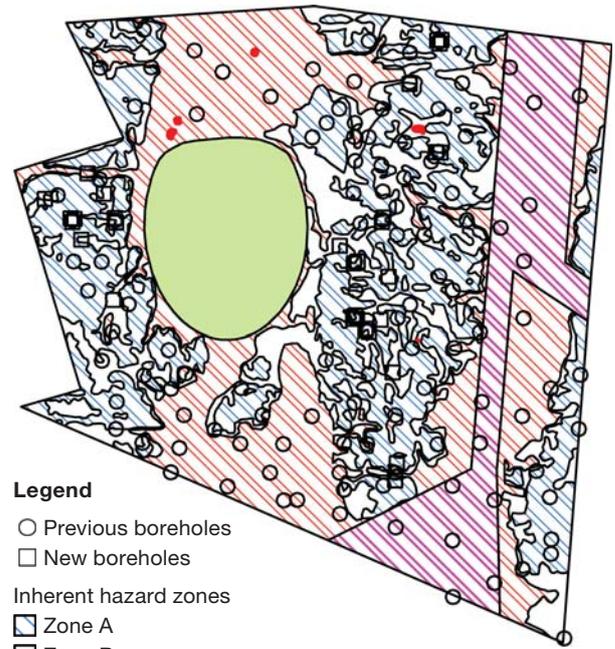
Figure 4: New hazard zoning

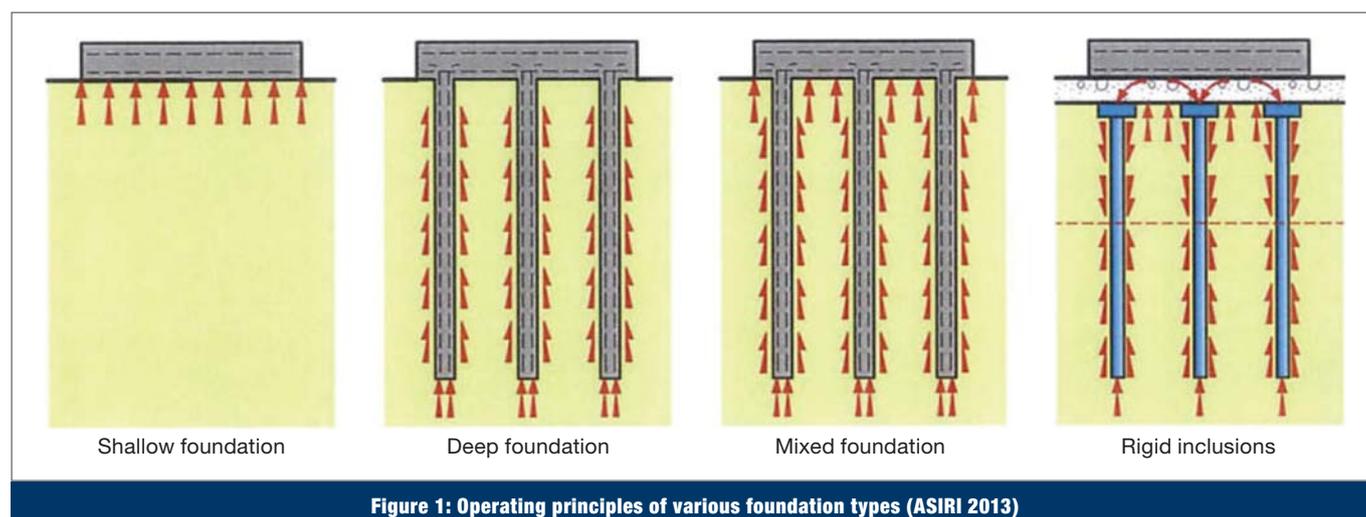
Figure 1: Operating principles of various foundation types (ASIRI 2013)

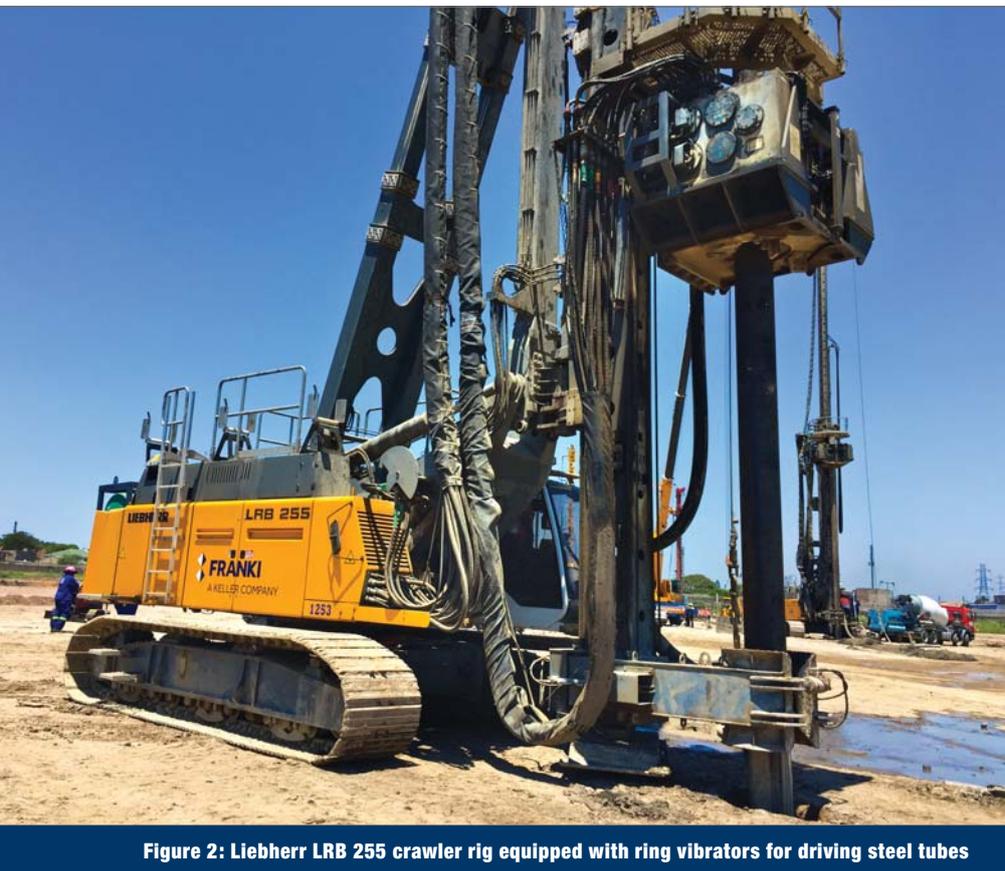
Figure 2: Liebherr LRB 255 crawler rig equipped with ring vibrators for driving steel tubes
