CIVIL ENGINEERING

**Focus on:
Geotechnical Engineering**

- Southern Cape Landslip
- Upgrading the Kranspoort Pass

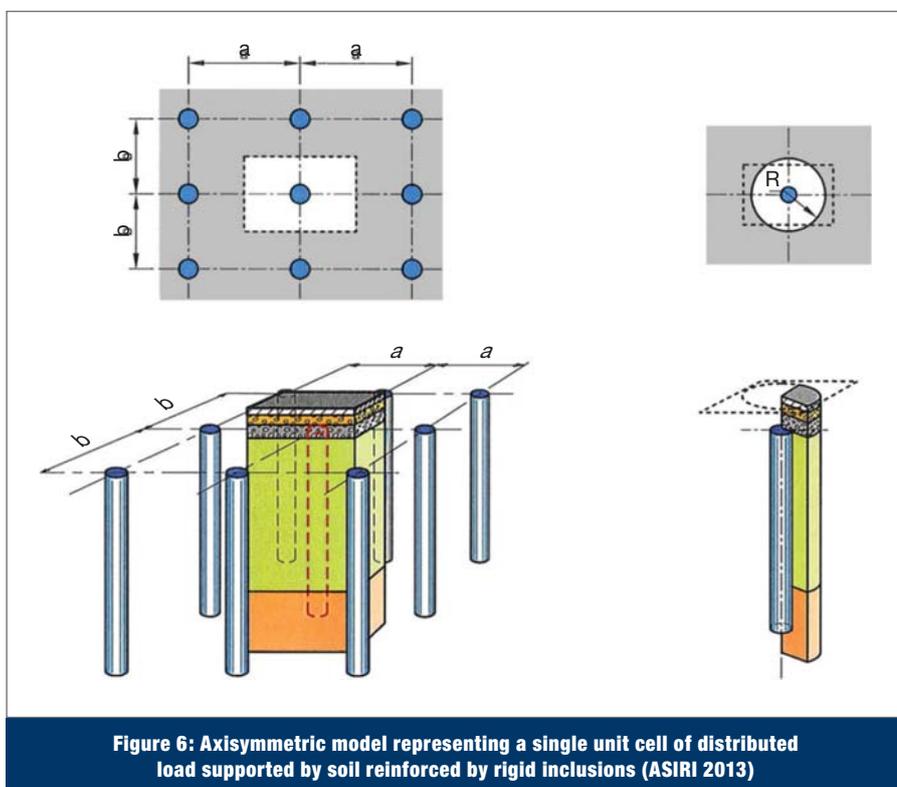
Figure 6: Axisymmetric model representing a single unit cell of distributed load supported by soil reinforced by rigid inclusions (ASIRI 2013)

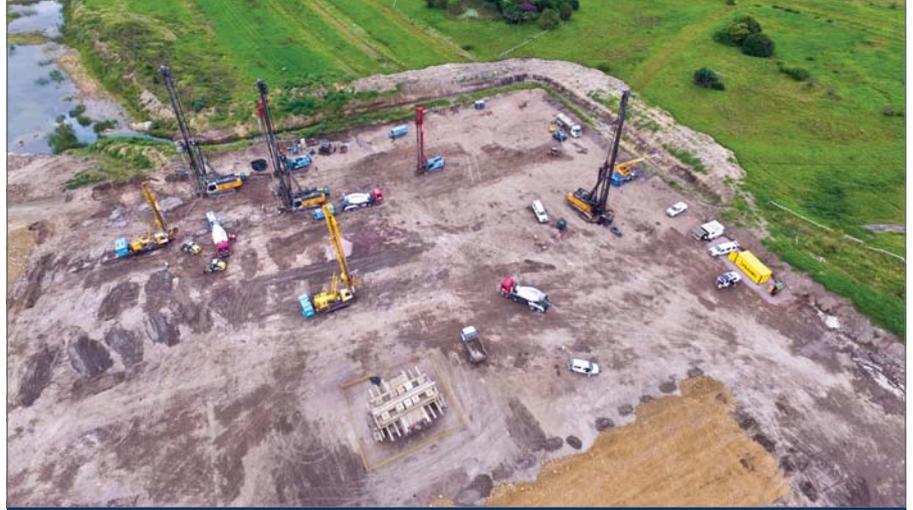
Figure 7 Aerial view of the ground improvement operations in the first area of the Clairwood Logistic Park development

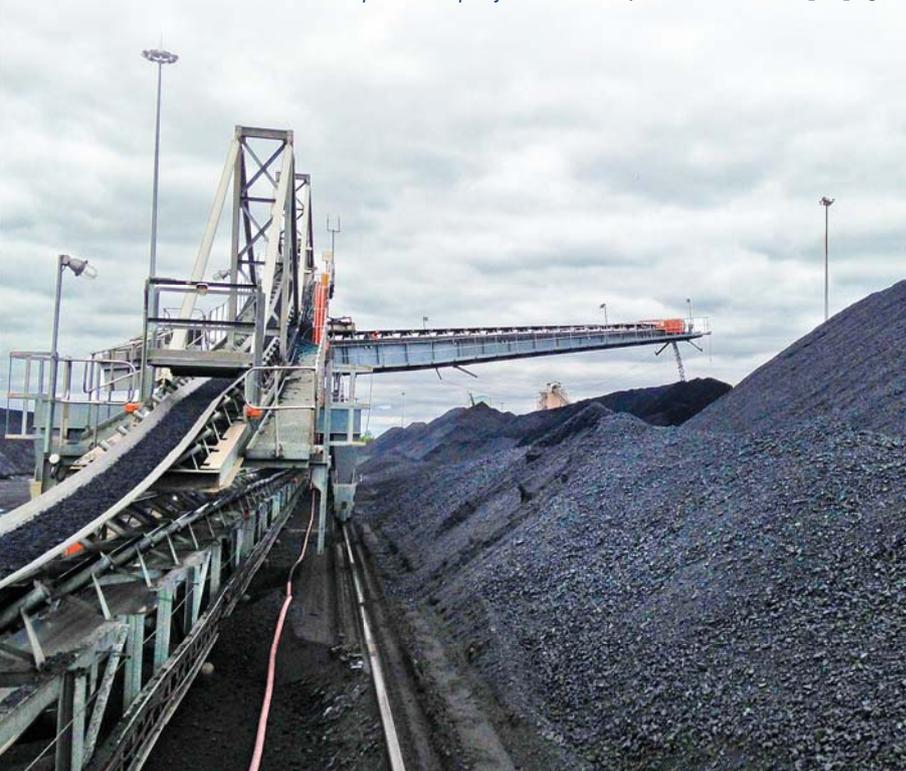
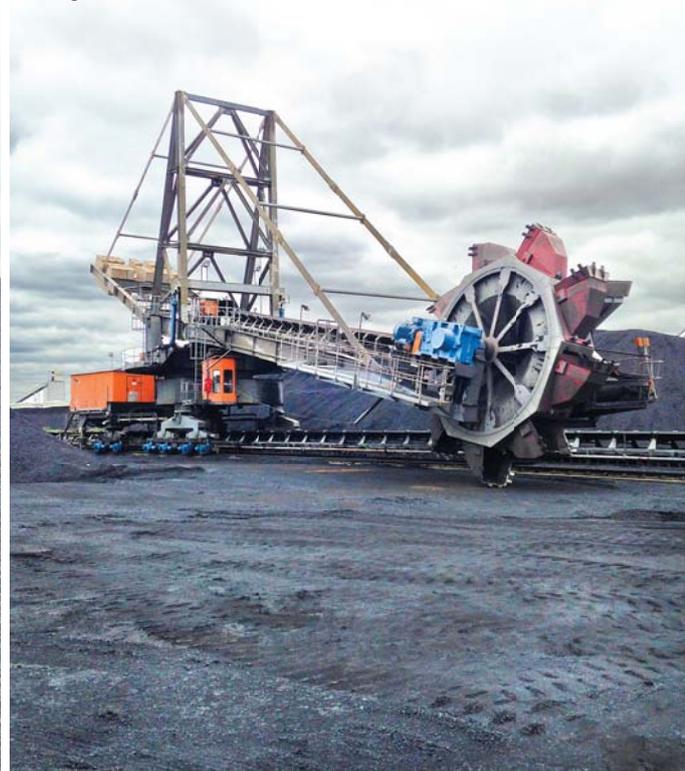
Figure 1: Existing GG6 stacker (left) and bucket wheel reclaimer (right)

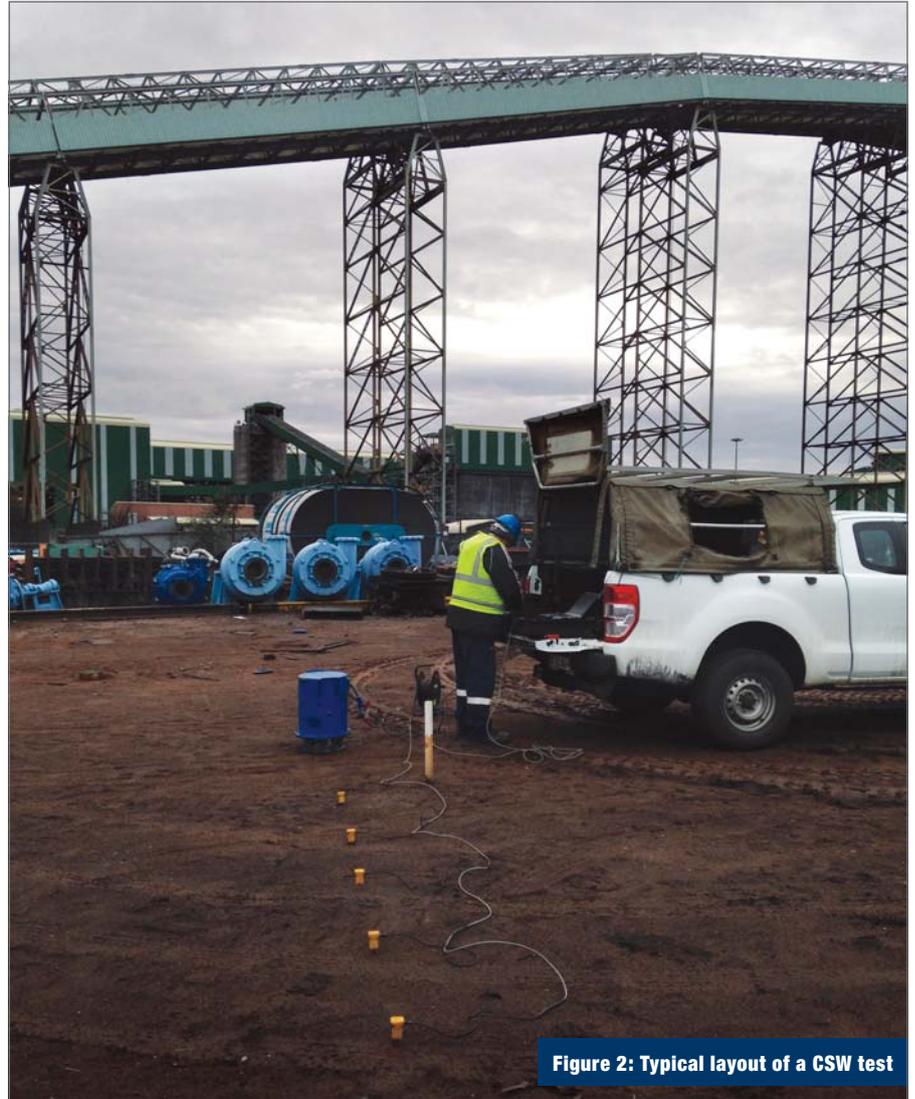
Figure 2: Typical layout of a CSW test

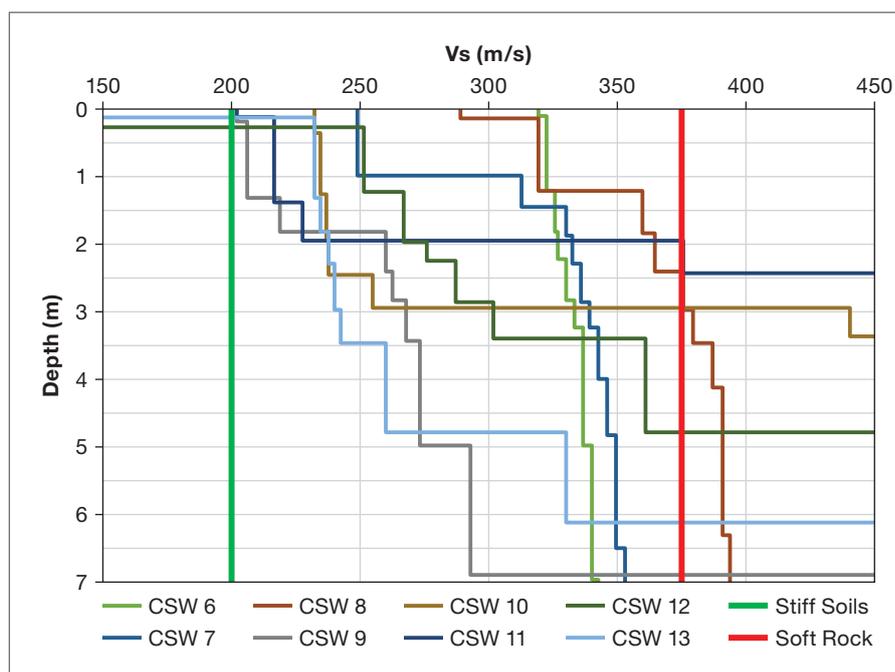
Figure 6: CSW results along the stacker rail beams

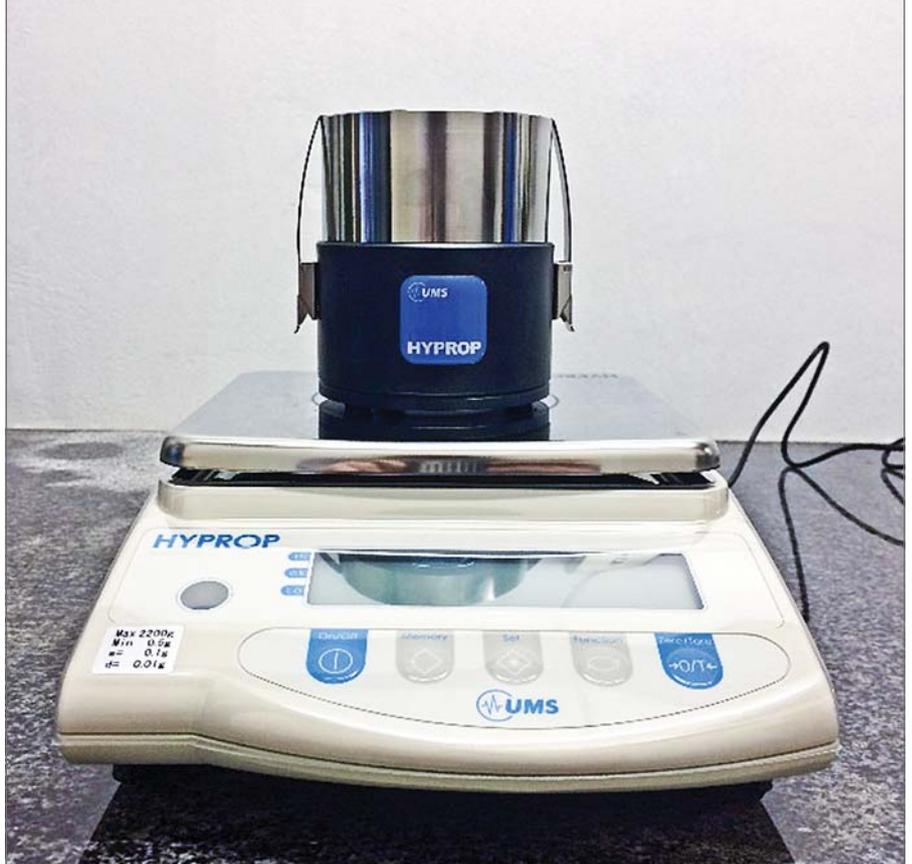
Figure 2: HYPROP device for determining soil moisture characteristics

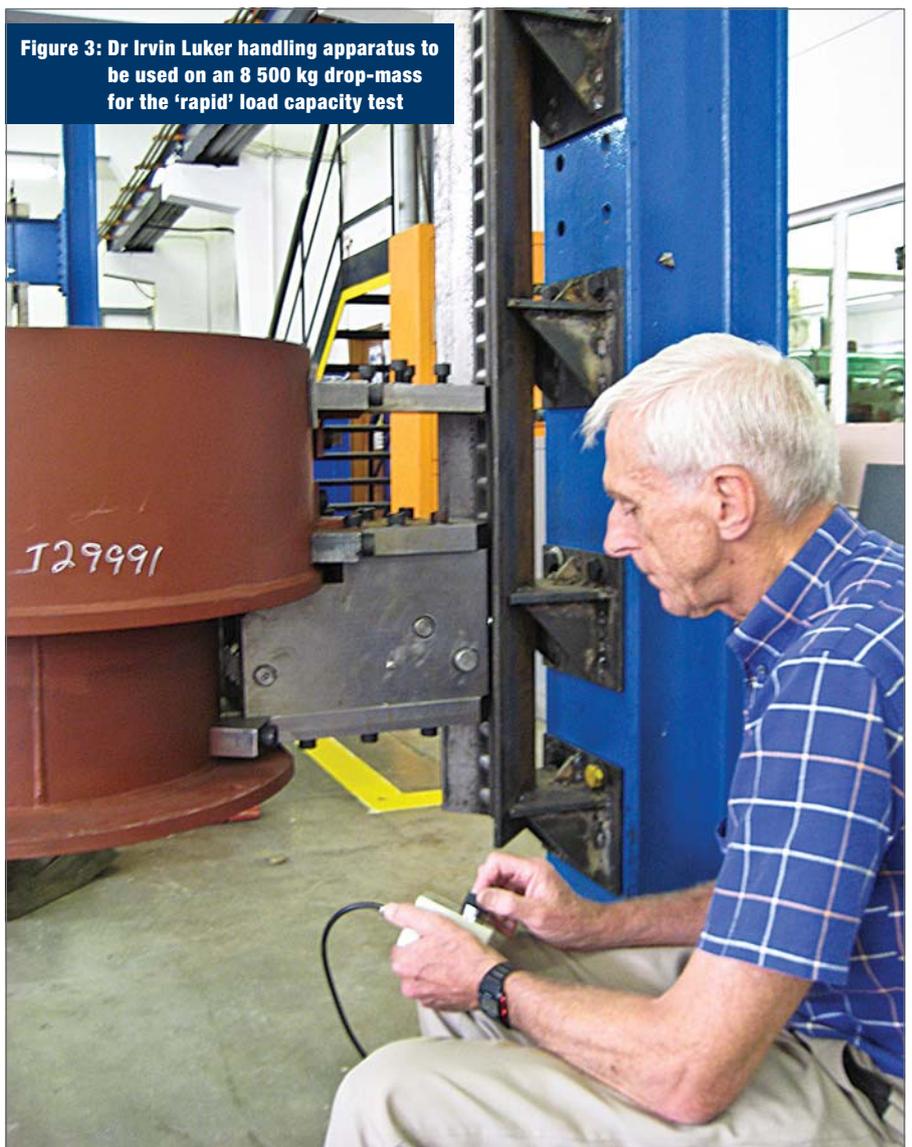
Figure 3: Dr Irvin Luker handling apparatus to be used on an 8 500 kg drop-mass for the 'rapid' load capacity test

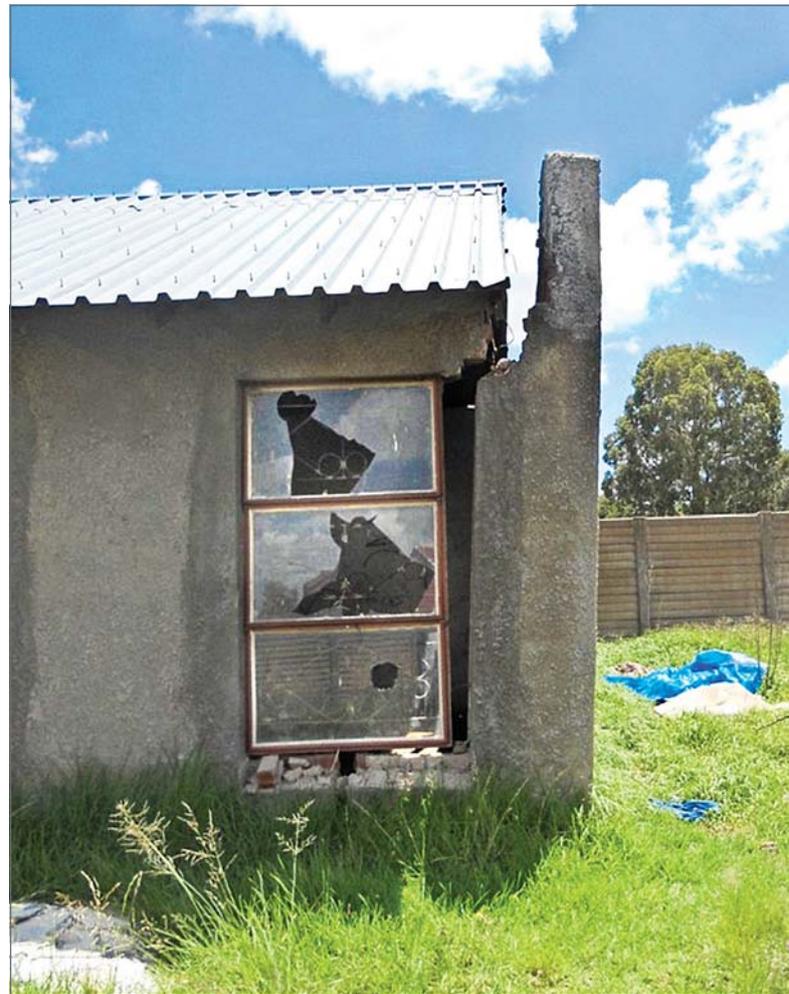
Photo 1: Example of a house which became unfit for habitation before receiving its first coat of paint

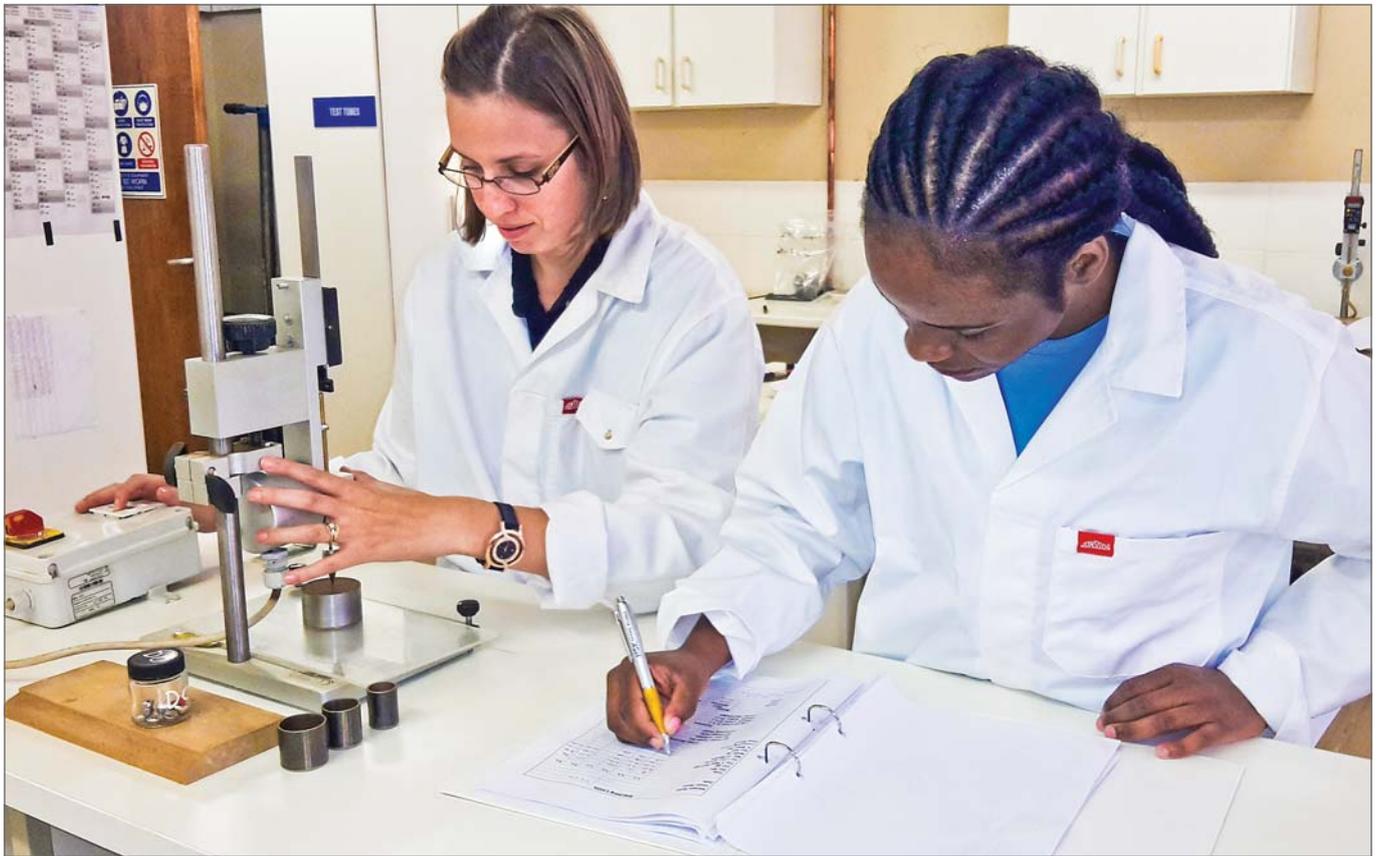
Photo 2: Testing by fall cone conducted by research student, Zandri, and research assistant, Charlotte

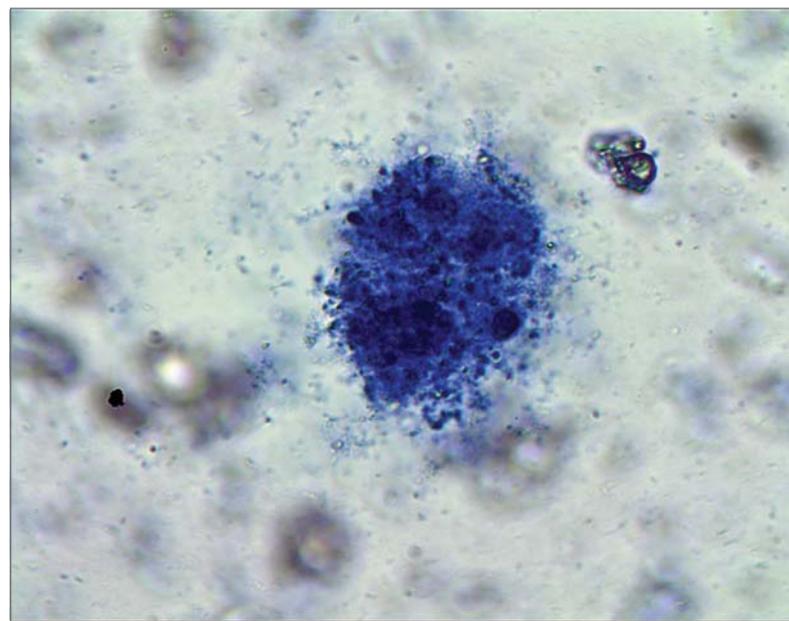
Photo 4: The large agglomeration of silt and clay-sized particles appears to be bound together by minute, blue-stained, high-cation exchange capacity clay particles

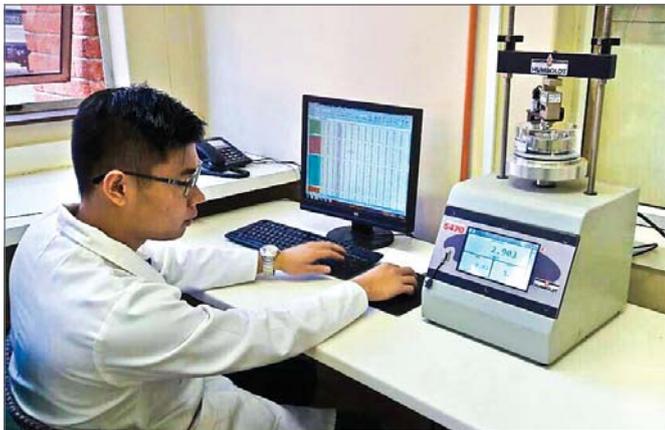
Photo 5: Research assistant, Alan, with the new conmatic auto consolidation apparatus recently acquired to conduct oedometer tests

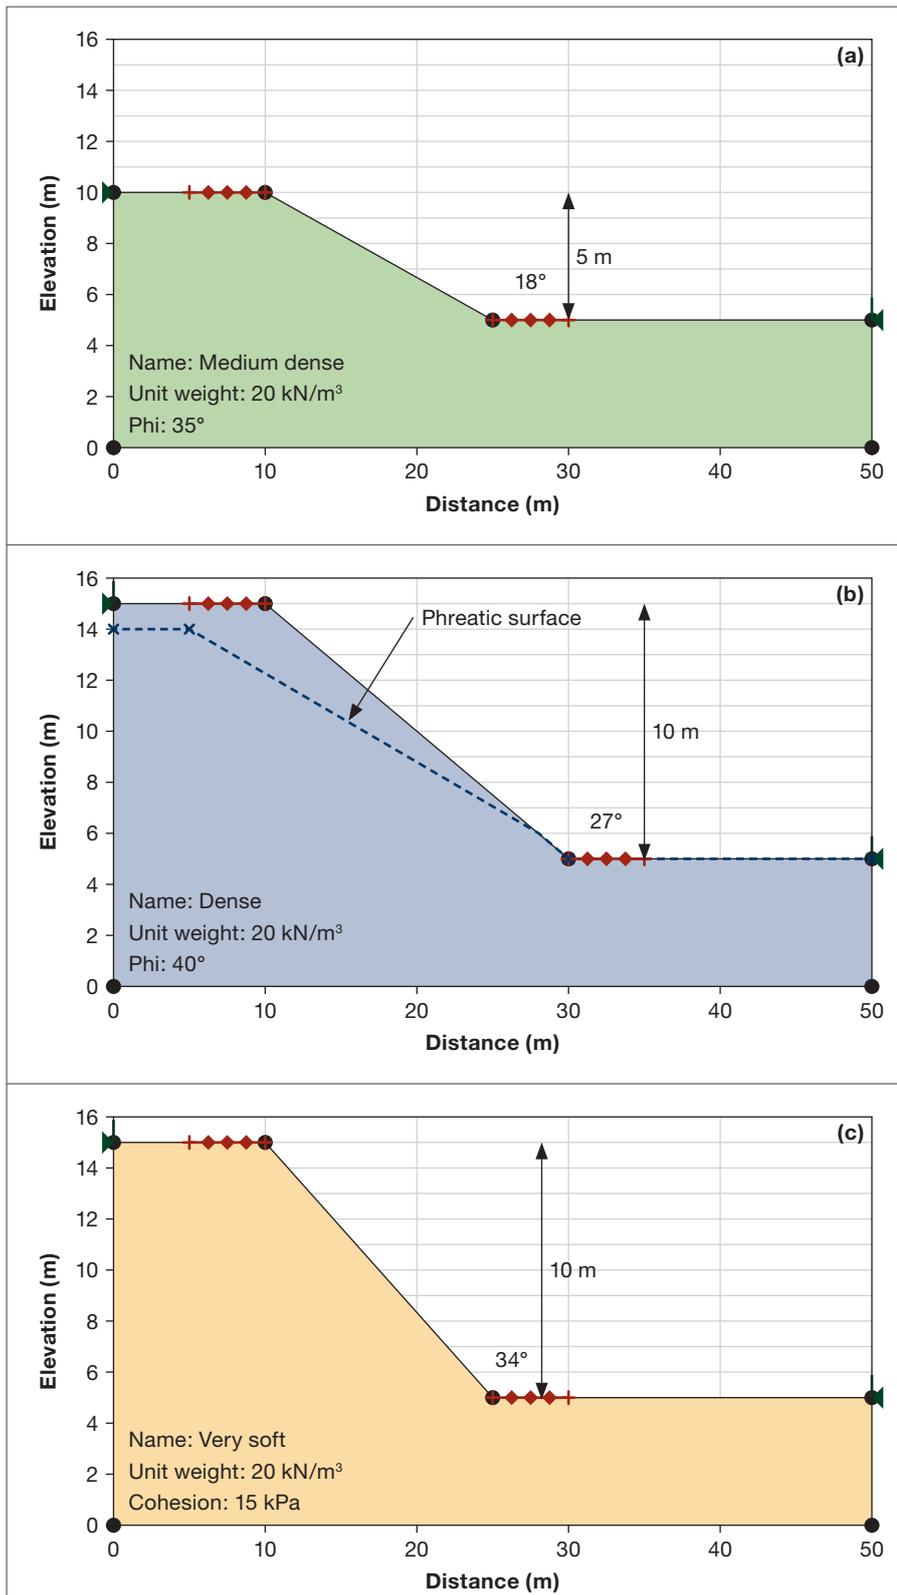
Figure 2: Example slopes: (a) drained without a phreatic surface, (b) drained with a phreatic surface, (c) undrained

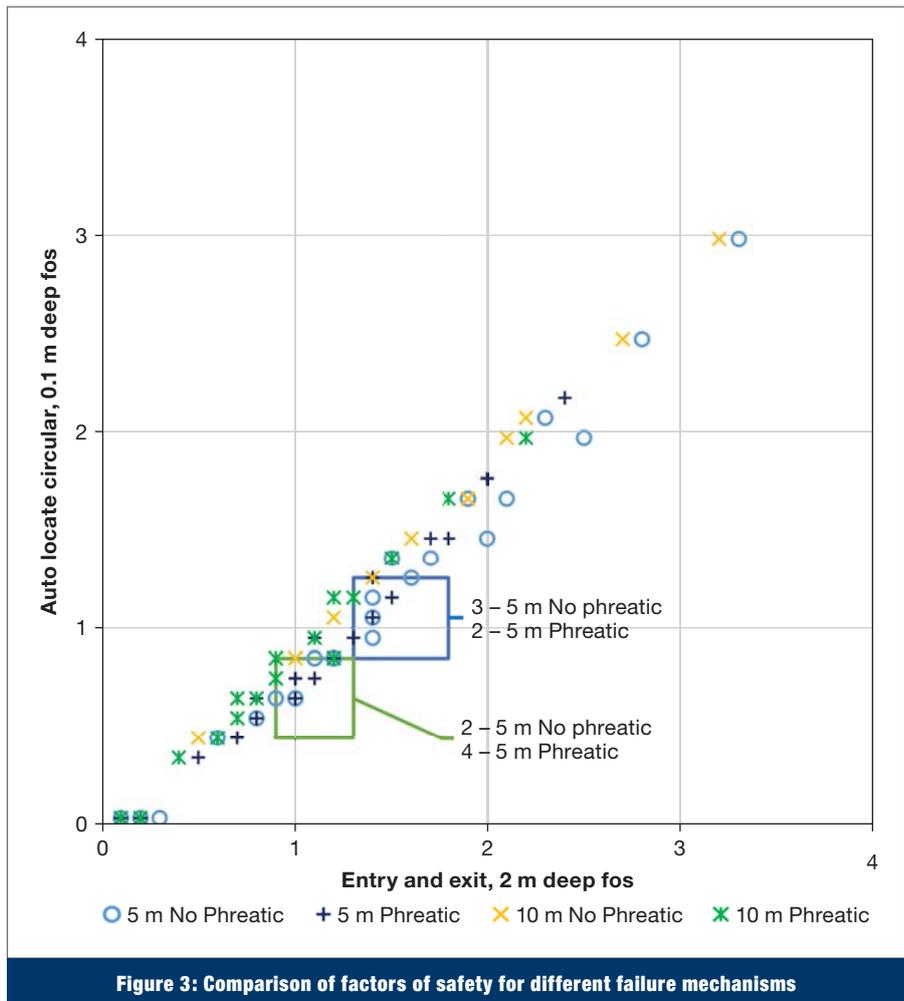
Figure 3: Comparison of factors of safety for different failure mechanisms
